Safety Alert No. 462
May 12, 2023

Process Explosion Causes Medical Evacuation

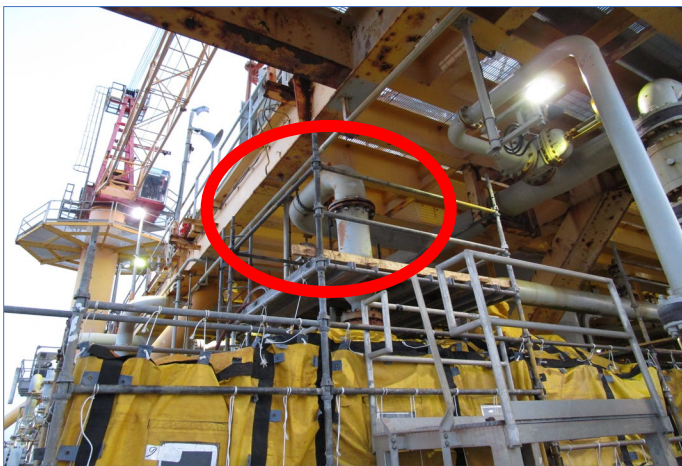
Figure 1: Worksite with flange and scaffolding, where the skillet was being installed.

Two workers were injured on an offshore platform while installing a skillet, the steel circular joining plate inside a section of piping. The incident occurred while the workers were on scaffolding and unbolting a 10-inch flange (Figure 1). After determining the skillet was the wrong size, the supervisor instructed a third worker to join the initial two workers on the scaffolding to take measurements of the skillet to verify the pipe size.

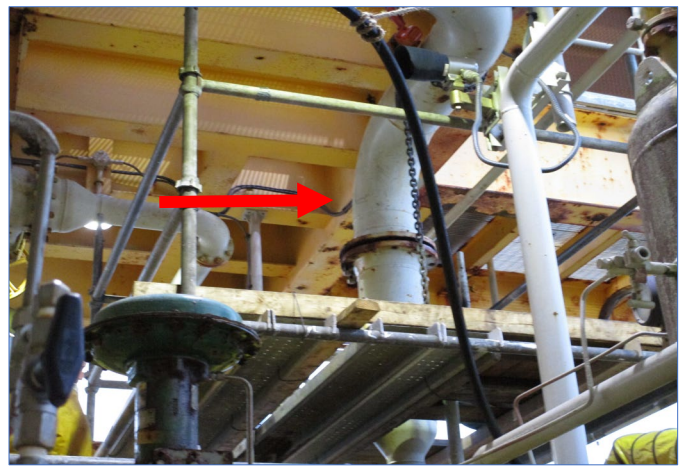
Figure 2: Opposite view of the flange with a chain hoist.

During this time, the two workers on the scaffolding became alarmed when a handheld gas detector signaled the presence of gas. Simultaneously, they heard pressure escaping between the pipe flange opening. The third worker, who was still in the tool shed, heard a rumbling sound and loud noise, and looked in the direction of the noise to see a black plume of smoke. The third worker noticed the other two workers were being exposed to the material being emitted from the gap in the parted flange (Figure 2). The two workers on the scaffolding experienced smoke
