# SAFETY ALERT

Safety Alert No. 438

April 18, 2022

## Barricades and Fall Protection Will Help Prevent Injuries Even Without Open Holes Visible

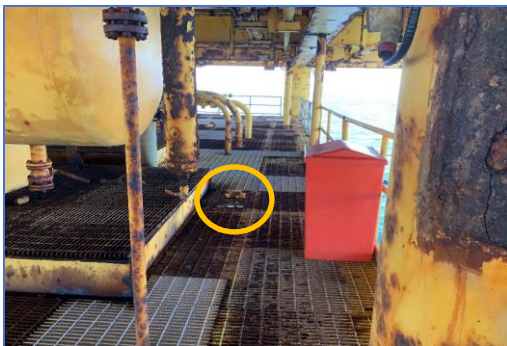
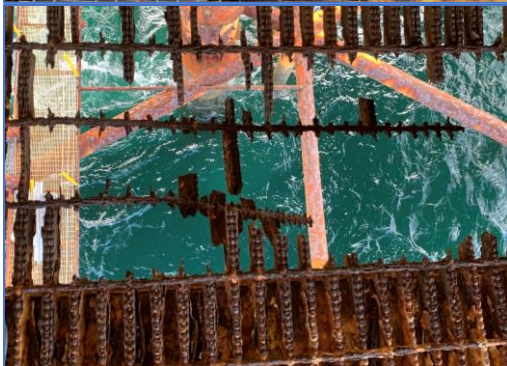
*(Left Top) Photo of unbaricaded deteriorated metal grating deck and (left bottom) close up of grating that parted. (Above) Photo of replaced corroded grating on the plus 10 deck where man overboard incident occurred.*

**Incident #2:** A construction crew member’s foot fell through grating when walking across an area known to have deteriorated and hazardous grating. The hazardous and deteriorated grating was not barricaded or flagged off (see left photos above), and the individual was not wearing any fall arrest equipment. The individual was able to grab a nearby skid panel during the fall and prevented himself from completely falling through the grating.

- Installing barricades or flagging areas around hazardous, deteriorated, or questionable grating even if there are no open holes present at the time.
- Having personnel wear proper fall arrest equipment when working in or near any area known to have or suspected to have degraded grating even if there aren’t any open holes.

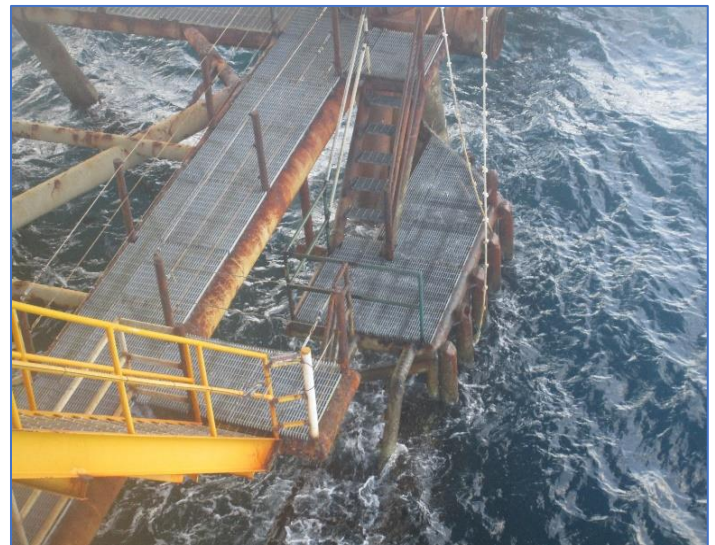
**Incident #1:** A construction contractor fell into the water while replacing corroded grating on the plus 10 deck. The individual self-rescued by swimming to the nearby boat landing and climbing out of the water. Before falling into the water, the individual exited the barricaded area, removed his fall protection, re-entered the barricaded area without fall protection, and

began taking measurements before the suspected grating gave way. Although the construction crew reported the incident to their immediate supervisor, the “man overboard” incident was not immediately reported to the facility’s person in charge. Photographs of the deteriorated grating and open hole were not captured.

- Ensuring all personnel inspect fall protection equipment before donning it and starting work in a barricaded area and/or an area with signage indicating the presence of holes or deteriorated grating and handrails.

- Ensuring that personnel write up a Job Safety Analysis (JSA) (or similar job safety work plan) that covers the fall protection equipment, barricading the area in question, and breaking down how to safely work when repairing/replacing deteriorated or missing grating and handrails.
