# SAFETY ALERT

**Safety Alert No. 454**

**December 14, 2022**

## **Auxiliary Line Abrading Causes Rope Guard Failure**

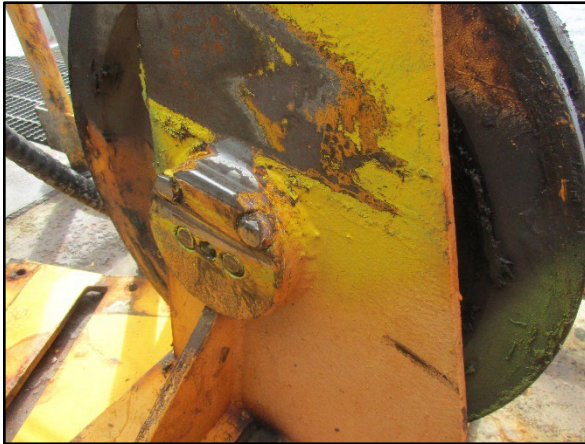
Abraded main line carrier sheave side plate and pin boss.

A BSEE investigation found that chronic scraping and rubbing by an auxiliary line created enough damage to the main line idler sheave carrier side plate, pin boos, rope guard, and auxiliary line that it caused the guard of the main load line idler sheave carrier to fail. The rope guard fell approximately 100 feet, landing near personnel working below.

This damage occurs when the auxiliary line is used at high rates of speed, causing the auxiliary line to jump onto the main line idler sheave. This incident involved an American Aero OM 450 crane; other cranes with a similar configuration could see the same issue. Additional information is included in the [BSEE Accident Investigation Report](#).

- Inspect idler sheaves and wire ropes for wear indicative of friction and abrading when performing pre-use inspections described in API RP 2D.
- Replace single main load line idler sheave carriers with a double sheave idler.
- Review [Safety Alert #426](#) regarding dropped object hazards.

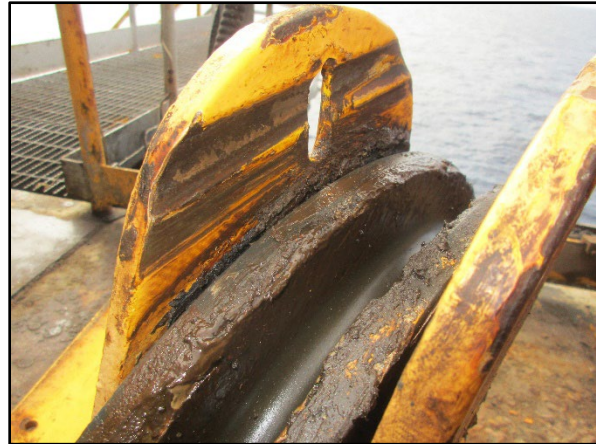
Inside abraded main line carrier sheave side plate that is missing rope guard.
