# Safety Alert

Safety Alert No. 260  
24 April 2008

## Guide Post Fails Catastrophically, Causes Fatality

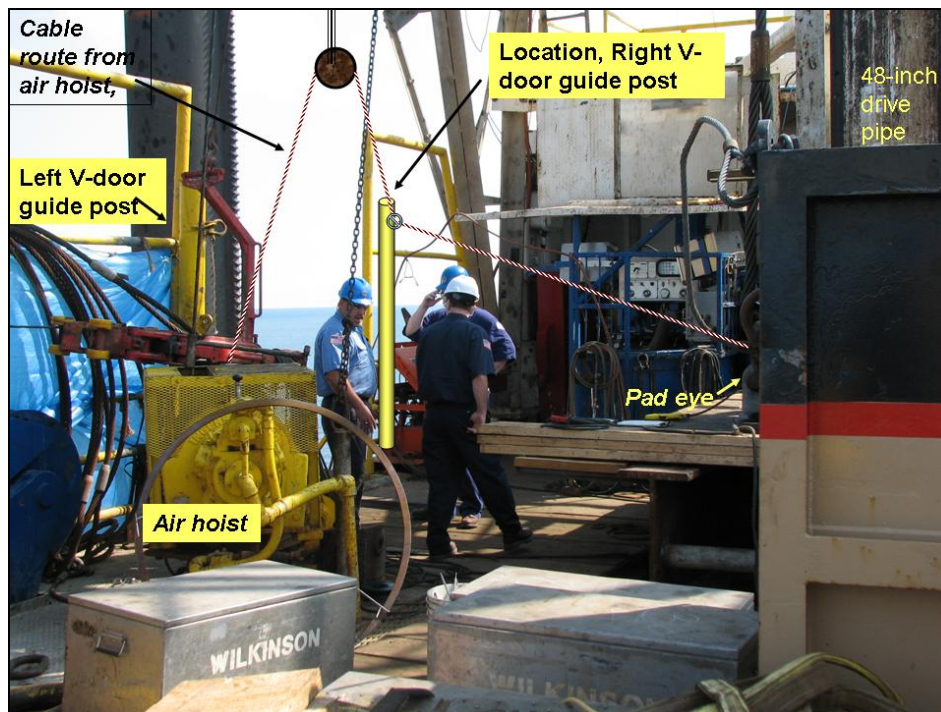
In a recent incident on a drilling rig a floor crew rigged a block and tackle assembly to the top of one of the V-door guide posts and used the air hoist to attempt to rotate a 48-inch drive pipe string.

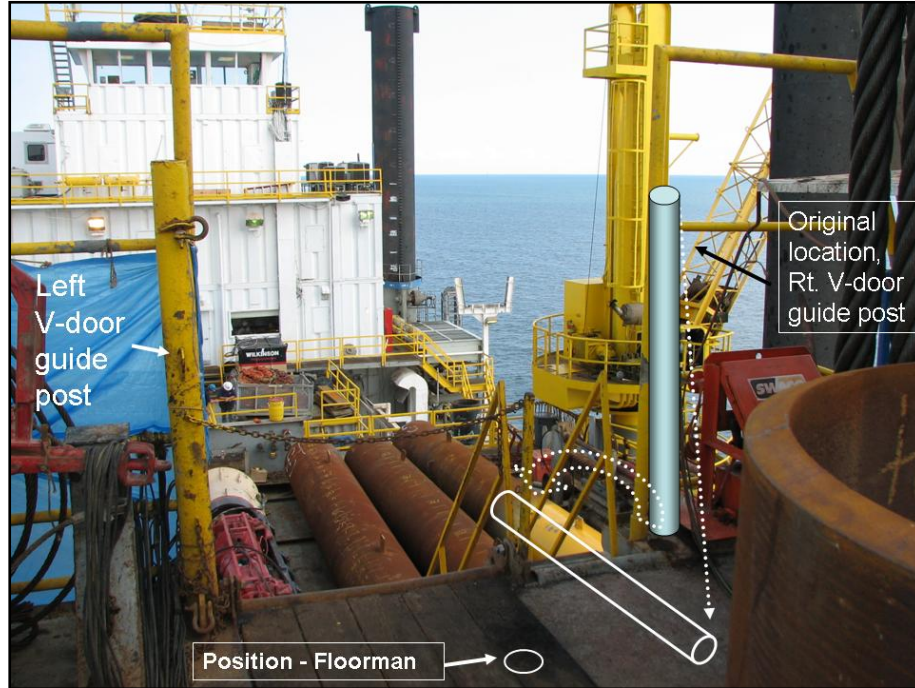
The string could not be rotated fully into position and when one of the floormen went to check the connection, the V-door guide post suddenly broke off from its weld. Propelled by the cable tension, the V-door post jumped across the floor fatally striking the floorman. A full account is available at:

1. Floor supervisors and rig managers did not review the methodology used to turn the drive pipe.
  - *The V-door guide posts are usually thin walled, tack-welded pipe that is not suitable for bearing loads. The post that failed had several pad eyes attached to it which facilitated its use as a base for supporting loads.*

- *Hooking up to the top of the V-door post multiplied the forces applied to the bottom of the post and the weld by a very large factor.*
  - *The routing of the cable did not allow enough of an angle to turn the drive pipe when the pad eye neared the stops. Applying further force simple pulled a bind rather than applying torque.*

- 2. Mark non-load bearing structural components of the rig that might be used for anchoring heavy loads and insure that all crew members understand what “non load bearing” means. Do not use V-door guide posts as a base of support for significant loads unless they are specifically designed for it.*
