MMS

Safety Alert No. 278 7 April 2009 Contact: Jack Williams (504) 736-1757

One Killed when Oil Pollution Pan Falls

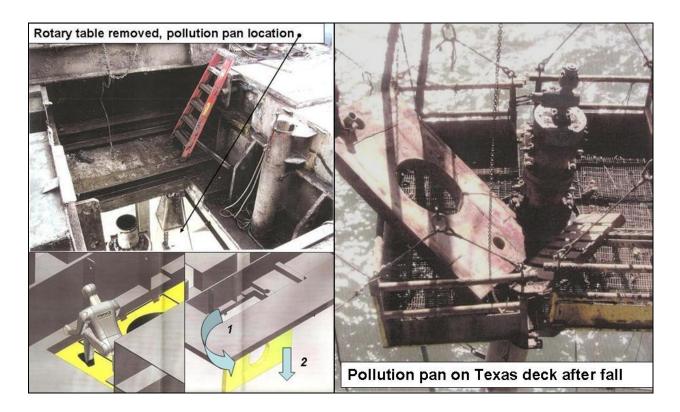
In a recent incident on a drilling rig a casing crew was rigging up to run 60-inch over-drive pipe. Two welders were cutting a hole in the pollution pan beneath the rotary when the pan suddenly dropped out from beneath them and fell 50-ft to the Texas deck. One of the welders fell with the pan and was killed.

An investigation discovered that the oil pollution pan was only attached to the rig by 3-inch metal straps, not hard-welded or bolted to the rig sub-structure. These straps were cut by the welders in the course of their work, which allowed the pan to fall out from beneath them.

- 1. The casing crew did not know how the oil pan was attached. They assumed (but did not check) that the pollution pan was directly welded or bolted. As a result, no fall protection was used.

- **1.** Rig OIMs and supervisors should review <u>how oil pollution pans are attached to their rig</u>. Contract supervisors should conduct a thorough review of the parameters of their tasks prior to starting work.
