**THE BUREAU OF OCEAN ENERGY MANAGEMENT,
REGULATION AND ENFORCEMENT**

**REPORT REGARDING THE CAUSES OF THE APRIL 20, 2010
MACONDO WELL BLOWOUT**

September 14, 2011

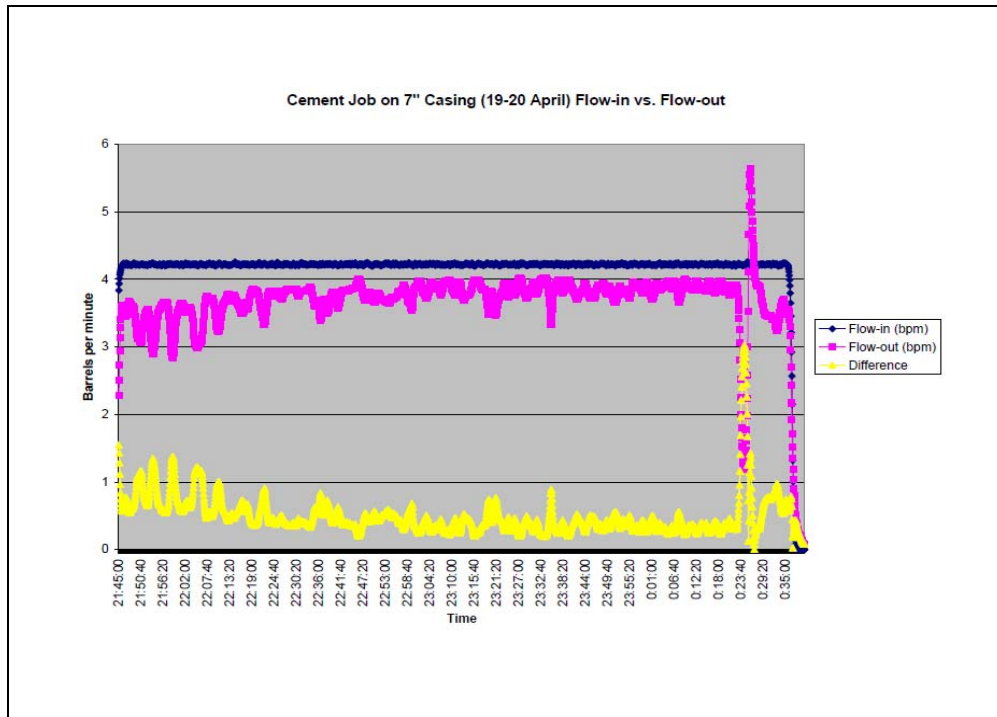
Figure 5 - Flow-out vs. Flow-in on the Production Casing Cement Job (Calculated by Panel)

This possible range of loss exceeded the entire volume of cement pumped during the production casing cement job. This could indicate that over-displacement of cement occurred in the shoe track. In other words, the cement could have been pumped into the well, past the shoe track, which would have left spacer and no cement in the shoe track to isolate the center of the production casing. If over-displacement occurred, it would have resulted in insufficient cement coverage in the shoe track.

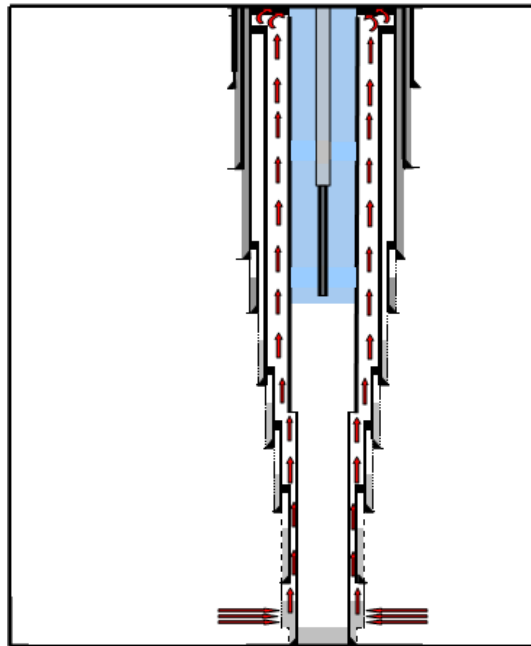
Figure 6 – Flow Up the Annulus and Through the Seal Assembly

Under this scenario, hydrocarbons would have flowed from the reservoir up the backside of the tapered casing string, and through the seal assembly into the riser. If this had occurred, the nitrified annular cement intended to isolate the hydrocarbon zone(s) at the production interval would have failed, the casing would have lifted or floated, and the seal assembly would have failed in conjunction with the casing lifting. This potential flow path is illustrated in Figure 6, below.

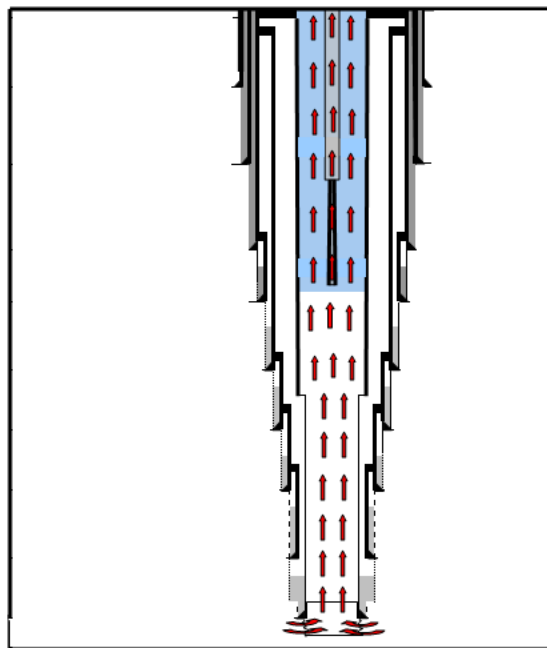
Figure 8 – Flow up the Production Casing Shoe Track

Under this scenario, hydrocarbons would have flowed from the reservoir through the casing shoe, into the well and up the riser to the rig. For this flow path to have occurred, the shoe track cement would have failed. A number of factors could have caused the shoe track cement to fail. First, mud in the wellbore could have contaminated the shoe track cement and caused the cement not to set properly. Second, the shoe track cement might have swapped out with the lighter drilling fluid in the rat hole. Third, some of the shoe track cement could have been lost into the formation. Finally, the failure of the shoe track could have resulted from a combination of these factors. This scenario is represented in Figure 8 below.

The approximately 189 foot bottom section of the casing in the well, called the shoe track, consisted of sections of casing with a reamer-guide shoe at the bottom and a dual flapper float collar on top. These sections of casing that make up the shoe track are meant to contain the top, or tail cement, which in the Macondo well was unfoamed cement.
