BSEE PANEL REPORT 2024-01

**Investigation of March 25, 2022, Hydraulic Workover Unit Failure Fatality**

**Lease OCS-G04909**

**Main Pass Block 64 Platform #19**

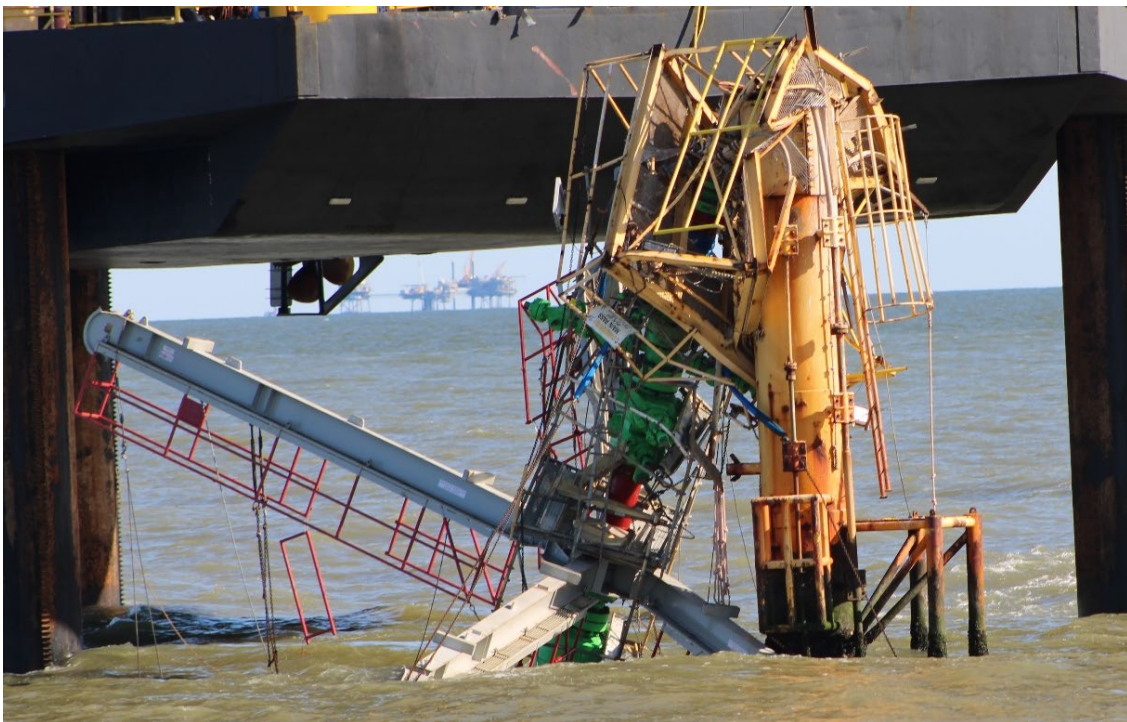
At approximately 0600 hours, a safety/handover meeting for the day crew was held. After the meeting, the day crew installed guy lines from the work basket and the jack back to the anchor beams. At approximately 0830 hours, after installing the guy lines from the pipe jack to the anchor beams, the victim unshackled the crane rigging from the pipe jack. At this time, wind speeds were 13 to 21 mph. Within a few minutes, as the crane moved away from the HWU, the unit began to sway and fell into the water (Figure 4). The victim was wearing fall protection that was secured near the top of the HWU and was still tied off when it fell, pulling him down into the water.

*Figure 4: HWU After Falling into the GOM*

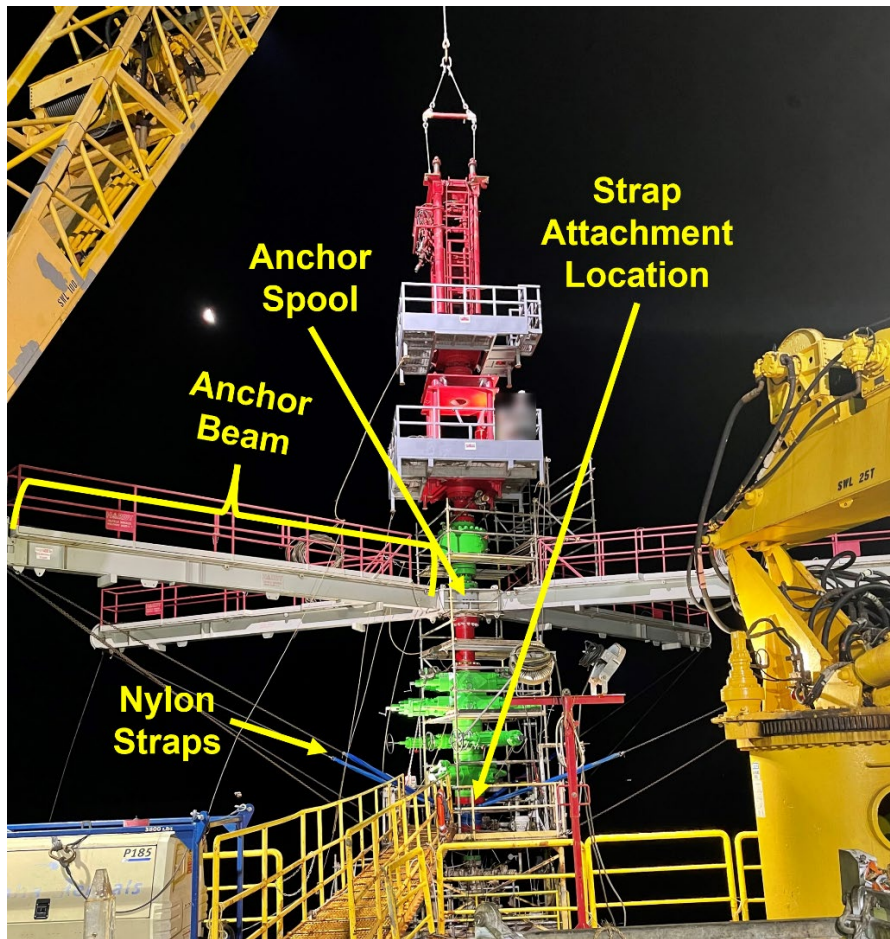
attached, as seen in Figure 6. Guy lines attached to the HWU above the Anchor Spool connect to the beams, and then the ends of those beams have guy lines fixed to the platform. The sole purpose of this system is to stabilize the HWU, not to support its weight.

Figure 6: Annotated HWU Showing Nylon Strap Location

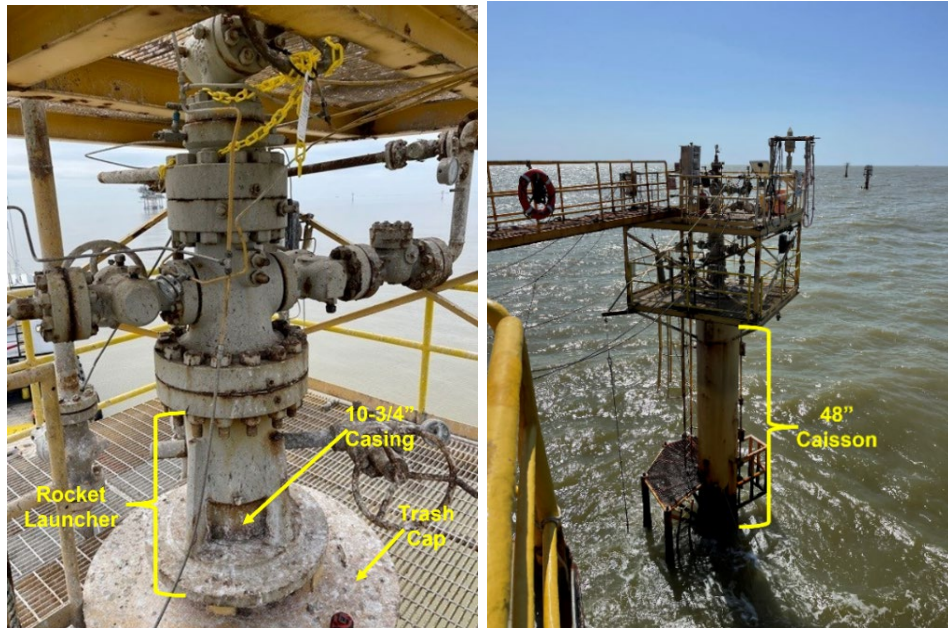
Figure 7: Annotated Elements of the Wellhead and Platform (Right Photo Taken from the L/B Swordfish)

The MP 64 #19 platform structure was affixed to the 48-inch caisson seen in Figure 7. Within the 48-inch caisson is the 20-inch drive pipe (structural casing) with a half-inch thickness when originally installed. To prevent debris from entering the annulus between the 48-inch caisson and 20-inch structural casing, a trash cap was installed on top of the caisson. The structural casing rises a few inches above the top of the trash cap, with the rocket launcher sitting on top of the structural casing. The rocket launcher base plate was approximately 28-inch in diameter. The 10-3/4-inch casing can be seen in the window of the rocket launcher. Inside the 10-3/4-inch casing is the 7-5/8-inch casing and the tubing. The weight placed on the wellhead is held up by the structural casing. BSEE found no evidence that the rocket launcher was welded to the structural casing, which allowed the wellhead to move.

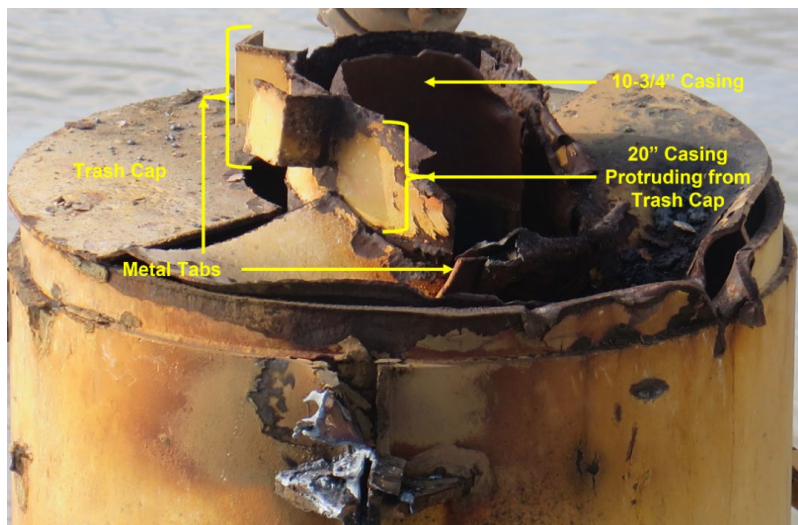
Figure 8: Annotated Casing After Site Clearance

There was no evidence that there were centralizers inside of the structural casing to keep the 10-3/4-inch casing appropriately centralized. Photographs show there were metal tabs attached to the structural casing where it protruded from the trash cap (Figure 8). However, those tabs were only welded to the structural casing, and BSEE did not observe evidence that the tabs were welded to the rocket launcher base plate (Figure 9).

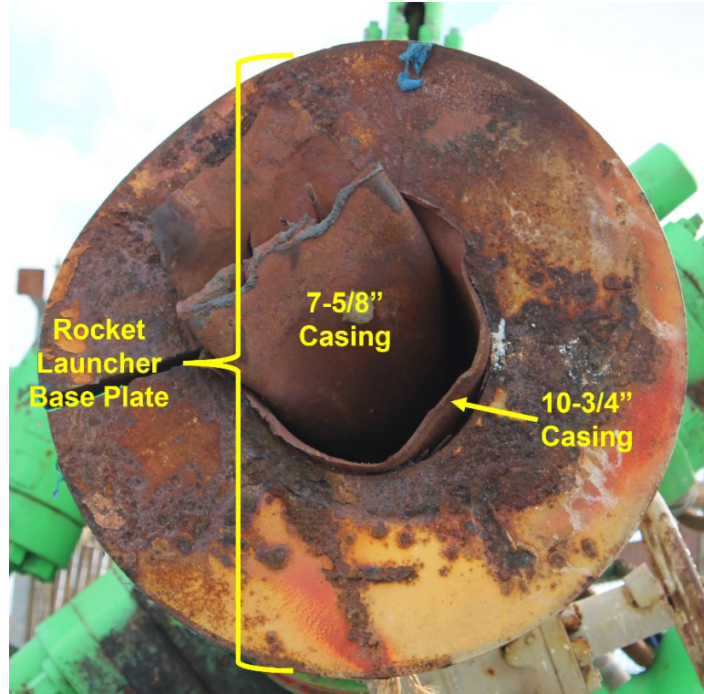
Figure 9: Bottom of Rocket Launcher Base Plate Post-Incident

Without mechanical centralizers, the 10-3/4-inch casing would have been free to move around in the structural casing. By extension, since the rocket launcher was not welded to the structural casing, the rocket launcher could move on the structural casing. This also means that while rigging up the HWU, the SBS crew needed to pay special attention that the rocket launcher was centralized on the structural casing. If the rocket launcher is not centralized on the structural casing, the ability of the structural casing to handle the load placed upon it can be compromised.

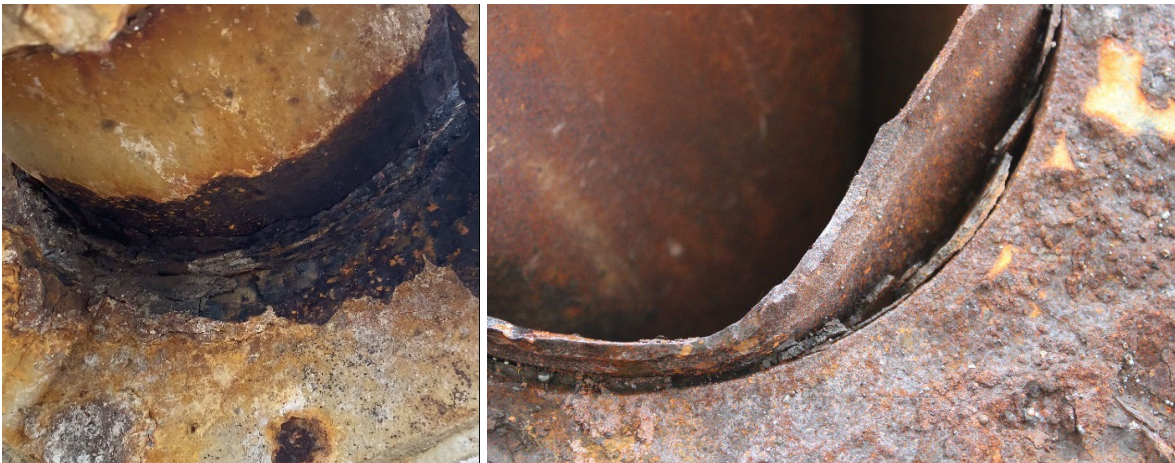
Figure 10: 10-3/4-inch Casing in Rocket Launcher from Top (Left) and Bottom (Right)

The rocket launcher sat on top of the structural casing but did not appear to have been welded to the metal tabs on the structural casing or the structural casing itself. Without the rocket launcher being mechanically fastened to the structural casing, the structural casing cannot provide substantial aid in counteracting the bending moment produced if the HWU leans. As such, much of the bending moment created at the rocket launcher-structural casing interface would not be taken by the structural casing, but rather by the 10-3/4-inch casing. This is because the rocket launcher base plate is surrounding the 10-3/4-inch casing. BSEE investigators observed severe corrosion on the 10-3/4-inch casing where it passed through the base plate of the rocket launcher (Figure 10).

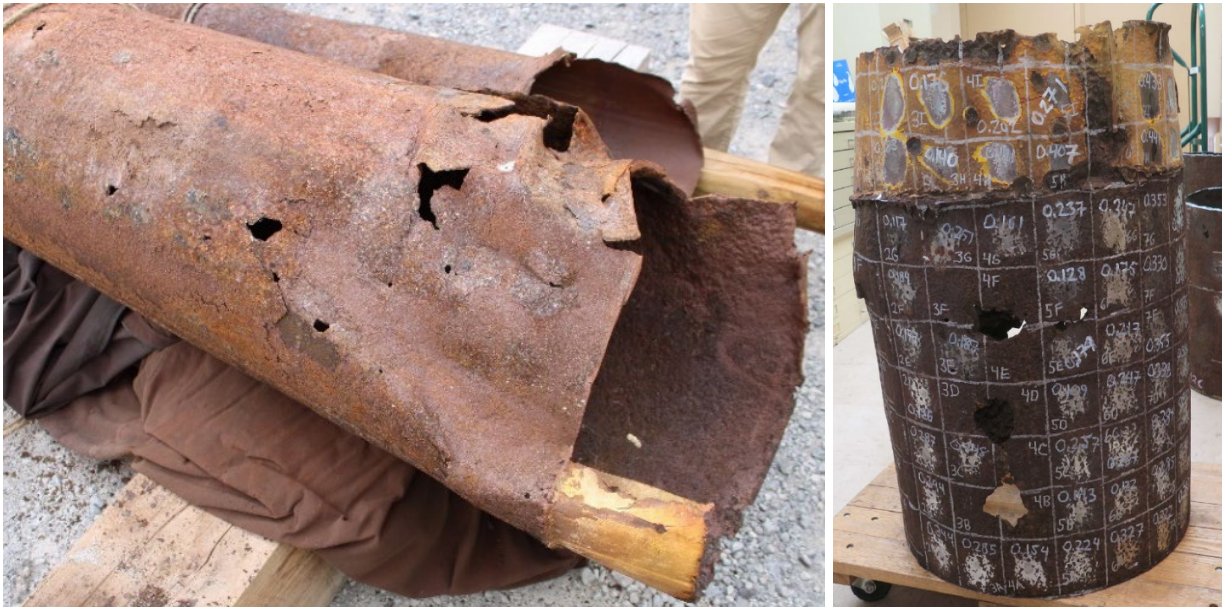
Figure 11: Corroded 20-inch Structural Casing After Recovery (Left) and After Cleaning for Thickness Measurements (Right)

While inspecting the structural casing after recovery (Figure 11), BSEE investigators observed the degradation due to corrosion on the structural casing below the trash cap. The scaling and holes indicate a severe level of corrosion prior to the incident. When originally installed, the structural casing was one half-inch thick. The thickness of the recovered structural casing ranged from zero inches, where the holes are located, to just below one-half inch. Figure 12 shows the various measurements, in inches, of the structural casing's thickness taken in a grid by ultrasonic thickness (UT) measurement. Multiple areas in the upper portion of the structural casing contained holes or heavy thinning. Note 1, highlighted in red, shows the grids that have holes present. Highlighted in yellow are all the grids that had a thickness of less than one quarter inch, which is half of the original thickness of the structural casing. Some grids could not be measured due to the curvature of the material (Note 2) or no material being present (Note 3). Rows 14, 15, and 16 corresponds to the direction that the HWU fell toward.

- The 20-inch structural casing could not sustain the forces applied.
  - The structural casing was severely corroded to the point of having many holes.

- When deciding the acceptable loading on a well, operators should consider the age of a well and how degradation from exposure, such as corrosion and fatigue, will decrease the well's structural integrity.

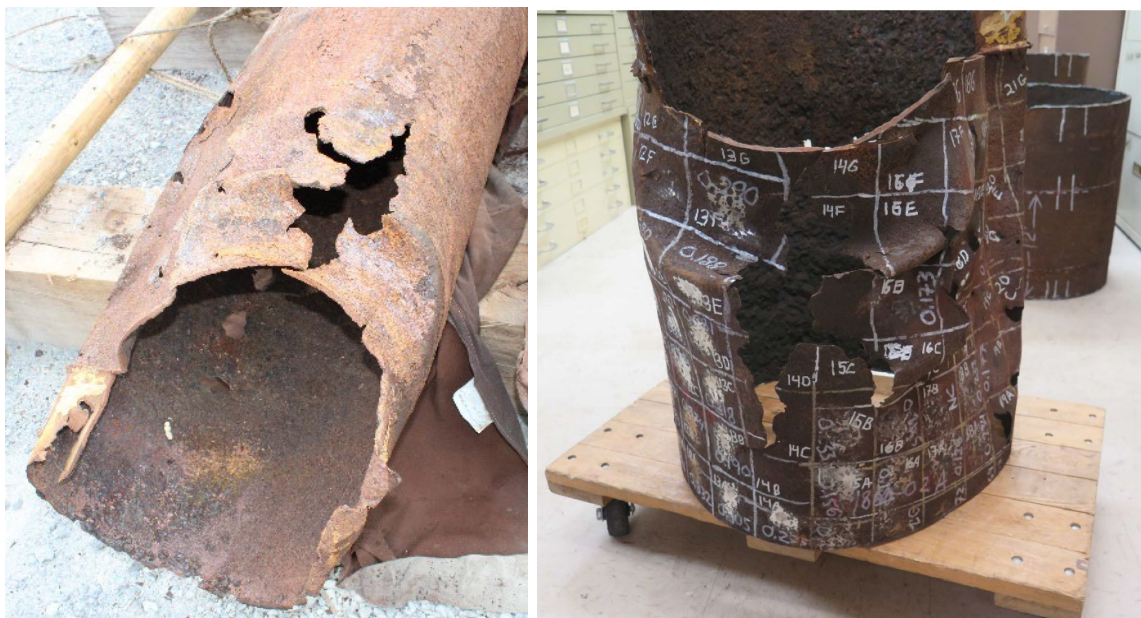
Approximately 120,000 pounds of equipment was placed on top of this severely degraded structural casing. Figure 13 shows where the structural casing buckled under the load. When the structural casing buckled, the 10-3/4-inch casing would have been the main element keeping the HWU from toppling. However, the 10-3/4-inch casing broke, and the 7-5/8-inch casing and the tubing inside bent when the HWU fell. The buckling occurred subsequent to the crane allowing the full HWU weight to transfer to the structural casing, which could no longer hold the HWU upright due to the unsteady foundation.

Figure 13: Buckled 20-inch Structural Casing After Recovery (Left) and After Cleaning for Thickness Measurements (Right)

- The rocket launcher was not attached to the structural casing and, therefore, did not aid in stability.
  - The structural casing buckled under the approximately 120,000-pound load within minutes after the crane was unlatched from the HWU.

- Conduct a structural analysis that involves an assessment of the wellhead and the casing system's condition to ensure the HWU's weight can be supported.

- The structural casing should be analyzed as a structural element when supporting an HWU, as when a platform's structure is supporting an HWU.
  - Determine the structural capability of the casing system, including for potential loads and conditions of loading. Then select, install, and use the equipment capable of withstanding these loads and conditions.
