Safety Alert No. 490
October 10, 2024

Delay in Publication of Derated Helideck Weight Capacity Leads to Near Miss Incident

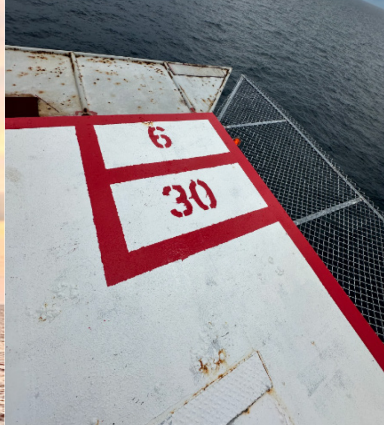
Figure 2. Helideck Rating & Sizing

Upon arrival and prior to landing at the facility, the pilot observed a freshly painted red-hatched area and a new visible weight rating of 6,000 lbs. (Figure 2) After verbally confirming with the platform operator over the radio that a helideck downgrade had occurred, the pilot deemed it unsafe to land. The pilot informed the flight operations center to revise the flight plan for a safe landing at a nearby facility.

- Ensuring all helideck conditions are accurate, validated, and published, including recent updates and/or deratings, through direct communication with facility operators and the FAA.

- Verbally confirming helideck weight ratings and conditions before takeoff and just prior to landing, especially for decommissioned or modified structures.
