Safety Alert No. 493

BSEE Investigation Determines Corrosion Caused Pipeline Explosion

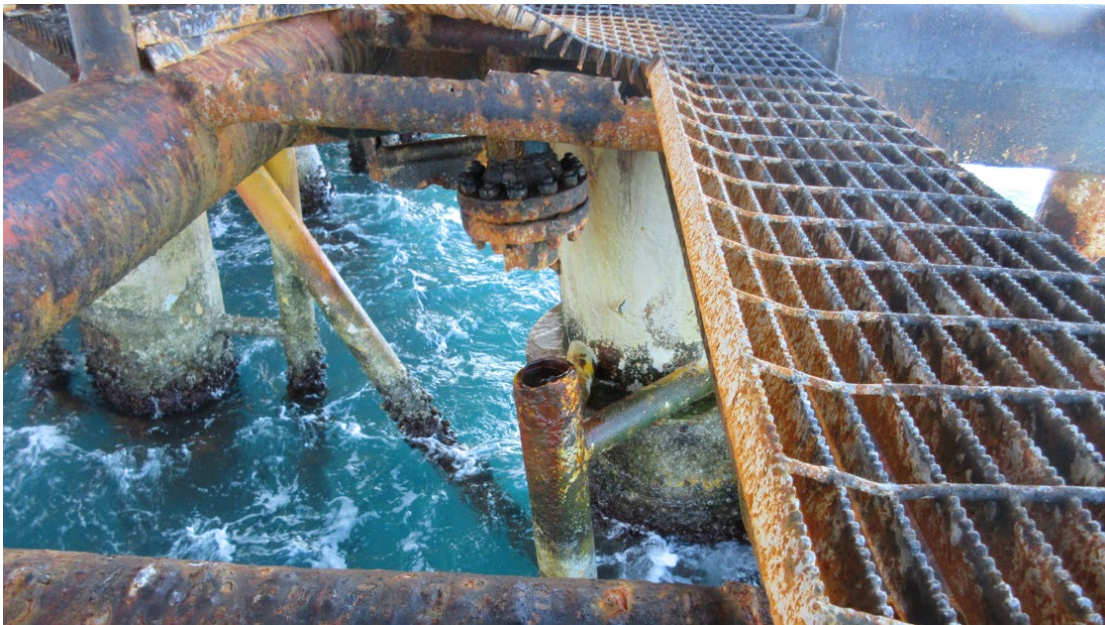
Figure 1. 8-inch bi-directional gas pipeline failure and damaged grating.

The Bureau of Safety and Environmental Enforcement (BSEE) recently investigated an explosion involving an 8-inch bidirectional gas pipeline, which significantly damaged life-saving equipment, wiring, and grating (Figure 1). The explosion ignited a fire that spread approximately 80 feet to the bottom of the production deck. In response, personnel activated the emergency shutdown system and instructed other platforms in the field to shut in. Additionally, all nonessential personnel mustered on the bridge-connected platform to ensure safety.

BSEE's investigation determined the explosion occurred due to a pipeline flange failure caused by severe outside diameter (OD) corrosion. The corrosion led to significant wall material loss and material strength degradation, resulting in a circumferential brittle failure of the flange. The applied loads on the flange were unknown, but external loads on the flange likely increased as corrosion reduced the flange's wall thickness, ultimately causing failure.

The OD corrosion was driven by high concentrations of chlorine (12,000 parts per million) in an oxygen-containing environment. High chlorine concentrations are known to dramatically accelerate the corrosion rates of carbon steels. Although the flange had been painted for corrosion protection, the coating was not properly maintained, allowing corrosion to develop over time. Following the facility's Level I inspection after the incident, a mechanical integrity inspection of the pipeline segment was conducted.

- Verify mechanical integrity tests of pipeline segments comply with industry standards. This pipeline segment had a five-year requirement but exceeded industry standards by three years.
- Ensure Level I inspections include a review of original design information, maintenance, repair, and operational history. Inspections should assess pipeline conditions, including corrosion evaluation, maintain accurate documentation of findings, and any corrective maintenance.
- Monitor pipeline wall loss and proactively address potential issues using non-destructive testing techniques to measure wall thickness along gas pipelines.
- Maintain protective coatings over time to prevent corrosion of exposed underlying steel.
- Consider utilizing chlorine gas detectors within bi-directional gas pipelines to continuously measure chlorine concentrations and provide early warnings of potential leaks.
