BSEE Panel Report 2023-001

Investigation of July 25, 2020, Flowline Jumper Failure

Lease OCS-G34536

Green Canyon Area Block 40

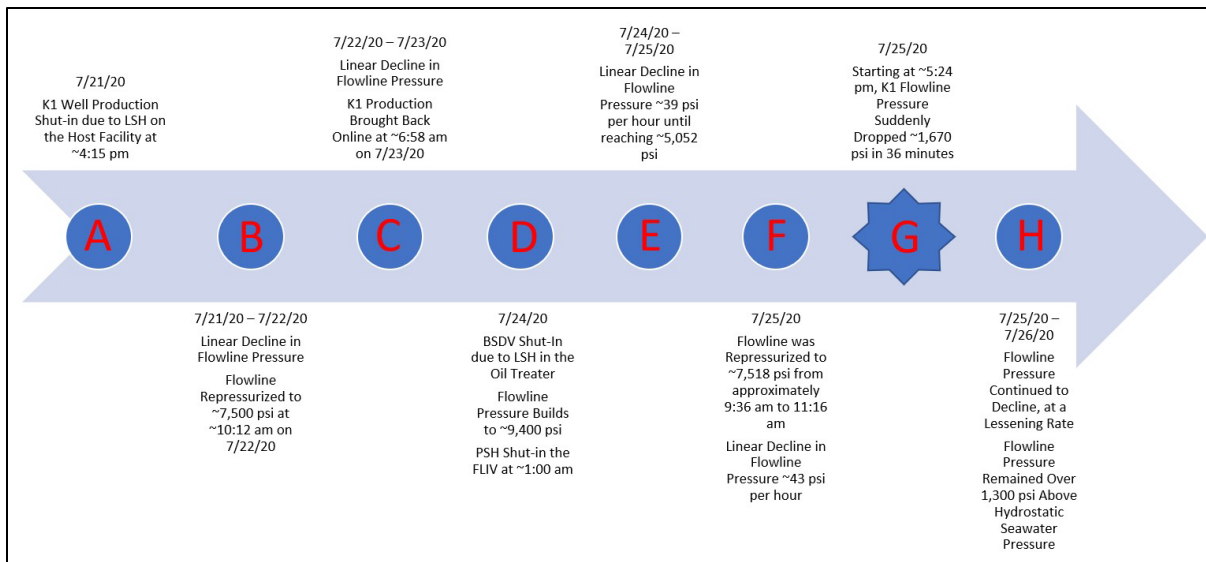
Figure 4: Katmai Flowline Timeline

On July 21, 2020, at approximately 4:15 p.m., K1 Well Production was shut-in due to a level safety high (LSH) alarm on the Host Facility (see Figure 4, A). A decision was made to leave the well shut-in for 12 hours to conduct a Pressure Build-Up Test (PBU). With the well shut-in, Fieldwood indicated standard thermal cooling of the flowline caused a linear decline in the flowline pressure (see Figure 4, B).⁵

Early in the morning of July 24, 2020, while the K1 Well was flowing, the boarding shutdown valve (BSDV) shut-in at the Host Facility due to a LSH in the oil treater (see Figure 4, D). This caused the flowline pressure to build up to over 9,400 psi at the PLET, tripping the PSH and shutting in the K1 Tree Flowline Isolation Valve (FLIV).

On July 25, 2020, at approximately 9:36 a.m., platform personnel opened the FLIV and PCV to repressurize (or re-charge) the Katmai Flowline (Katmai Flowline pressure = 5,052 psi) using pressure from the K1 Well. By repressurizing the Katmai Flowline, the platform personnel were able to reduce the differential pressure observed at the subsea choke. Fieldwood reported that at 11:16 a.m., the flowline re-pressurization was completed, and pressure was approximately 7,518 psi (see Figure 4, F).

Discussions included the possibility of a leak or a hydrate formation, among other possibilities. The flowline pressure was not trending toward the ambient pressure of the sea (hydrostatic pressure line) (~930 psi) (see Figure 4, H). The group decided to monitor the pressure trend through the night while waiting on a flyover and vessel survey. They decided not to repressurize the flowline pending those inspection results and confirmation of subsea integrity.

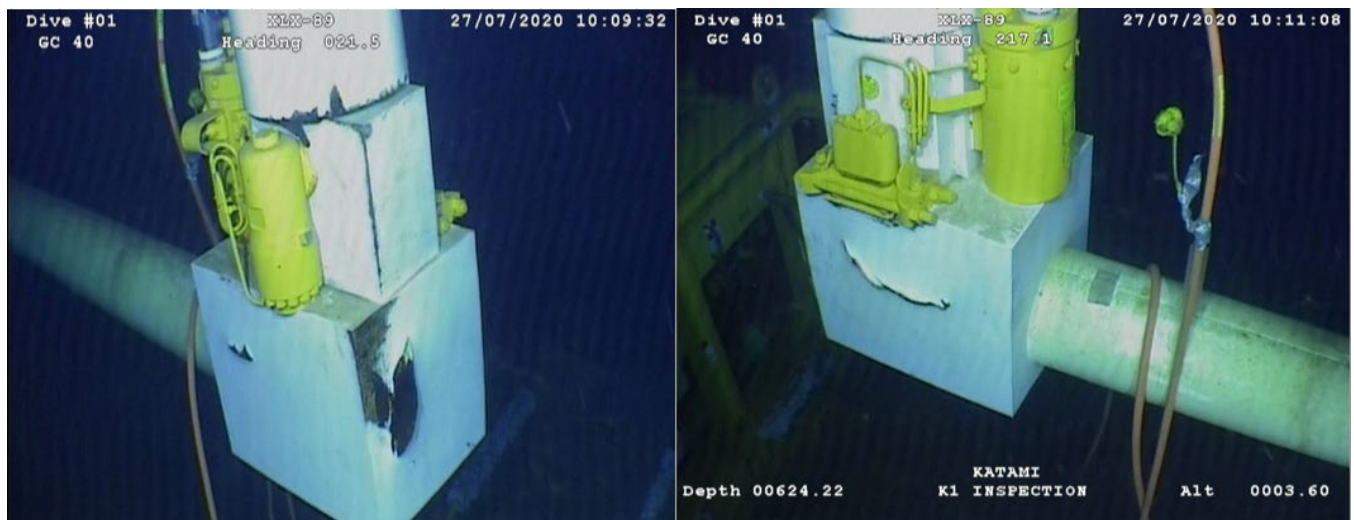
Figure 6: Images from ROV video on July 27, 2020

On July 27, 2020, an ROV deployed from a motor vessel in GC Block 40 performed an inspection of the subsea components downstream of the K1 Tree. ROV live video surveillance identified the potential leak source at or around the MPFM/Blind Tee connection area (Figure 6).

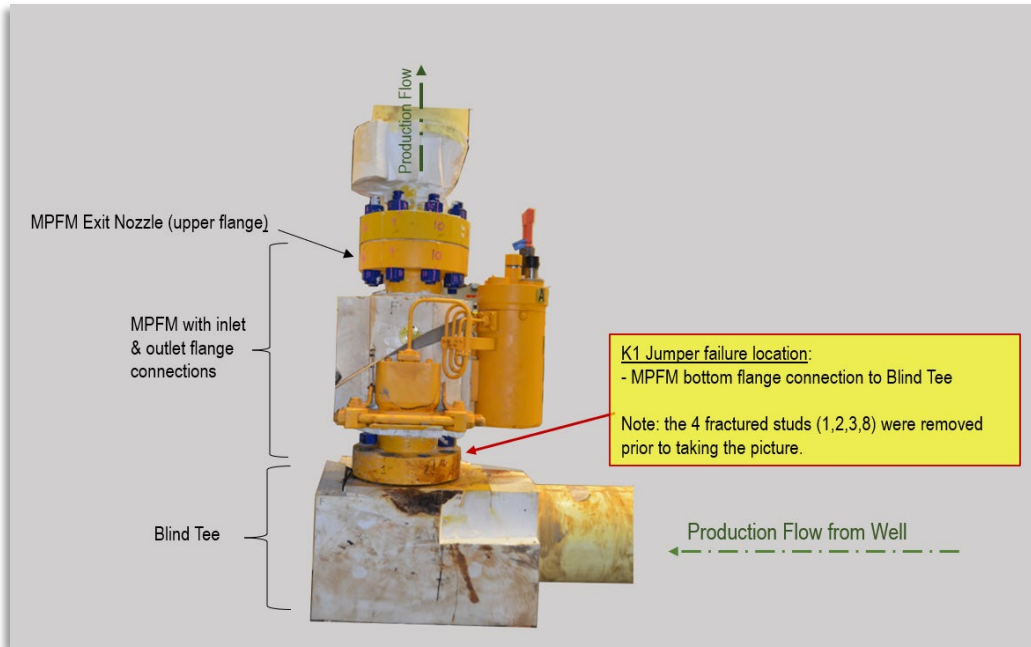
Figure 9: Katmai K1 Jumper Section #2

Before removing any thermal insulation surrounding the cut section, SES performed a borescope of the inside of Section 2. The SES results of the borescope presented no evidence of blockage that might have caused an overpressure event. There also was no evidence of wall thickness loss that might have contributed to the leak. SES removed most of the thermal insulation material from around the MPFM lower flange first, before removing insulation material from around the MPFM upper flange. Nuts number 1, 2, 3, and 8 came out with the snapped (failed) studs, while nuts 4, 5, 6, and 7 were still attached to the studs. The four fractured studs (1, 2, 3, 8) were located on one side of the MPFM lower flange connection (see Figure 9 and Figure 14). The SES investigation found that all stud fractures occurred at the root of the last engaged thread at the studs' mating nuts (see Figure 11). The fractures occurred at the studs' thread root in the area where the nut and flange met. All fractures appeared to be brittle.

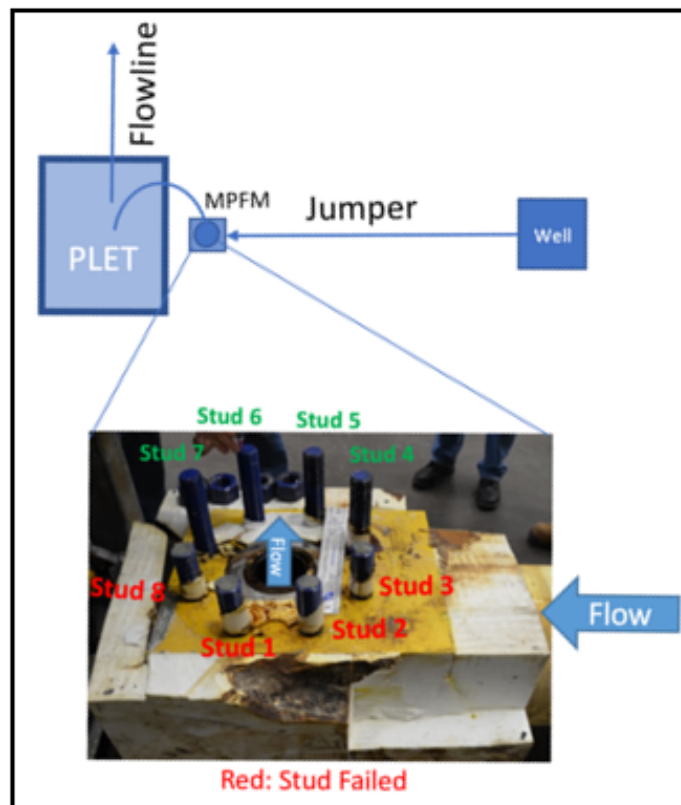
Figure 10: General depiction of the MPFM Failed Studs in Relation to Well and PLET Location

Four of the eight studs located on the bottom flange fractured. The fracture occurred at the thread root of the stud at the nut to the flange joint. The failed studs' material microstructure exhibited a fine-grain gamma (γ) phase with delta (δ) phase present at the grain boundary. The presence of the delta (δ) phase renders the material susceptible to cracking due to Hydrogen embrittlement (HE) when used for the subsea environment with cathodic protection.

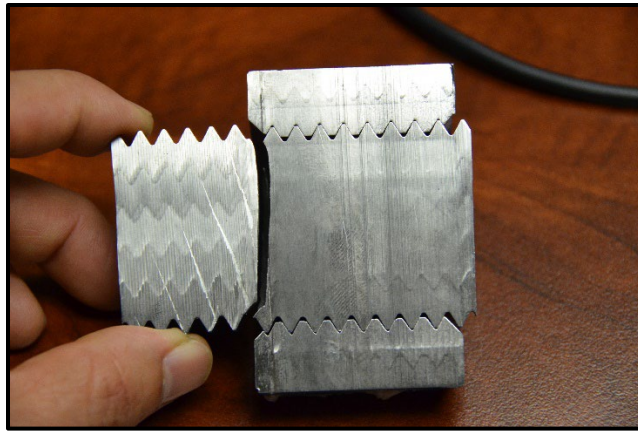
Figure 11: MPFM Fractured Stud

SES performed optical fractography, scanning electron microscopy (SEM), and energy-dispersive X-ray spectroscopy (EDS) examinations of the fractured surfaces of the upper (short) end of studs 1, 2, 3, and 8. All stud failures exhibited a brittle fracture. Figure 13 shows the studs' fracture progression. Macroscopic fracture features show the grain tear pattern to be similar for all four studs. The arrow pointing outward indicates the tear direction during the failure of the stud (see Figure 13). SES could not find a direct correlation between the tear direction and the FEA stress. The seemingly random fracture progression orientations would suggest the stud preload may have been the dominant source of stress.

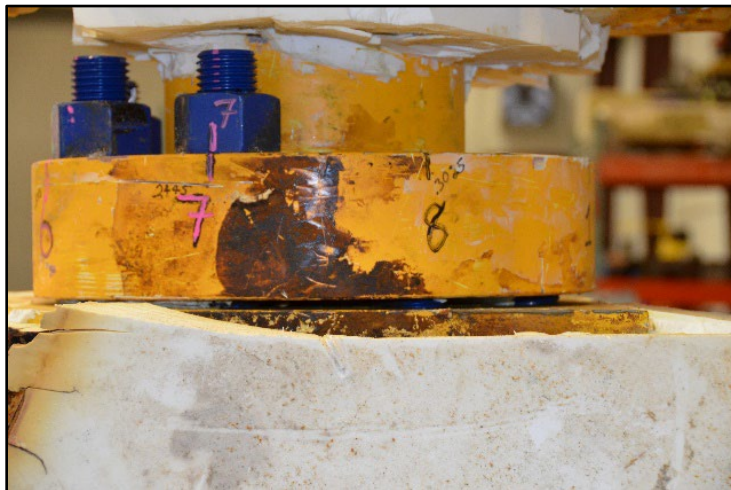
Figure 12: MPFM Lower Flange Connection

Critical dimensions were measured, and detailed pictures were taken for nuts 1, 2, 3, and 8 showing the orientation of the studs in relation to the nuts and their placement on the flange. There was no evidence to indicate the nuts backed off during service. Flange face gaps were measured around the MPFM lower flange connection at each stud connection. The flange face gaps were higher by the failed studs (see Figure 12).

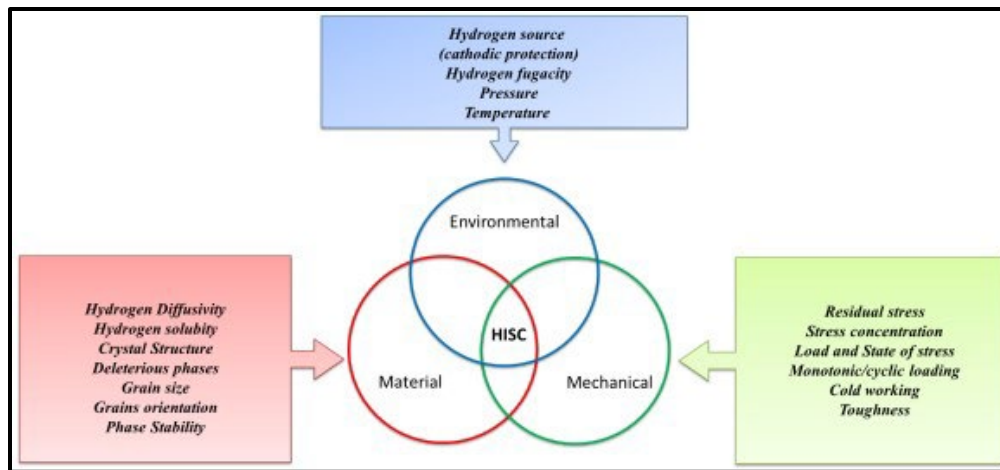
Figure 14: Hydrogen Embrittlement Requirements¹⁹

1. Hydrogen source environment. Here, the failure occurred in a subsea environment with cathodic protection, which is known to be a hydrogen-source environment.
2. Material susceptible to HE. Here, the fractured studs were made from nickel-based alloy 718 (Inconel 718) and heat-treated according to the ASTM B637 standard. The failed studs’ material microstructure was fine-grain gamma (γ) phase with delta (δ) phase present at the grain boundary. This Inconel 718 material microstructure is known to be susceptible to HE.
3. Stress. Here, the normal stress applied during flange assembly is enough stress to initiate HE failure.

- Utilize an industry-knowledgeable metallurgist to evaluate all current and future subsea fasteners to verify fasteners are fit for service and not prone to Hydrogen Embrittlement (HE) or any other environmental cracking failures. For future installations, ensure the metallurgical evaluation is performed during the engineering technical review phase before releasing the engineering design for construction.

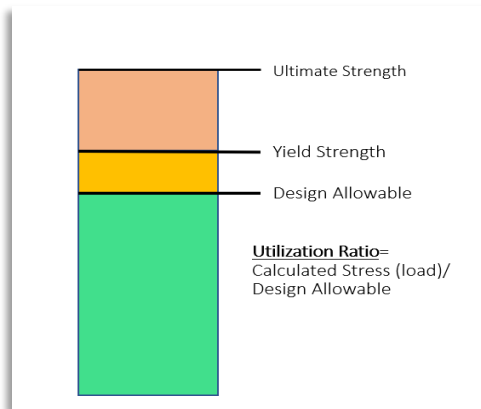
Figure 15: Utilization Ratio (UR)

The Utilization Ratio (UR) compares the calculated stresses (loads) to the allowable design stresses (loads) (see Figure 15). It is important to point out that the allowable design stress (load) is less than the material’s yield strength. The yield strength is the stress corresponding to the yield point at which the material begins to deform plastically. The ultimate tensile strength of the material is the maximum stress that a material can withstand while being stretched or pulled before breaking. OSS issued the allowable design stress for the MPFM flange connection.

The two load cases which simulated the max stress load conditions which occurred during the production life of the K1 Jumper before the jumper failure were the “As-leak” and the “Pressure Spike” load case. The analysis of the “As-leak” load case and the “pressure spike” load case indicated the stresses were within acceptable limits. The maximum utilization ratio for both cases occurred at the MPFM lower flange and was 88.76% for the “As-leak” case and 93.4% for the “Pressure Spike” case. In these calculations, the MPFM maximum allowable design stress was provided by OSS and utilized in SES’s load case simulations.
