Safety Alert No. 459

## Lack of training with Hydraulic Torque Wrench contributes to fatality aboard drill ship

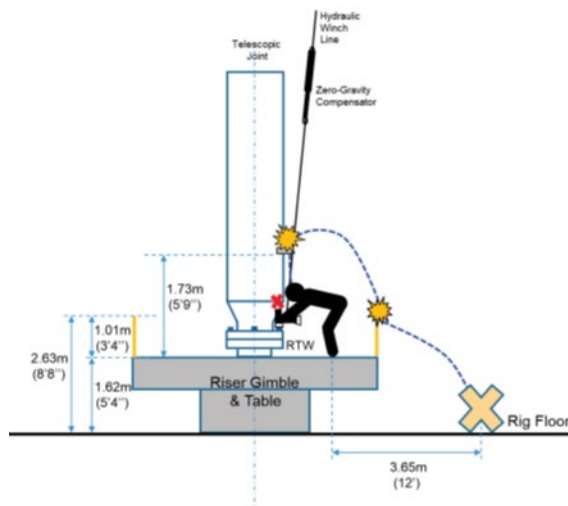
Figure 1. Floorhand Bolt Removal

The incident investigation found that the rig crew was using a hydraulic torque wrench to extract the bolts from a telescopic riser joint (TJ) flange. During the operation, the HTW T socket became stuck between the bolt head and the tapered edge of the TJ. After failing to manually dislodge the HTW using physical exertion, the rig crew utilized a Hydraulic Utility Wrench to supply upward force and applied tension to free the tool.

After applying the upward force, the torque wrench became unstuck under tension and shot upwards leading to the crewmember being struck.

- Ensure the Job Safety Analysis captures the limitations of the HTW when in use.
- Verify all employees understand the Job Safety Analysis and have been formally trained on operating both the HTW and HUW.
- Emphasize the initiation of Stop Work Authority if an imminent danger is observed.
- Expand the Drill Floor Observer responsibilities to monitor all aspects of jobs occurring on the rig floor.
- Consider utilizing a HTW with a compatible design that corresponds with the beveled edge of the TJ.
- Explore options for employing a load indicator, or a similar design mechanism onto the HUW package.
- Ensure pre-job reviews, promote the sharing of feedback from previous experiences.

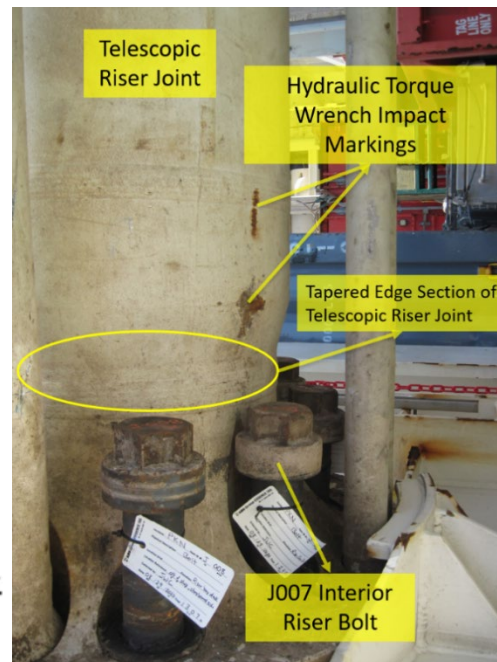
Figure 2. Riser Bolt and Telescopic Riser Joint
