SAFETY ALERT

Safety Alert No. 367
October 2, 2019

Saturated Glycol Handling Leads to Fire

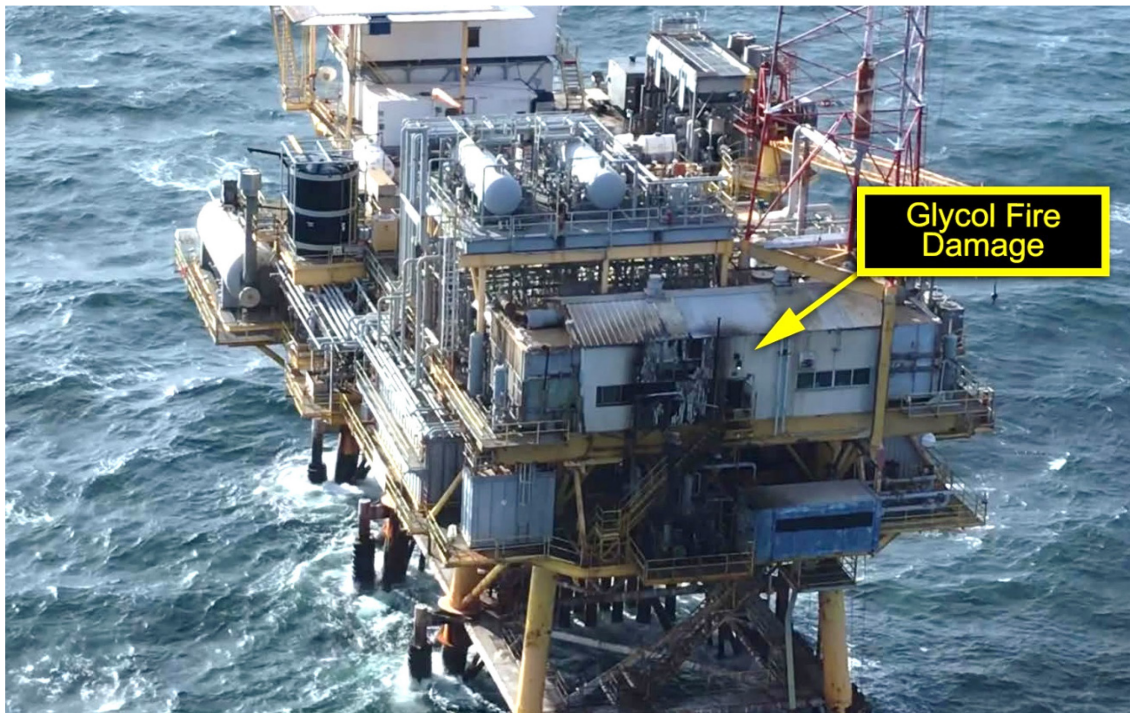
Fire damage was caused when an unattended glycol reboiler was starting up. The glycol and hydrogen condensate ignited.

BSEE determined the cause of the fire to be high water content combined with a rapid increase in temperature, which flooded the still column; the flooded still column expelled glycol and hydrocarbon condensate onto the reboiler stack, where it ignited.

- Provide advanced training to personnel who work with glycol units to address handling saturated glycol safely;
- Ensure that procedures specify that glycol system start-up should be a manned operation;
- Ensure that procedures specify circulation time before increasing boiler temperature; and
- Review reboiler stack installations and consider adding insulation to mitigate the stack as an ignition source.
