Society of Naval Architects & Marine Engineers
Northern California Section
Student Paper Presentation
April 9, 1992

The Grounding of *Exxon Valdez*: An Examination of the Human and Organizational Factors

by
William H. Moore, Student Member
Department of Naval Architecture & Offshore Engineering
University of California at Berkeley

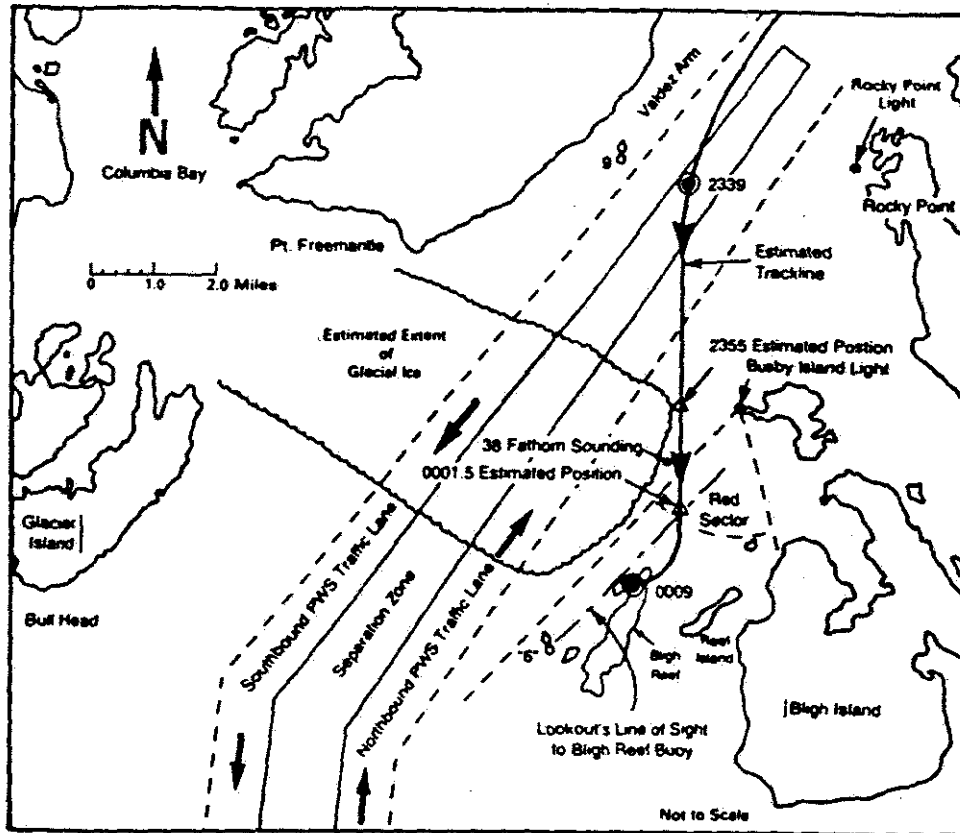
Figure 1: Trackline of *Exxon Valdez* [9]

At 2347 the ship left the Traffic Separation Scheme (TSS) going into the inbound lane to avoid the ice. At 2355 the helmsman was relieved by Robert Kagan [6]. The NTSB has simulated the path which *Exxon Valdez* traveled once deviating from the TSS and is

shown in Figure 1. The ship was on "load program up" which meant she was increasing her speed while exiting the harbor. Thus, *Exxon Valdez* was traveling at 12 knots and on automatic pilot just prior to hitting Bligh Reef. Putting the ship on automatic pilot in confined waters and not telling the third mate the master had done so was extremely inconsistent with

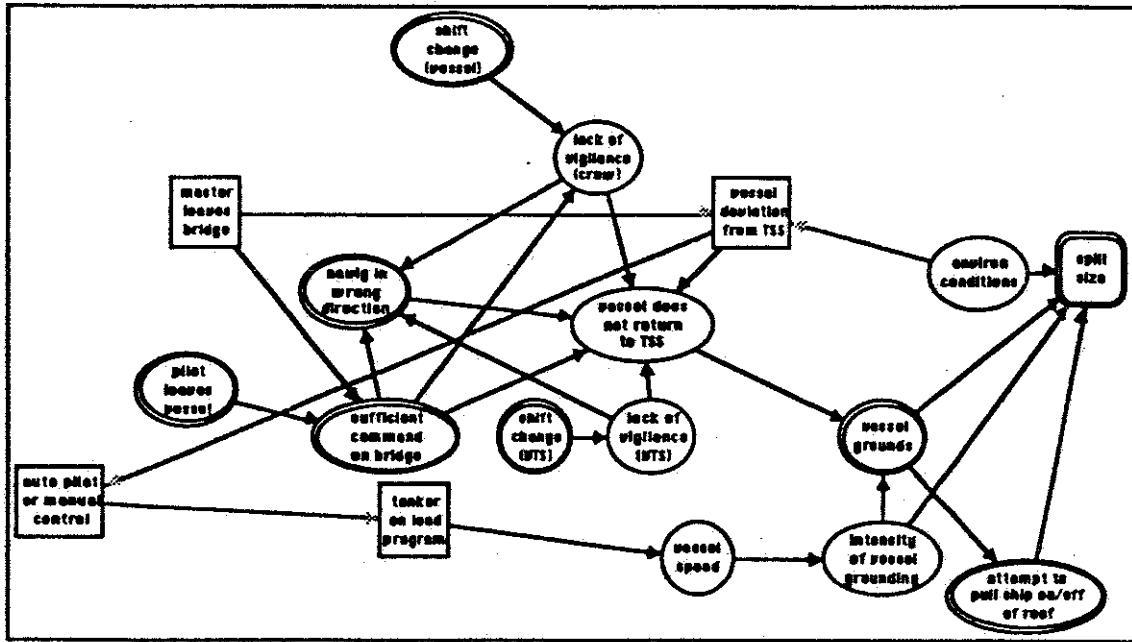
Figure 2: Influence of events and decisions leading to the grounding of *Exxon Valdez*

The model represent the set of events that occurred aboard the *Exxon Valdez*, the vessel transit in and out of the TSS, and at VTC in Valdez. Figure 2 summarizes the dependency of events, direct causes and decisions involved in the grounding discussed above. These influences are represented by nodes, (events, causes, and decisions) and arcs which establish the dependencies. Probabilities are represented by oval nodes, deterministic events are represented by double-lined oval nodes, decisions are represented by rectangular nodes, and expected returns are represented by double-lined rectangular nodes. The development of influence diagram models should be the effort of a group of experts. Discussion of differences in opinion of the relationships of between events and their causes illicit the development of more realistic models [14].

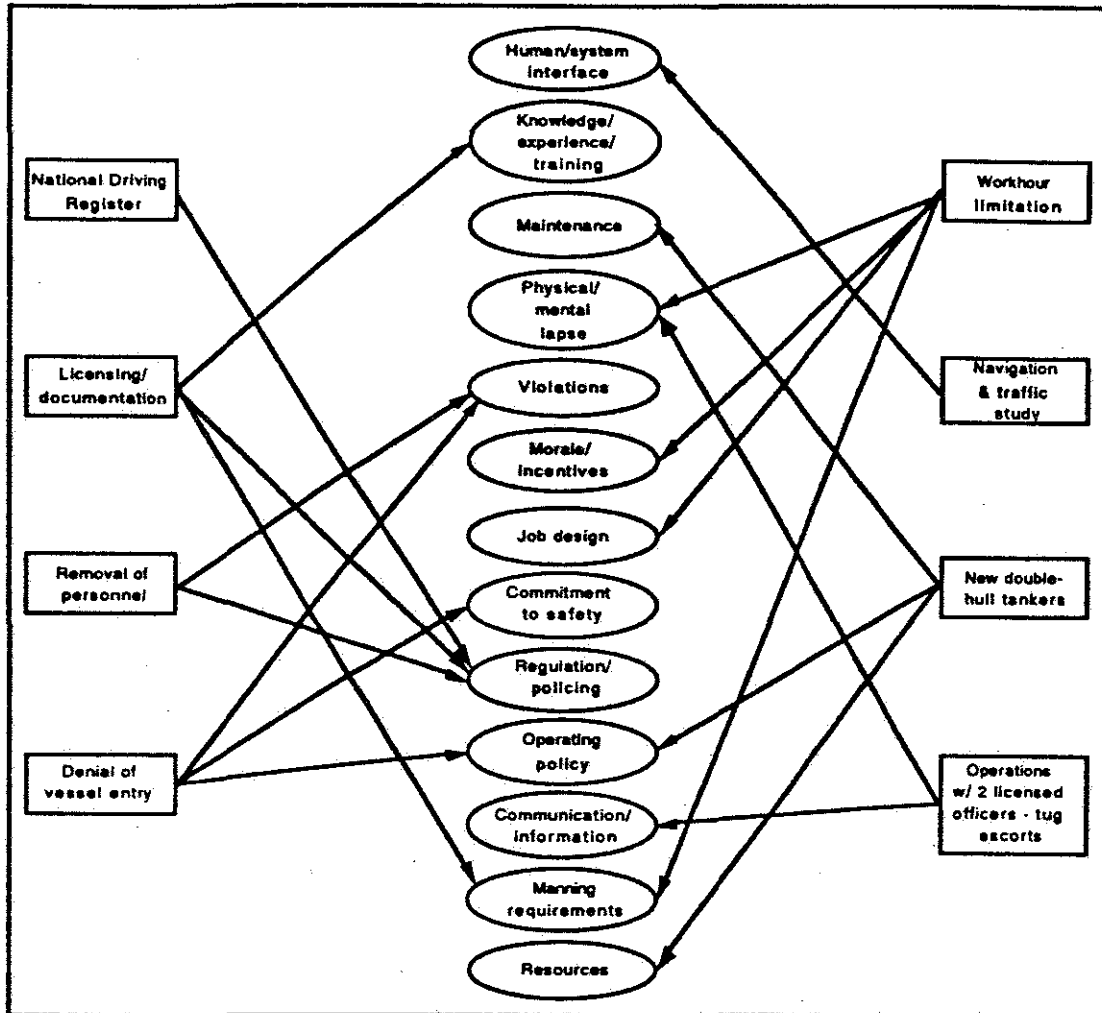
Figure 5: Influences of Oil Pollution Act of 1990 on HOE related accident causes

The influence diagram frameworks in Figure 4 can be used to determine the effectiveness HOE related management alternatives of OPA 90 on the overall failure probabilities of the system. Figure 5 summarizes the influences of OPA 90 on the various contributing causes of marine related accidents discussed above. The importance in evaluating are to determine their effectiveness in reducing the overall failure probability of this class of grounding accidents. For example, when legislating OPA 90, was the reduction of cargo capacity of double-hull tankers resulting in more tanker traffic to maintain capacities taken into account [15]? The additional traffic could increase the risk of other classes of accidents such as collisions. It is imperative that these issues are addressed in the PRA analyses framework.

- (5) limit crew workhours aboard tankers to 15 hrs/day but no more than 36 hours in any 72 hour period;
- (6) mandates the Coast Guard conduct studies on vessel traffic and tanker navigation;
- (7) requires all new tanker builds to be double-hulled in addition to the phasing out of existing tankers beginning in 1995 and concluding in 2010; and,
- (8) require the Coast Guard to designate areas where two licensed personnel are required to navigate and tug escorts are necessary.
