***ASSESSMENT OF DAMAGE AND FAILURE  
MECHANISMS FOR OFFSHORE STRUCTURES AND  
PIPELINES IN HURRICANES GUSTAV AND IKE***

**FINAL REPORT  
February 2010**

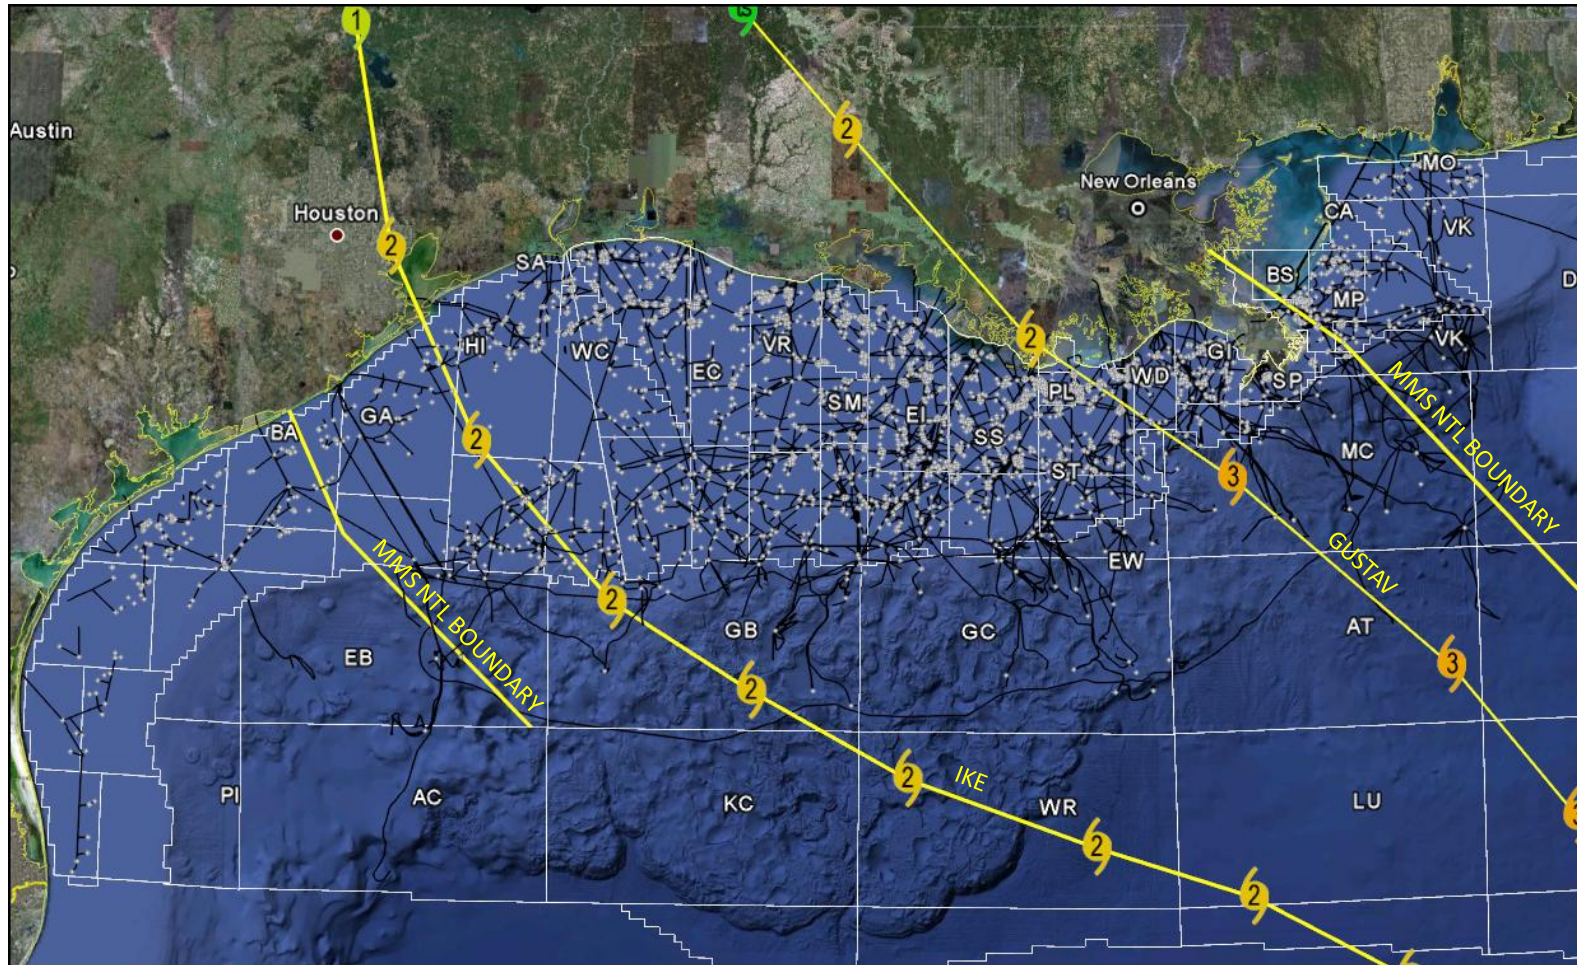
**Figure 2.1 Paths of Hurricanes Gustav and Ike and the Gulf of Mexico Offshore Infrastructure.**

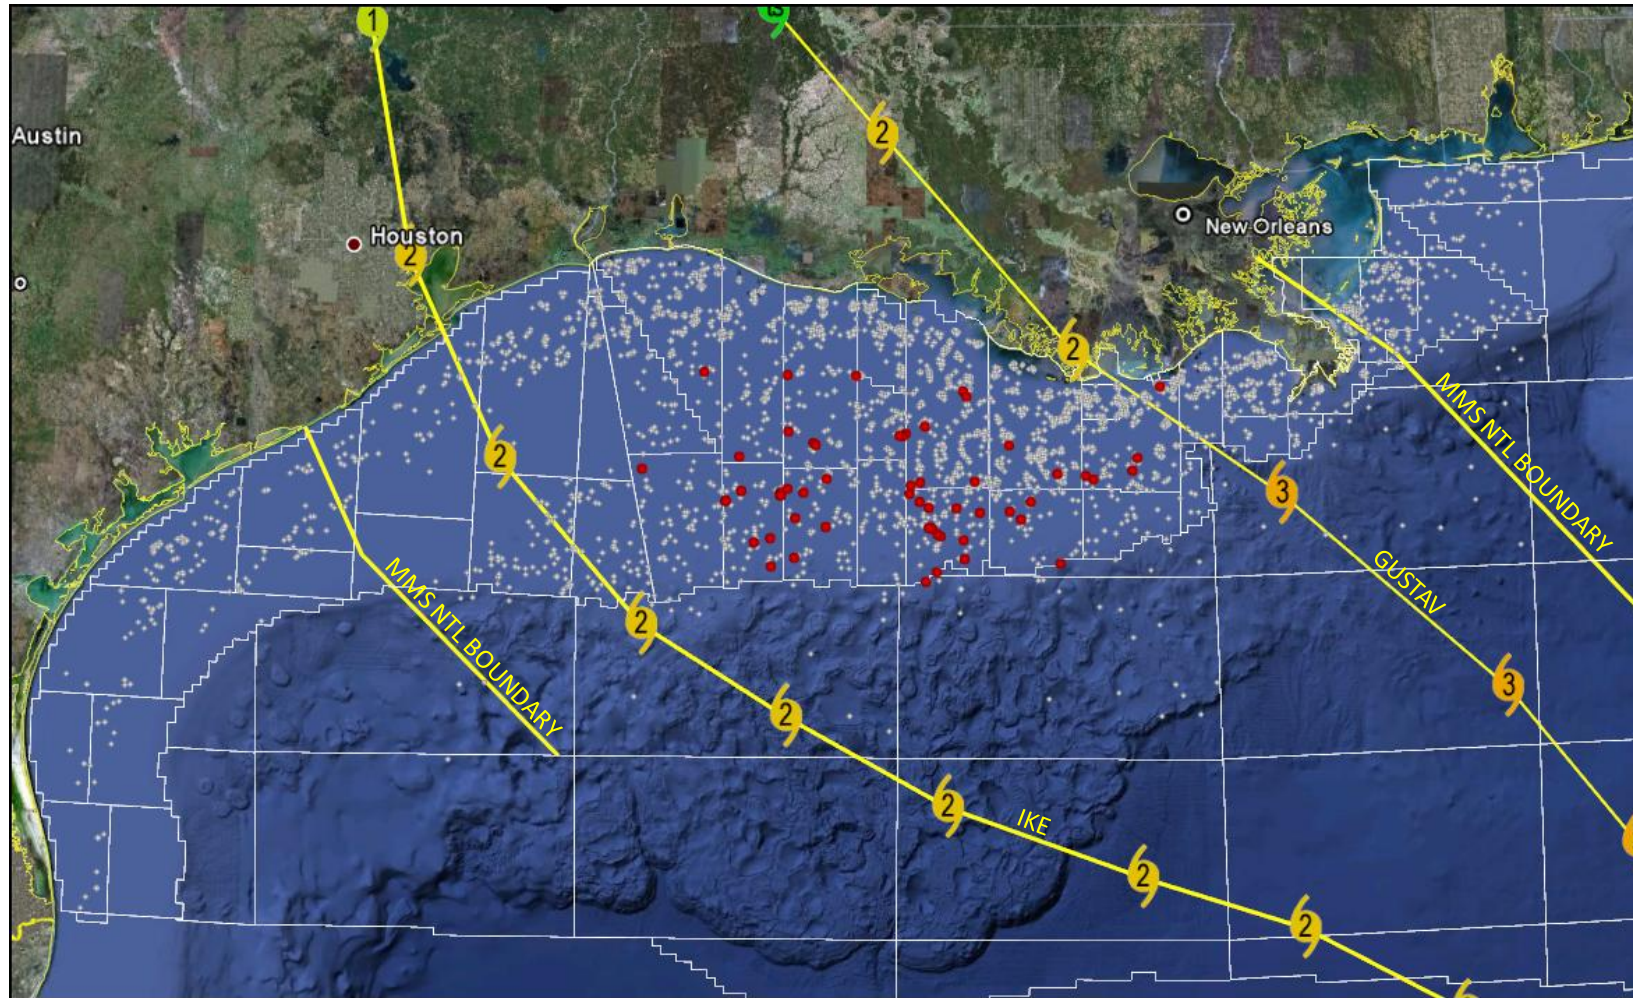
**Figure 4.6 Location of Destroyed Platforms Compared to Path of Hurricanes.**

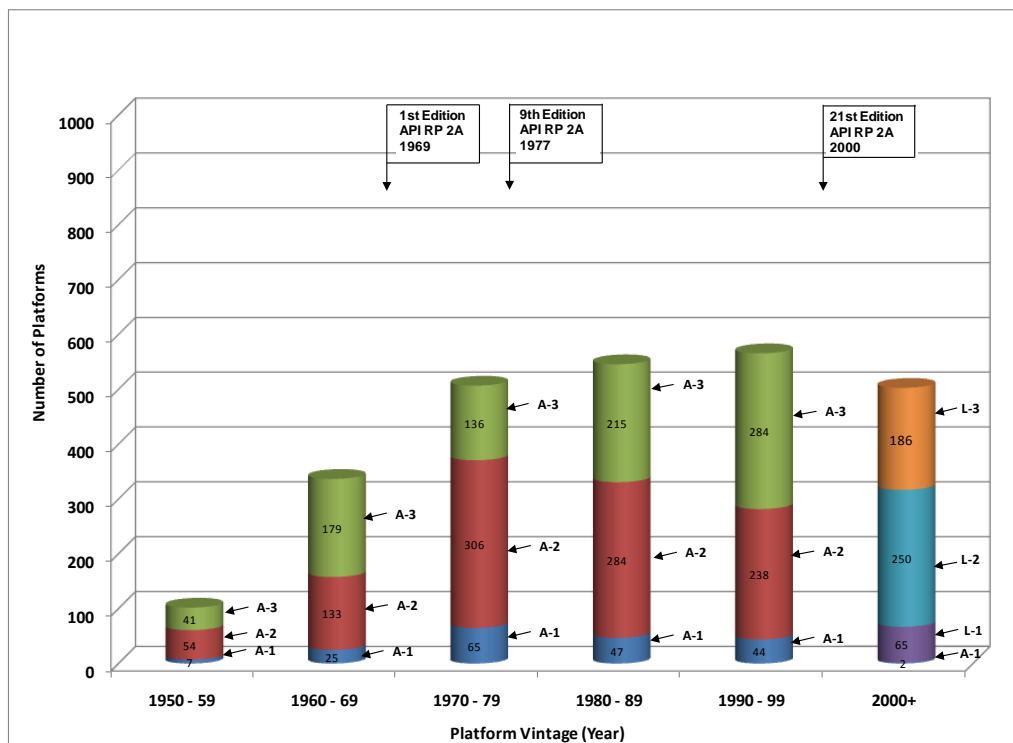
**Figure 4.8 Exposed Platforms by Vintage and API Category**  
Excludes Platforms with an Unknown API Category

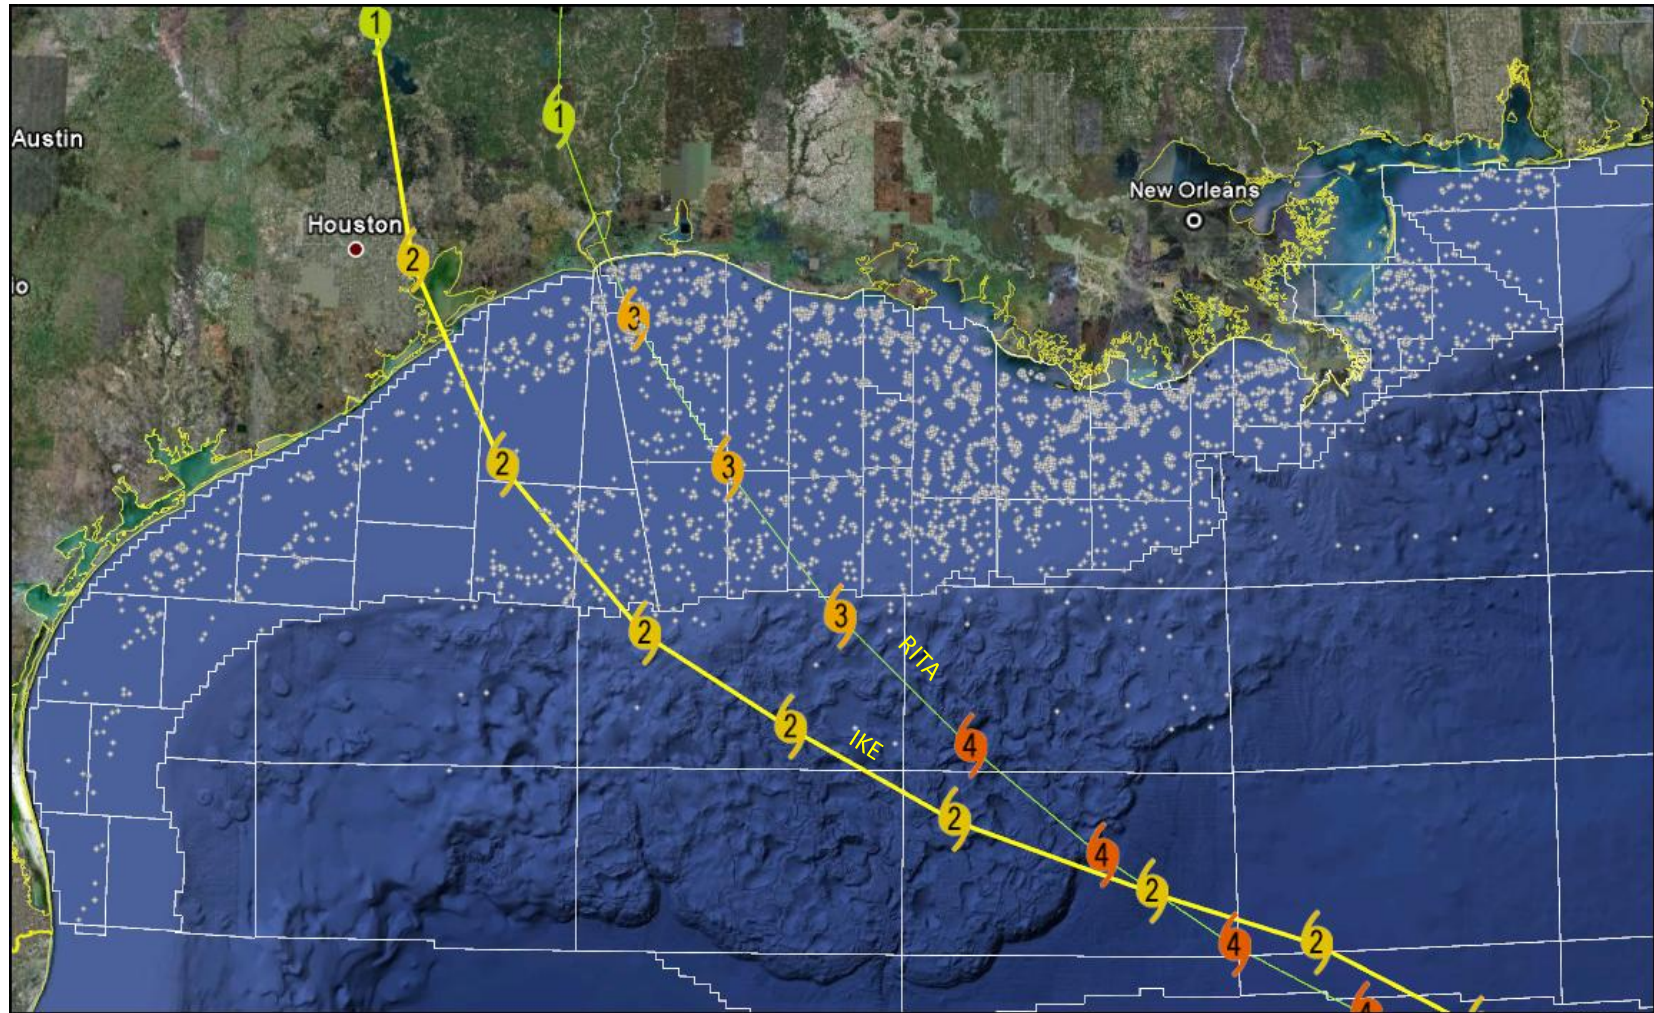
**Figure 4.9 Hurricane Ike and Rita Path Comparison**  
All existing platforms at the time of Hurricane Ike are shown for reference

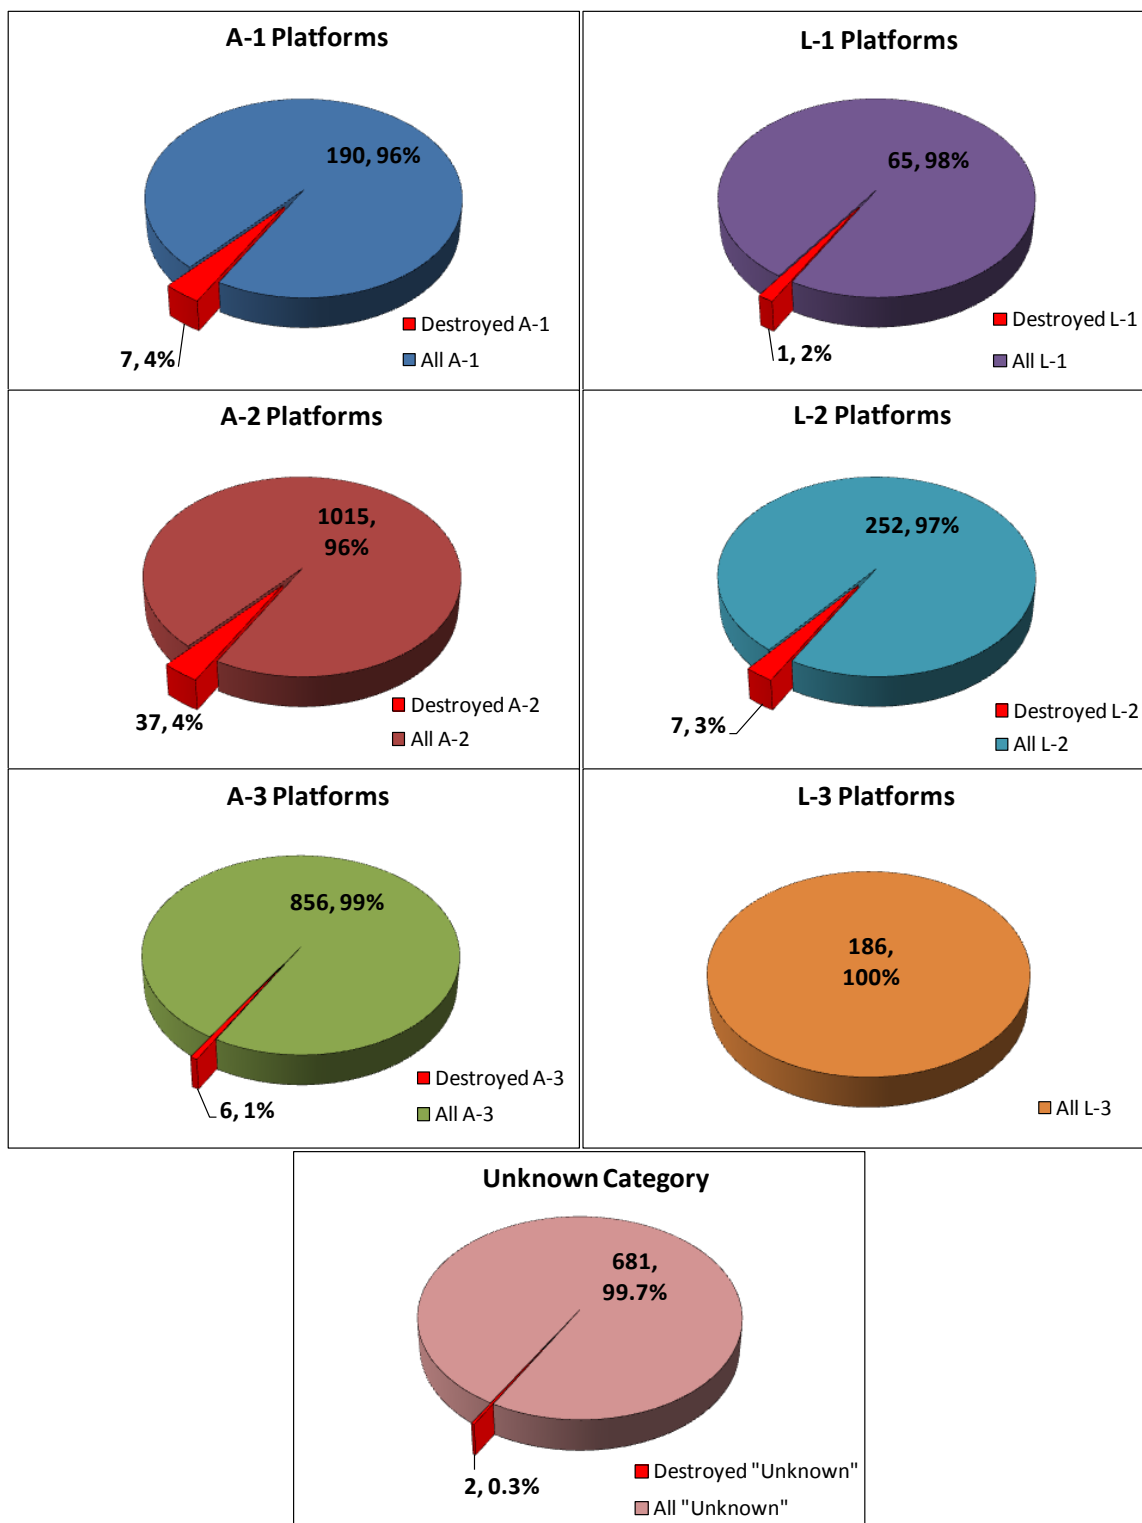
**Figure 5.2 Exposed and Destroyed Platforms by API Category**  
Note: There were no L-3 category structures destroyed.

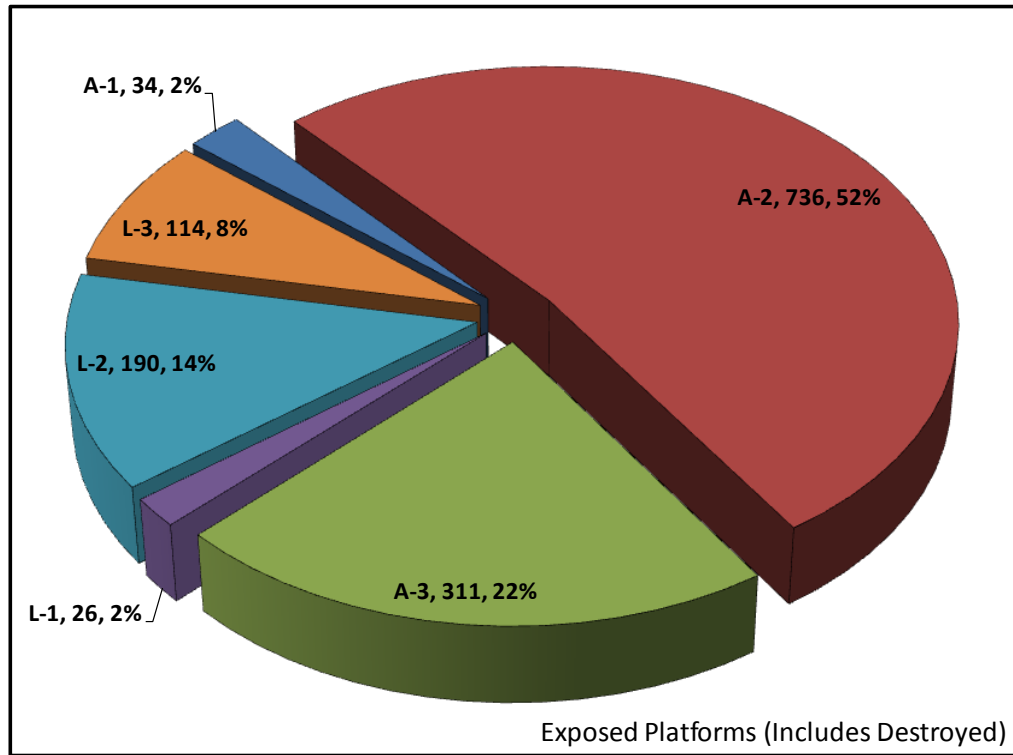
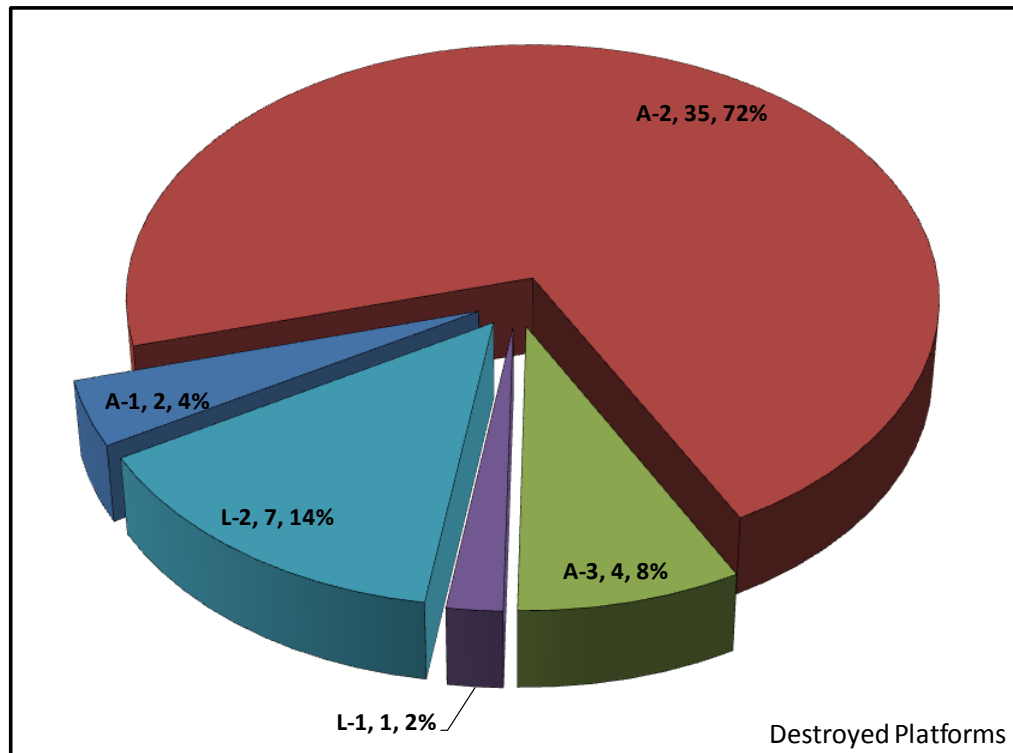
Figure 5.3 Hindcast Wave vs. API Recommended Wave for Exposed and Destroyed Platforms

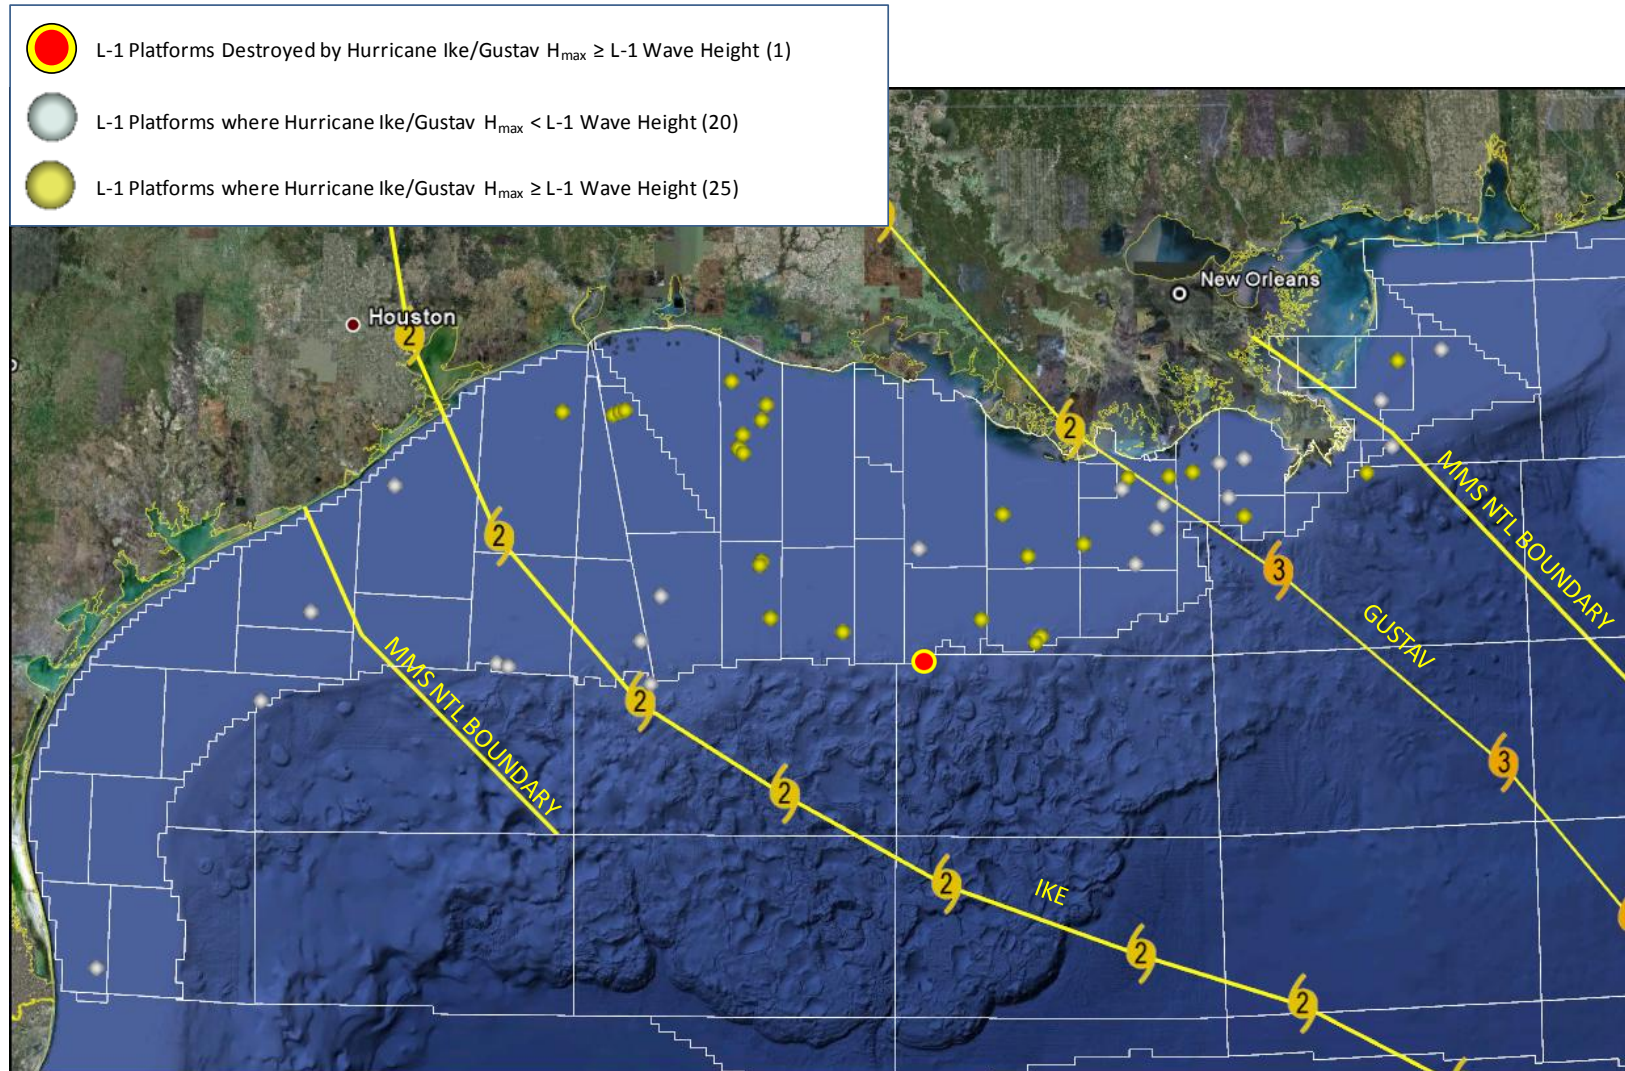
**Figure 5.4 Hindcast  $H_{max}$  vs. API Recommended Design Wave for L-1 Platform**  
Note: Shown are only those platforms with a calculable hindcast and recommended wave

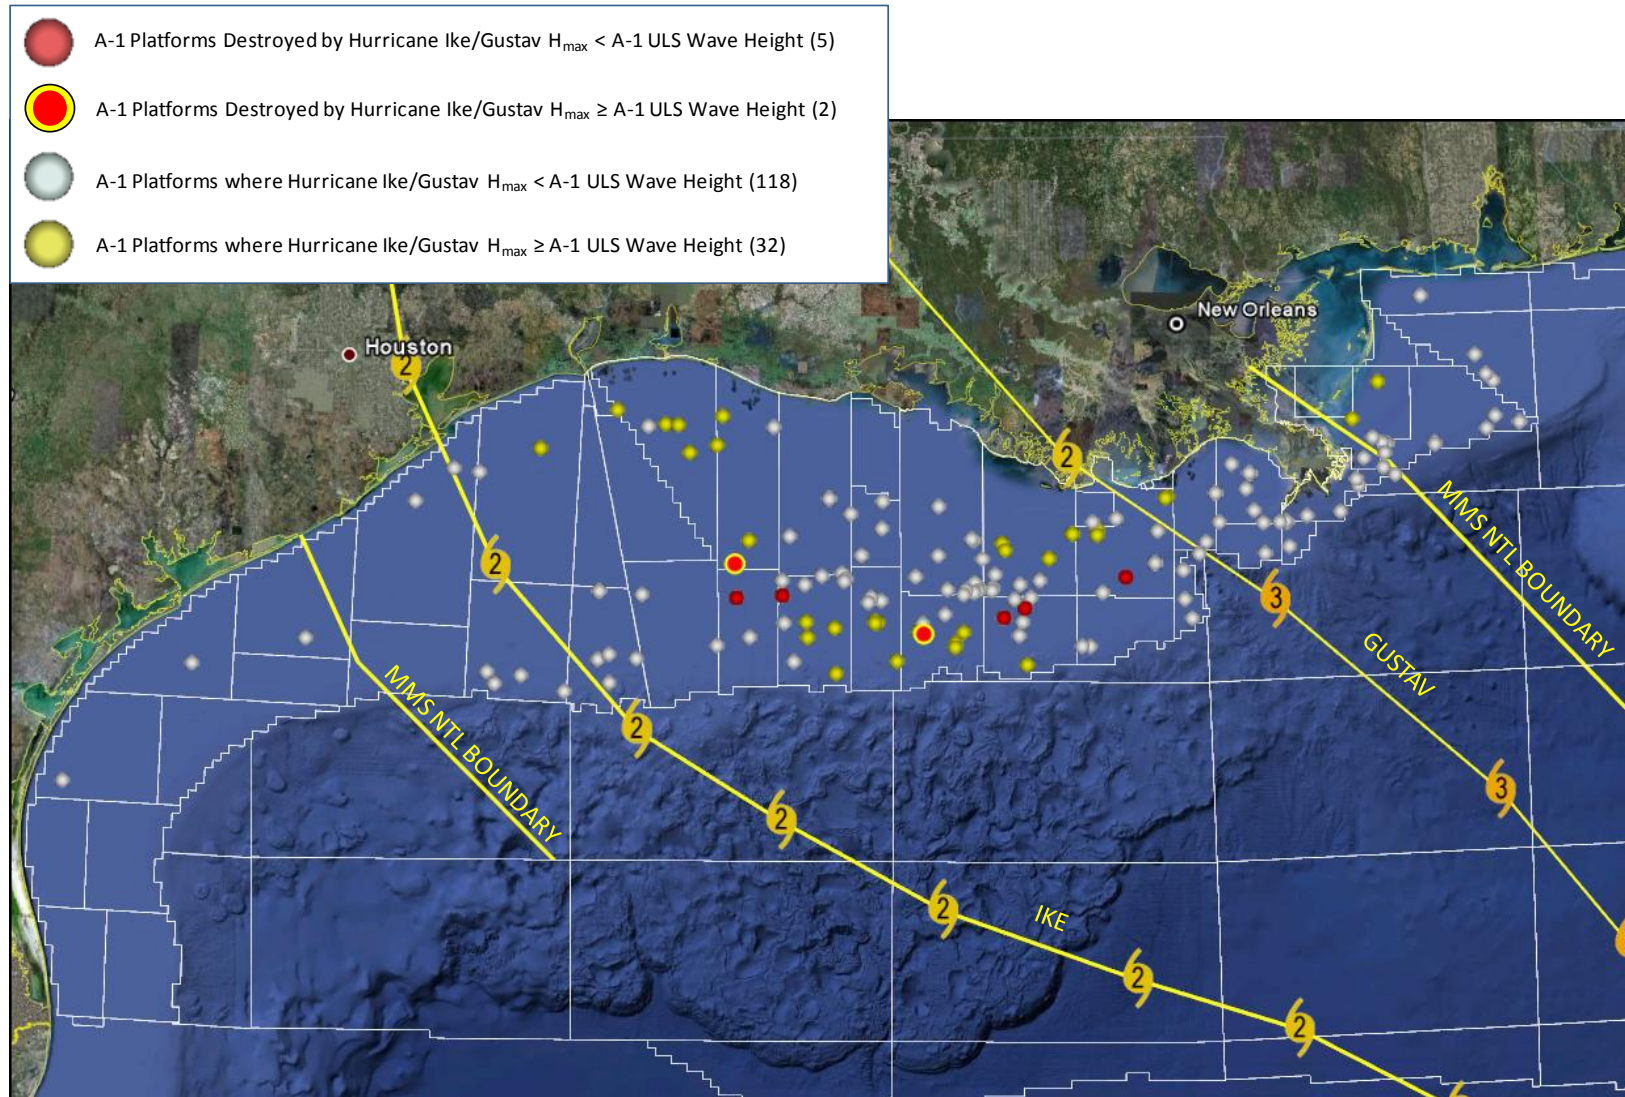
**Figure 5.5 Hindcast  $H_{max}$  vs. API Recommended Wave for A-1 Platform**  
Note: Shown are only those platforms with a calculable hindcast and recommended wave

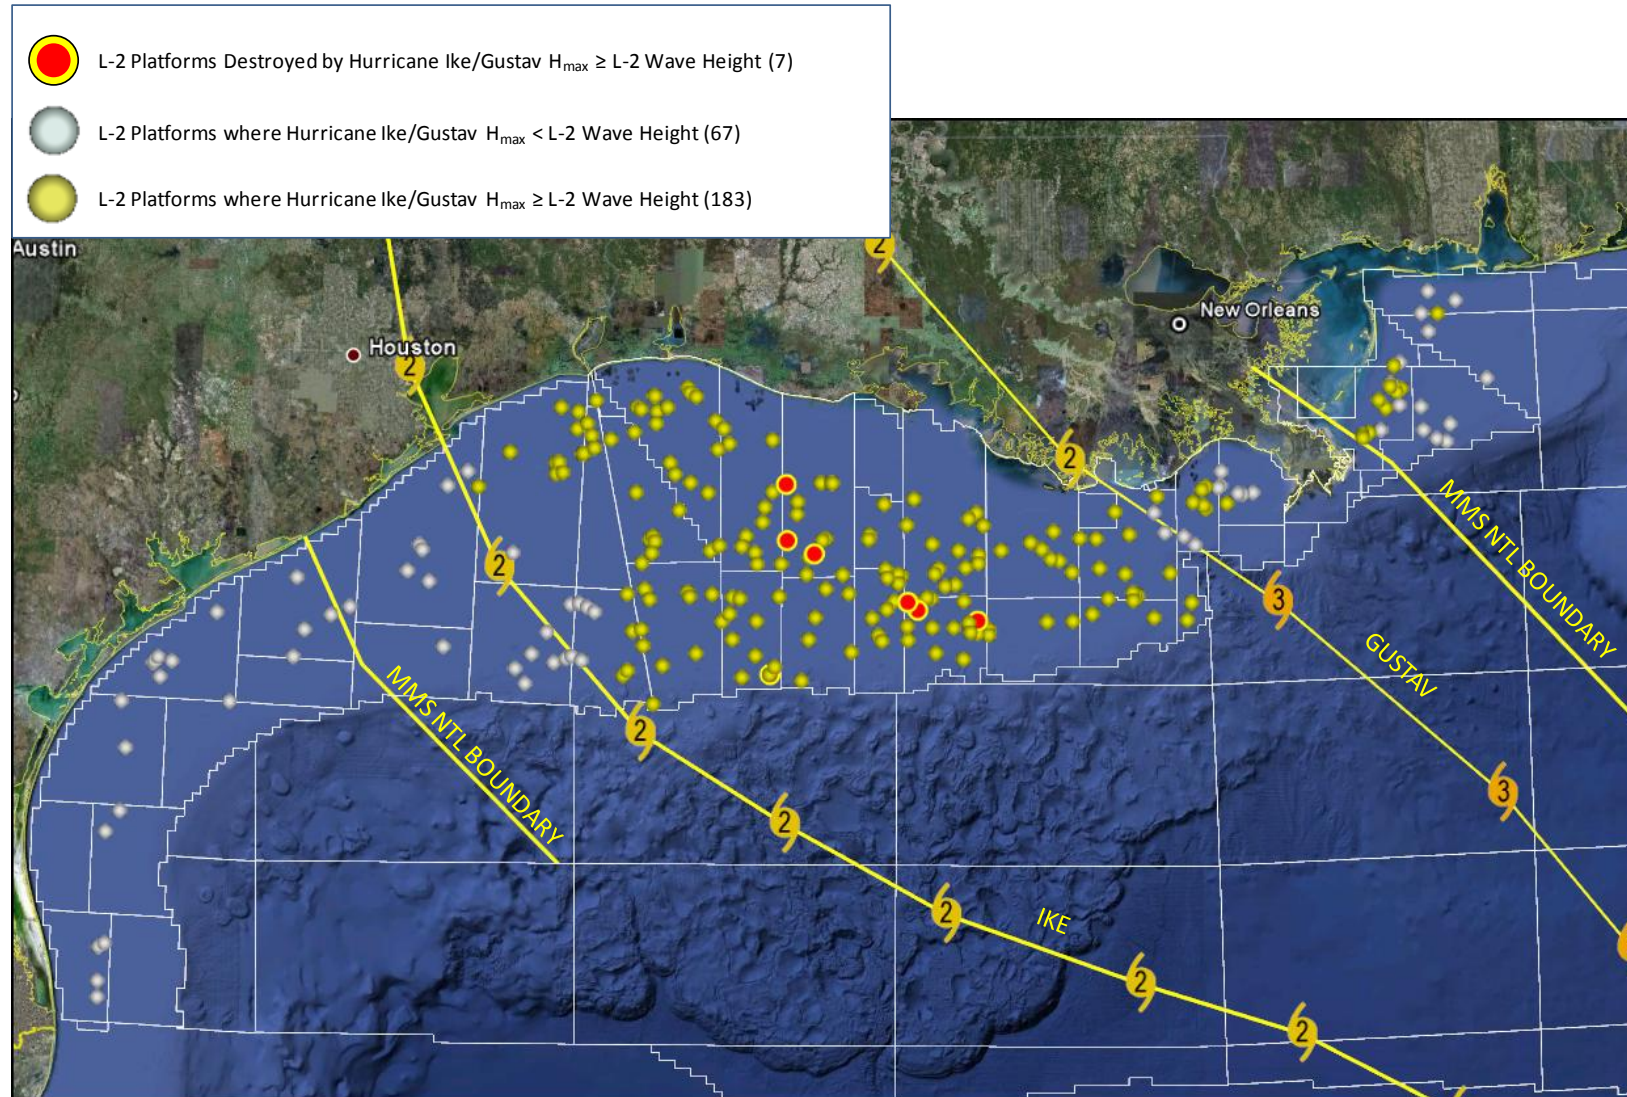
**Figure 5.6 Hindcast  $H_{max}$  vs. API Recommended Design Wave for L-2 Platform**  
Note: Shown are only those platforms with a calculable hindcast and recommended wave

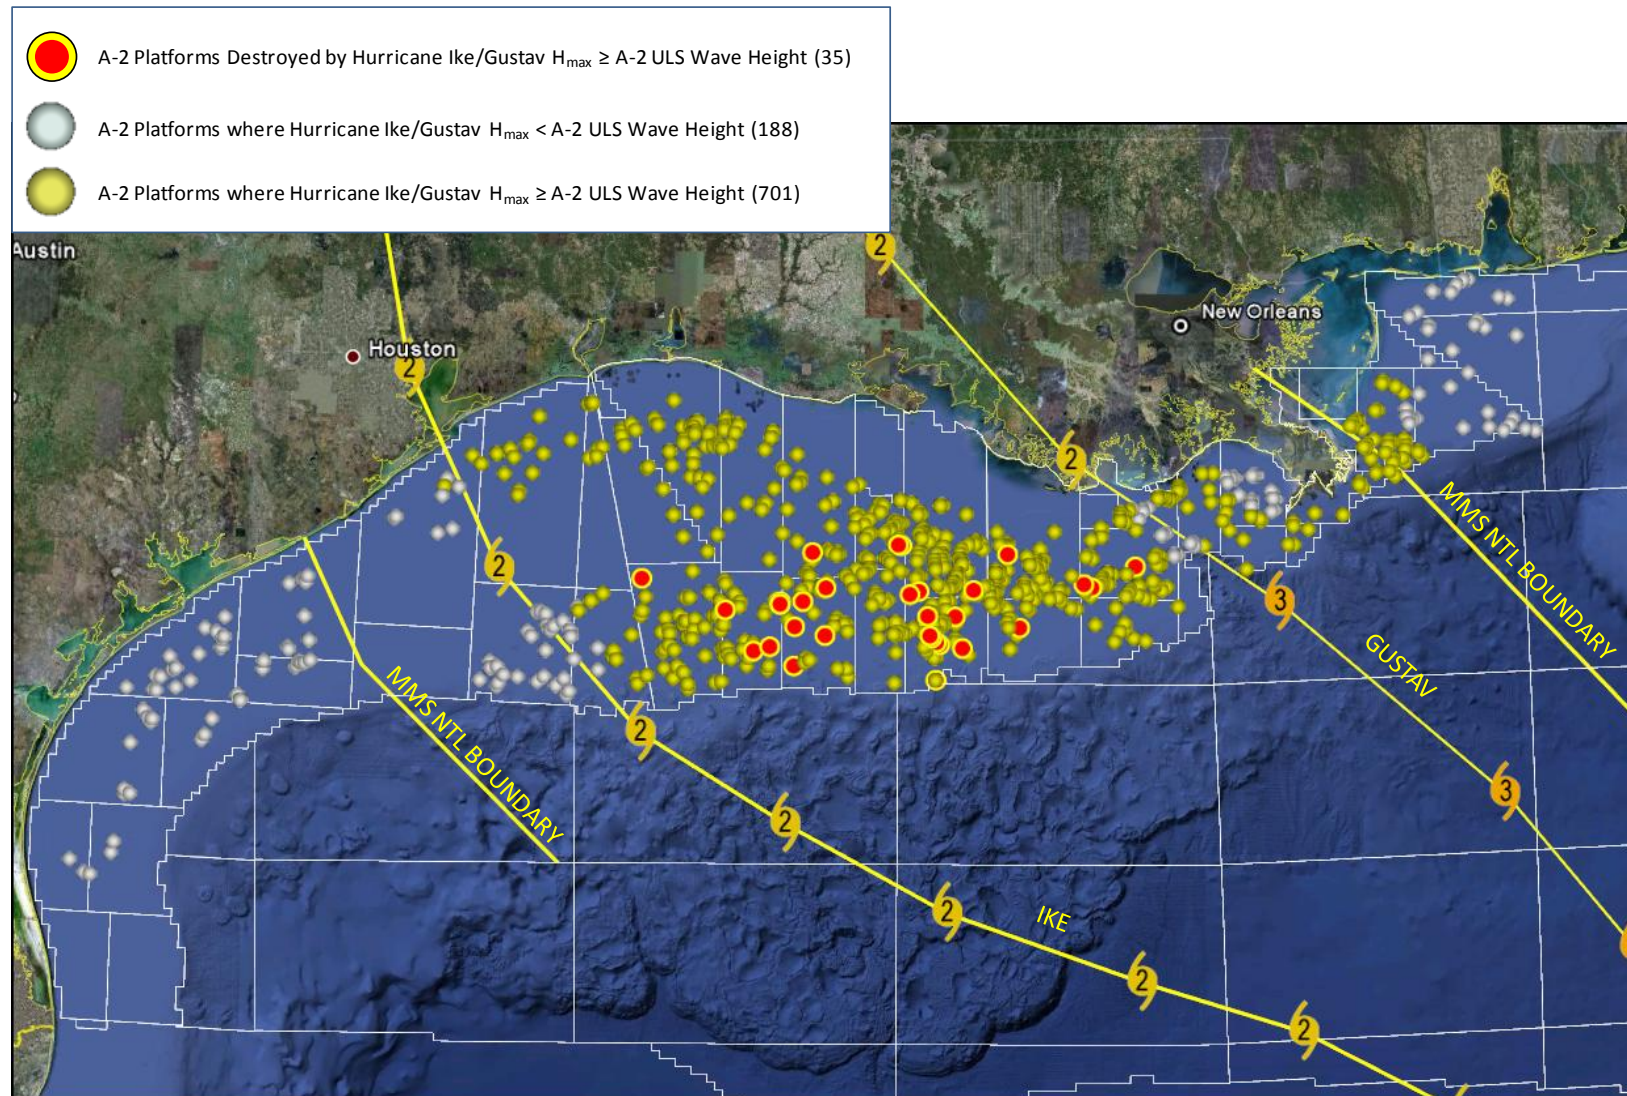
**Figure 5.7 Hindcast  $H_{max}$  vs. API Recommended Wave for A-2 Platforms**  
Note: Shown are only those platforms with a calculable hindcast and recommended wave

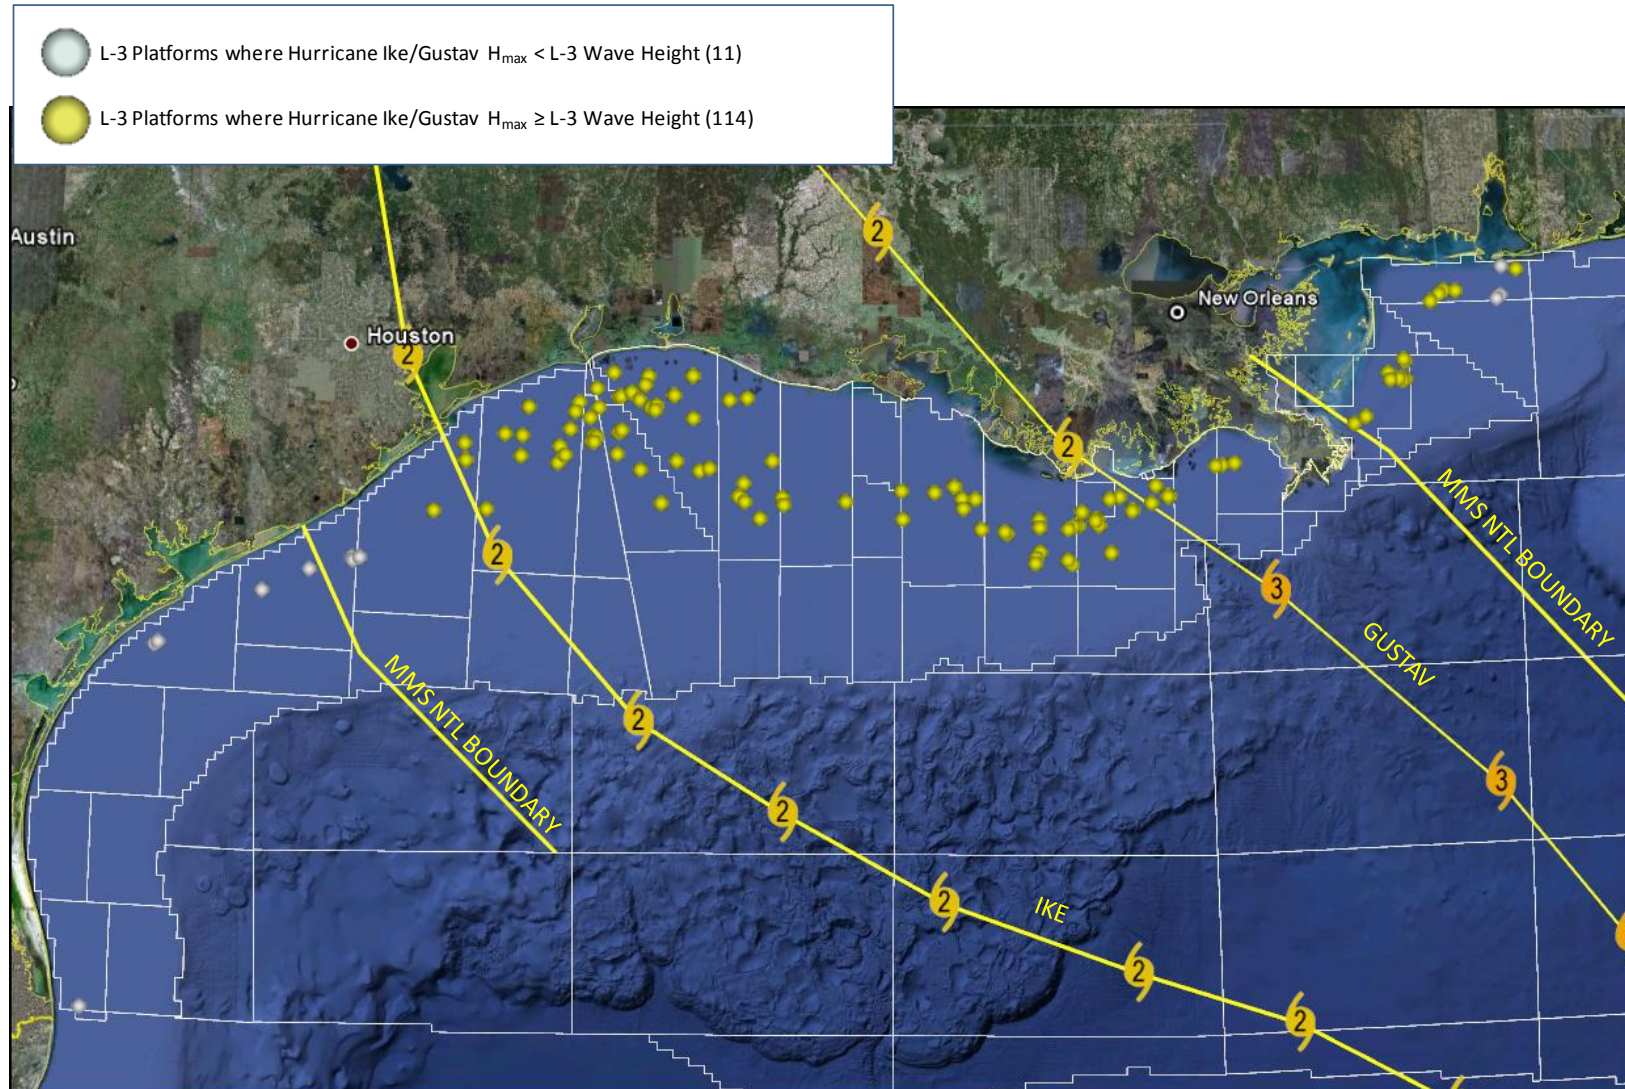
**Figure 5.8 Hindcast  $H_{max}$  vs. API Recommended Design Wave for L-3 Platform**  
Note: Shown are only those platforms with a calculable hindcast and recommended wave

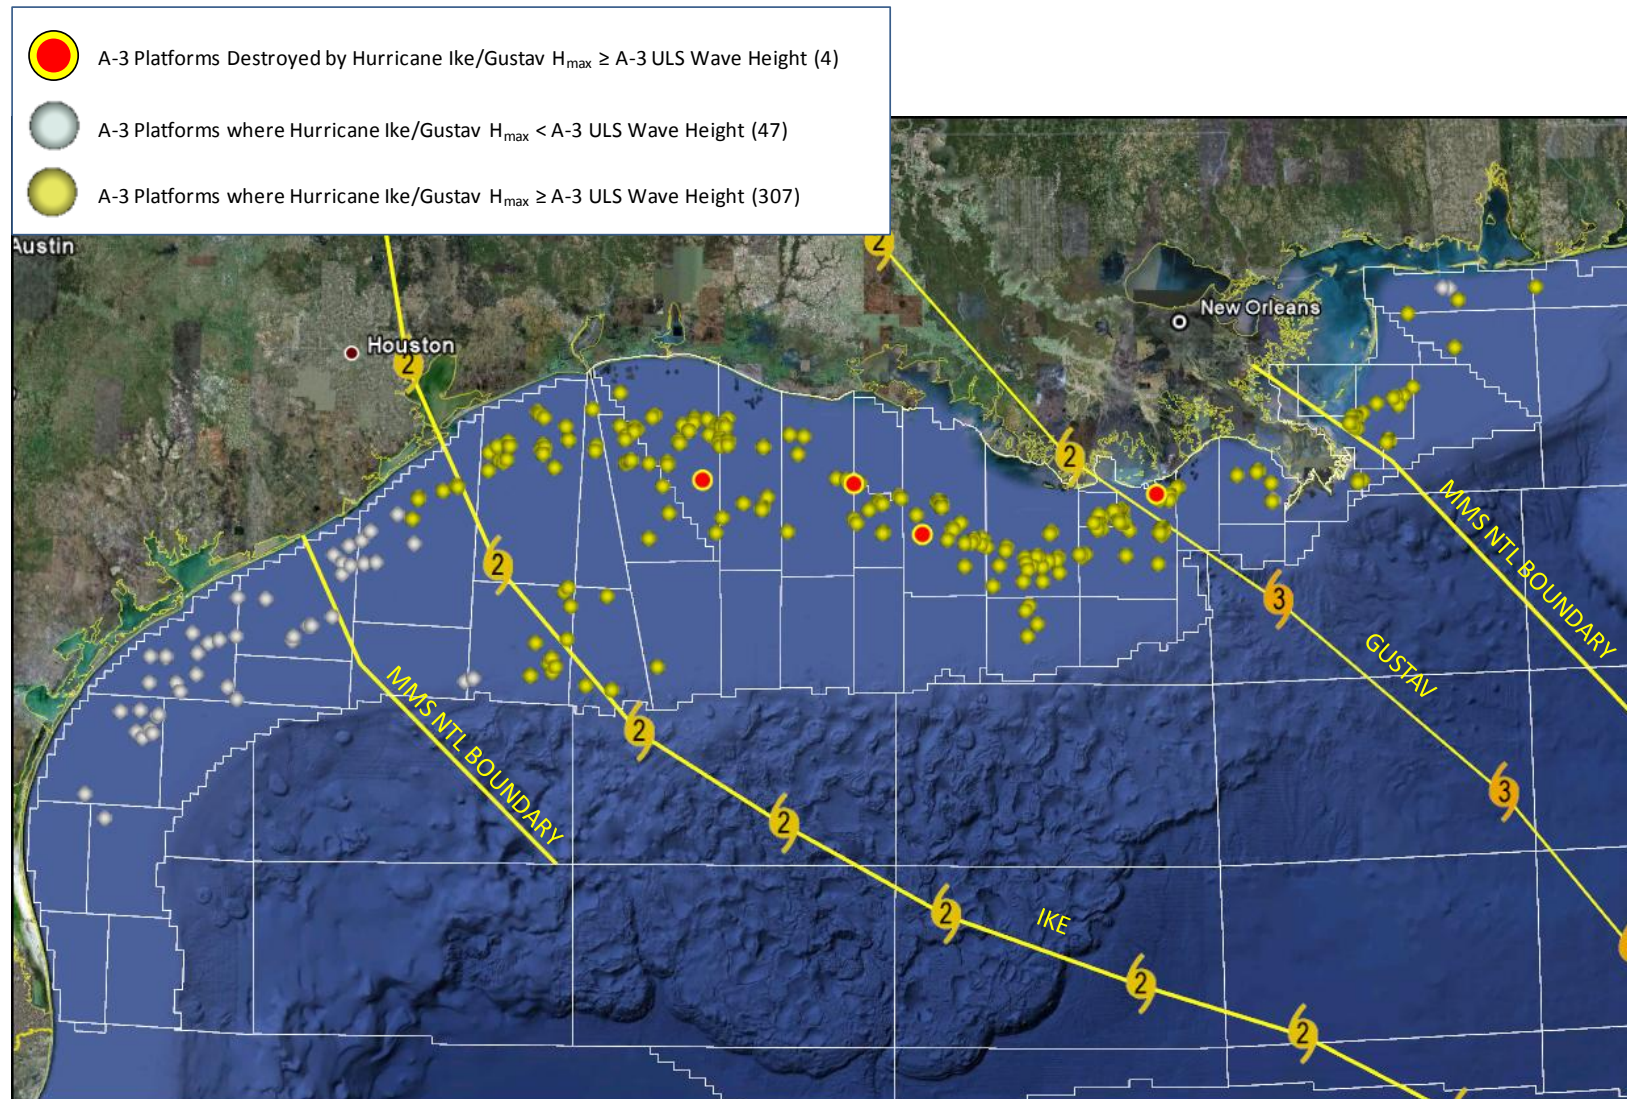
**Figure 5.9 Hindcast  $H_{max}$  vs. API Recommended Wave for A-3 Platform**  
Note: Shown are only those platforms with a calculable hindcast and recommended wave

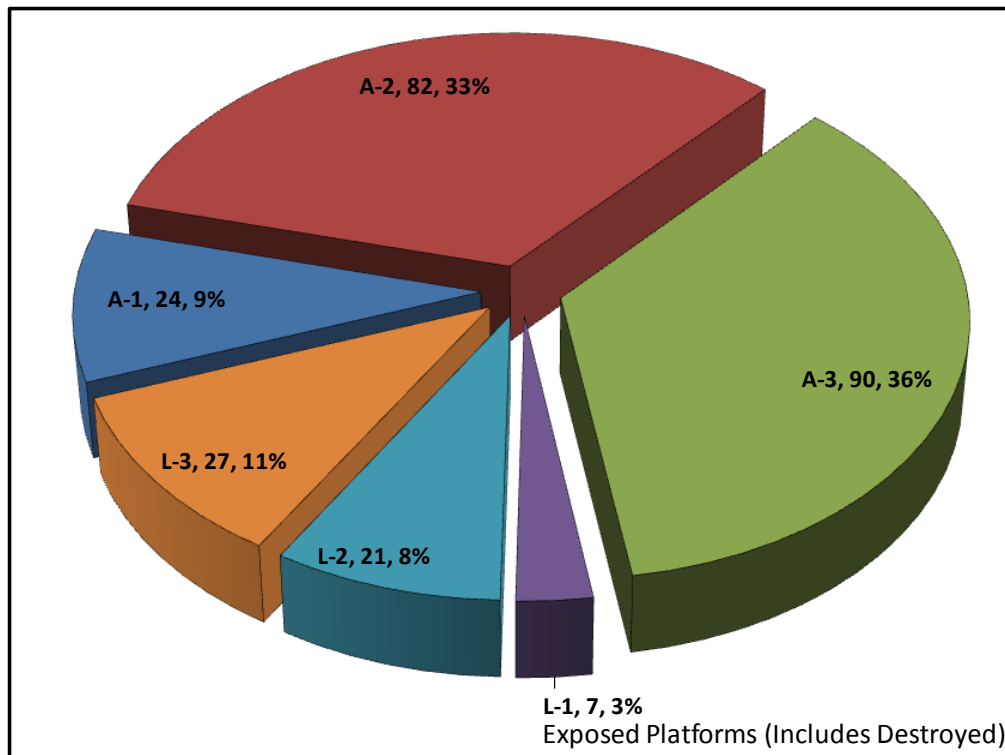
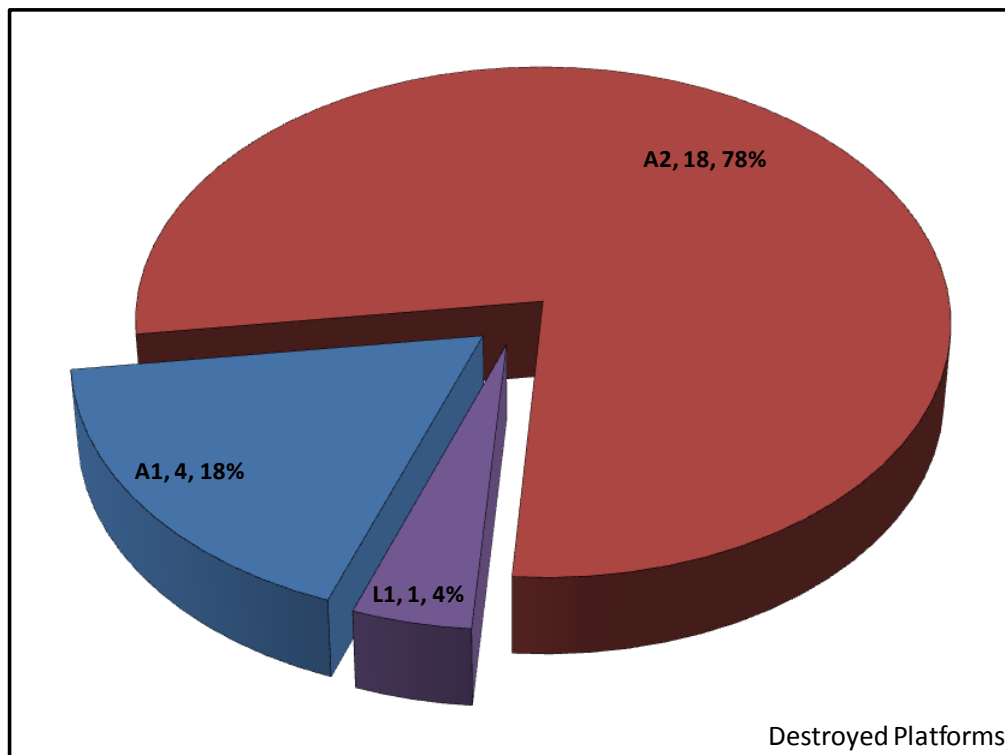
**Figure 5.10 Hindcast Crest Elevation Exceeds Actual (Reported) Deck Height for Exposed and Destroyed Platforms**

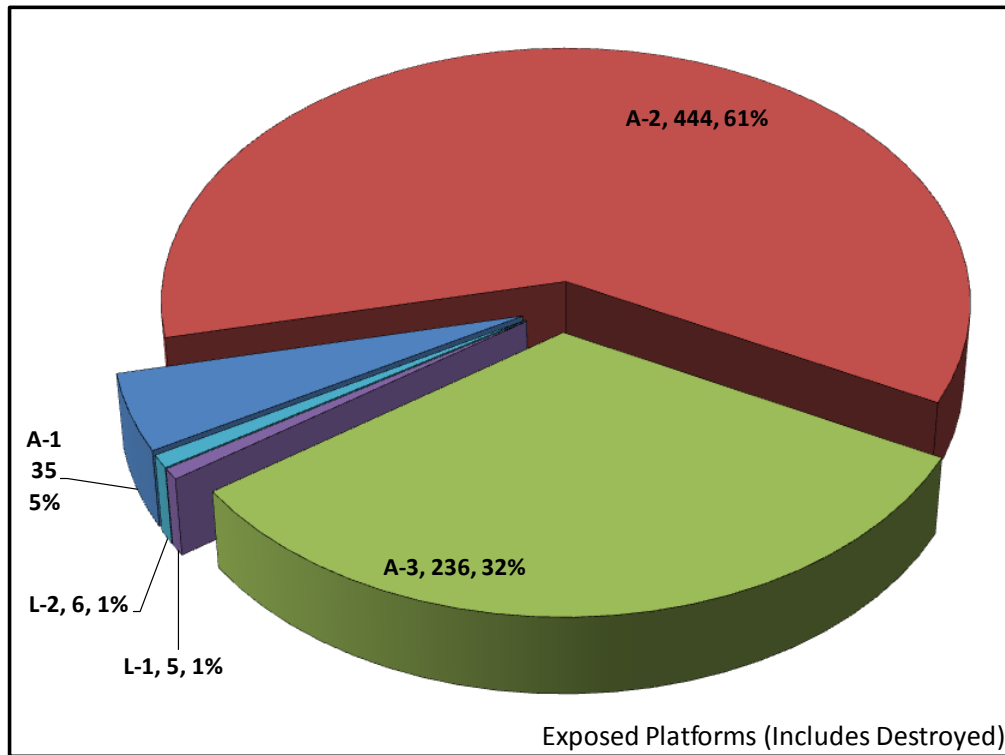
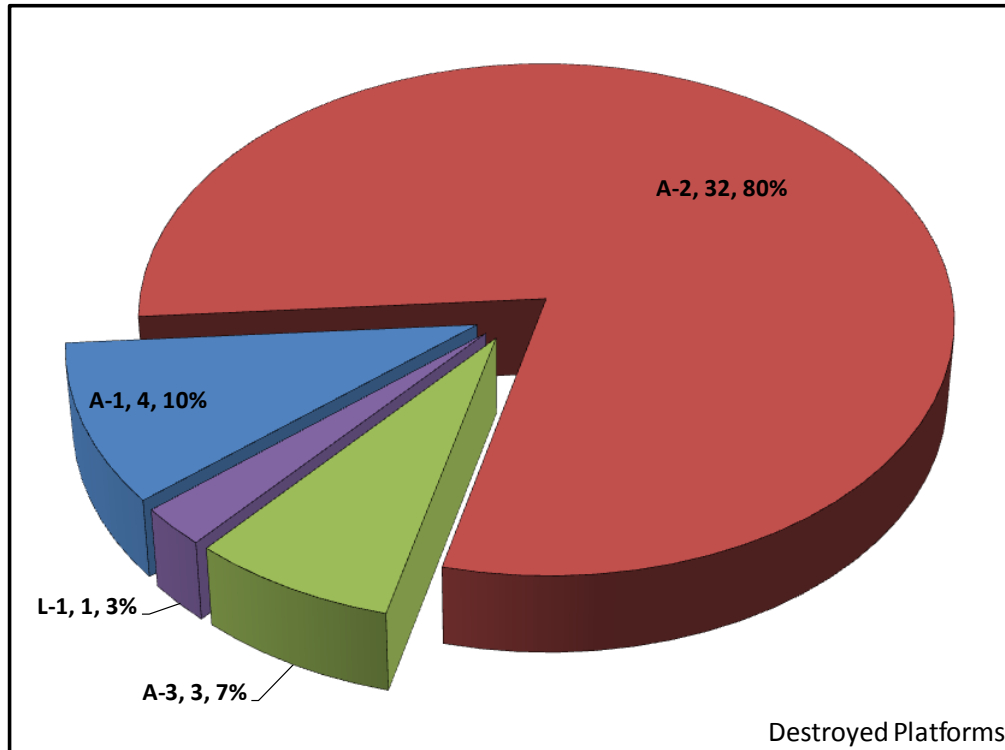
**Figure 5.17 Crest Elevation Exceeds API Recommended Deck Height for Exposed and Destroyed Platforms**
