***ASSESSMENT OF DAMAGE AND FAILURE  
MECHANISMS FOR OFFSHORE STRUCTURES AND  
PIPELINES IN HURRICANES GUSTAV AND IKE***

**FINAL REPORT  
February 2010**

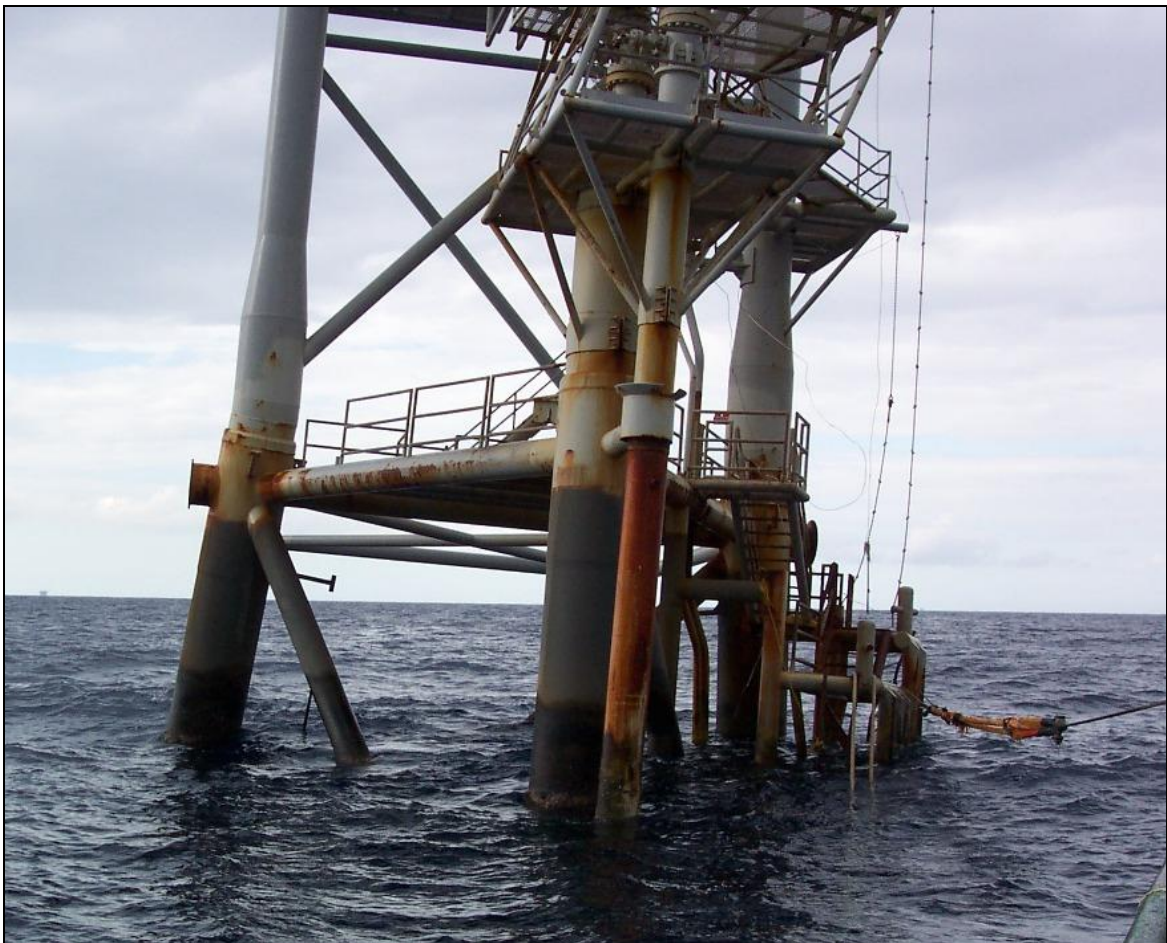
**Figure 6.10 Leaning Platform in the East Cameron Area**

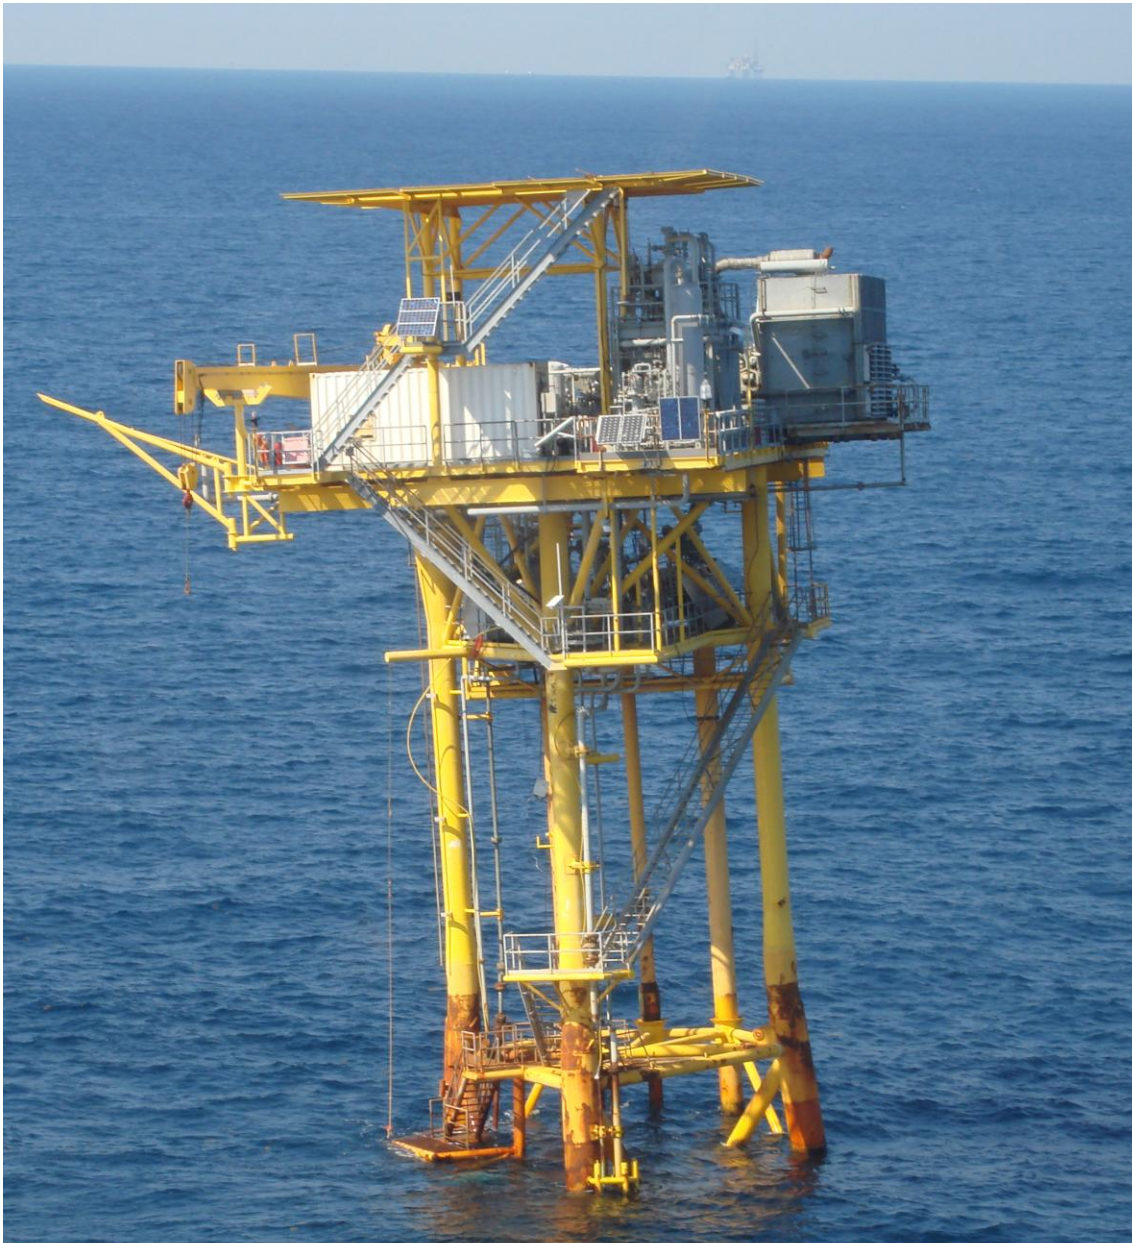
**Figure 6.11 Leaning Tripod Platform in the Eugene Island Area**

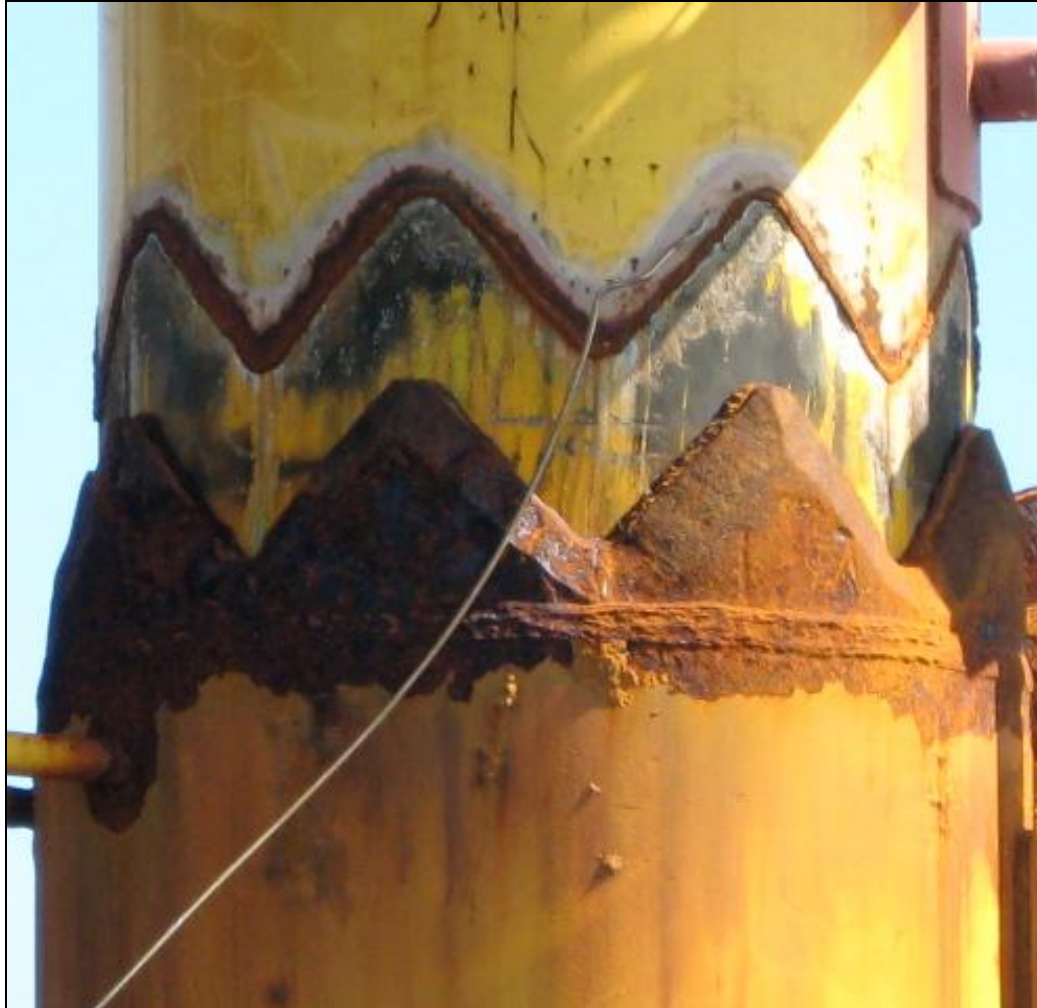
**Figure 6.12 Crown Shim Failure due to Inadequate Welding**

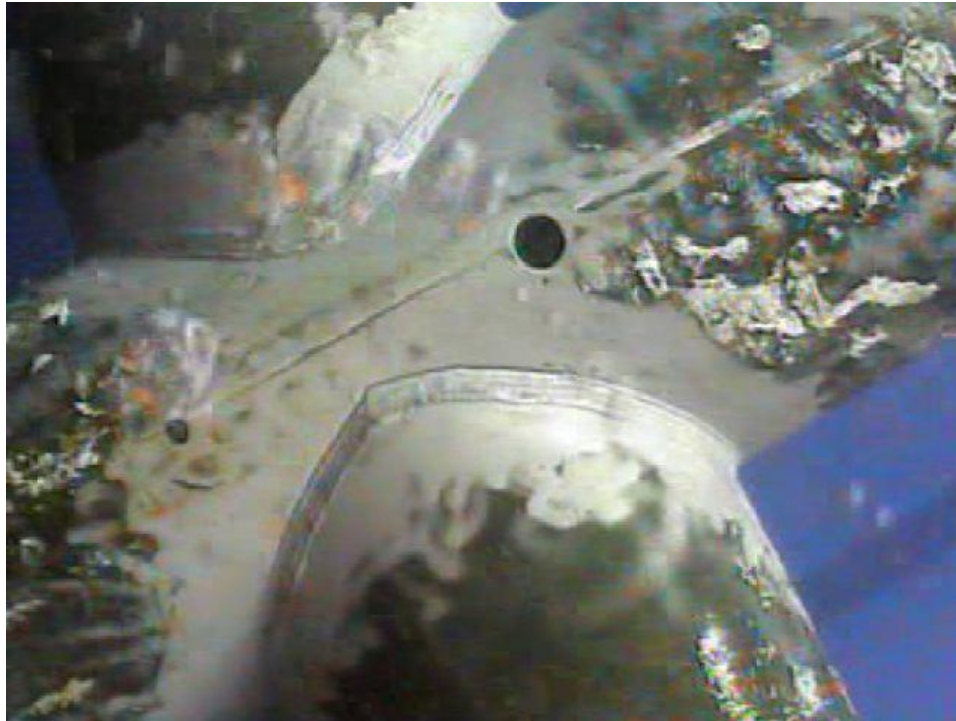
**Figure 6.13 Drill Stops to Prevent Crack Propagation**

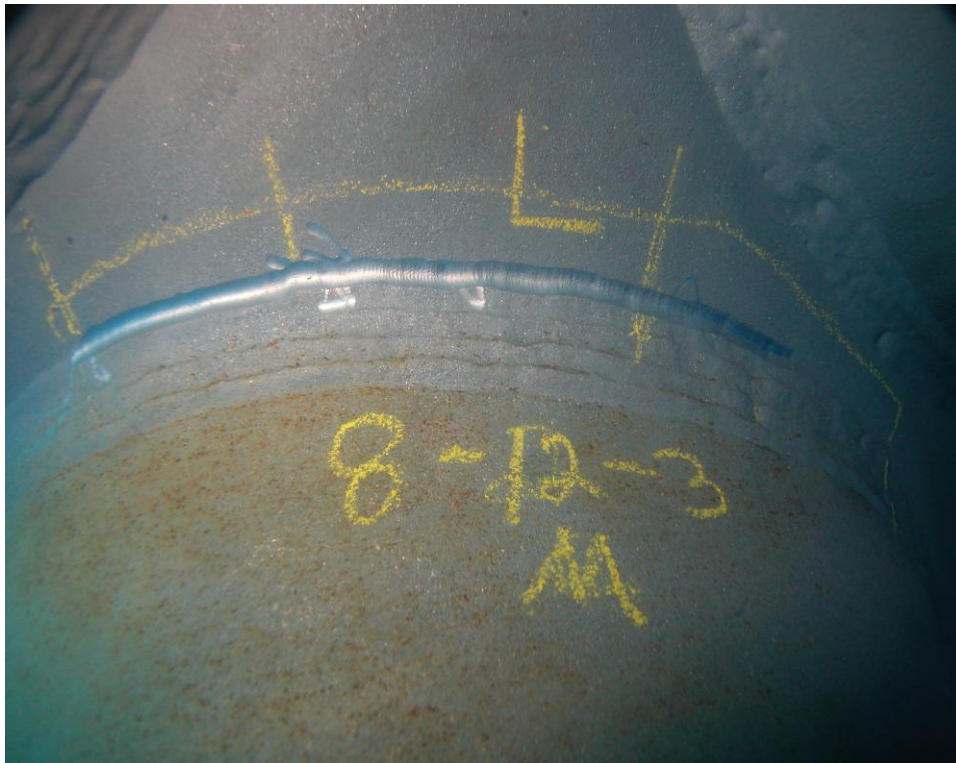
**Figure 6.14 Grinding to Prevent Crack Propagation at Connection**

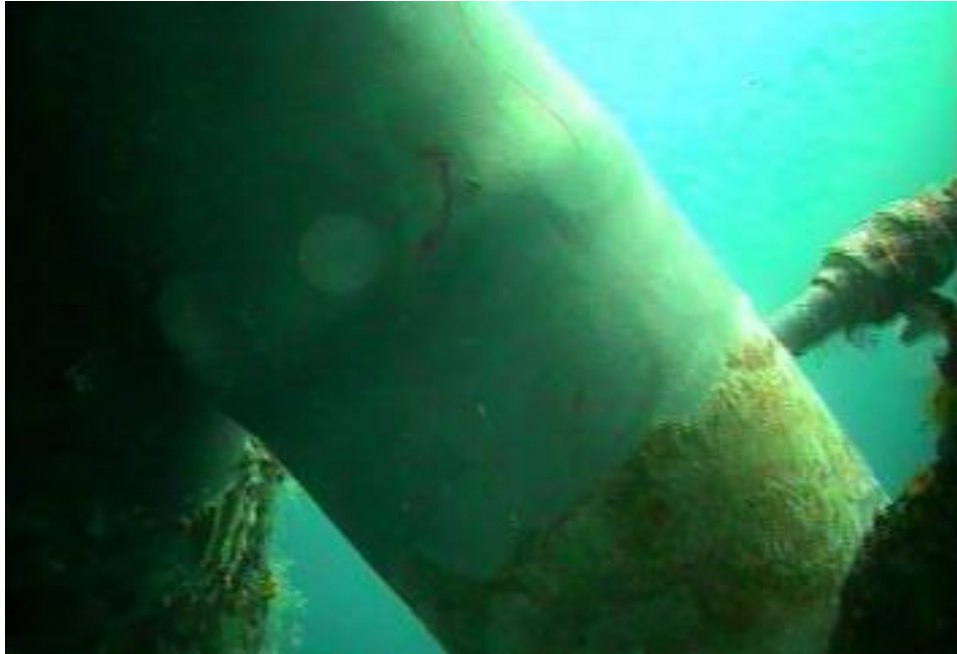
**Figure 6.15 Grout Valve Installed on VD**

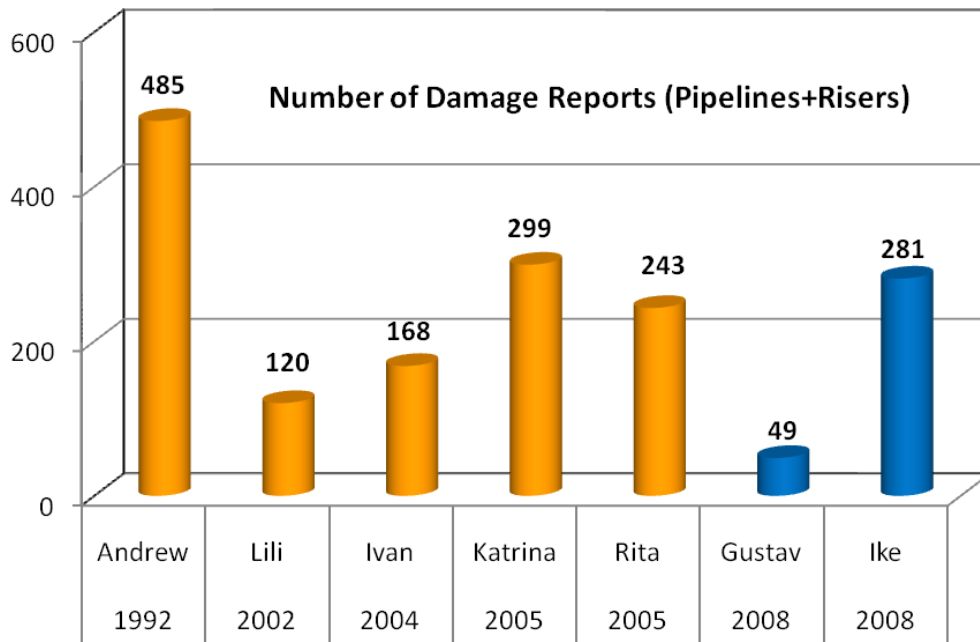
**Figure 7.1 Total Number of Damage Reports**

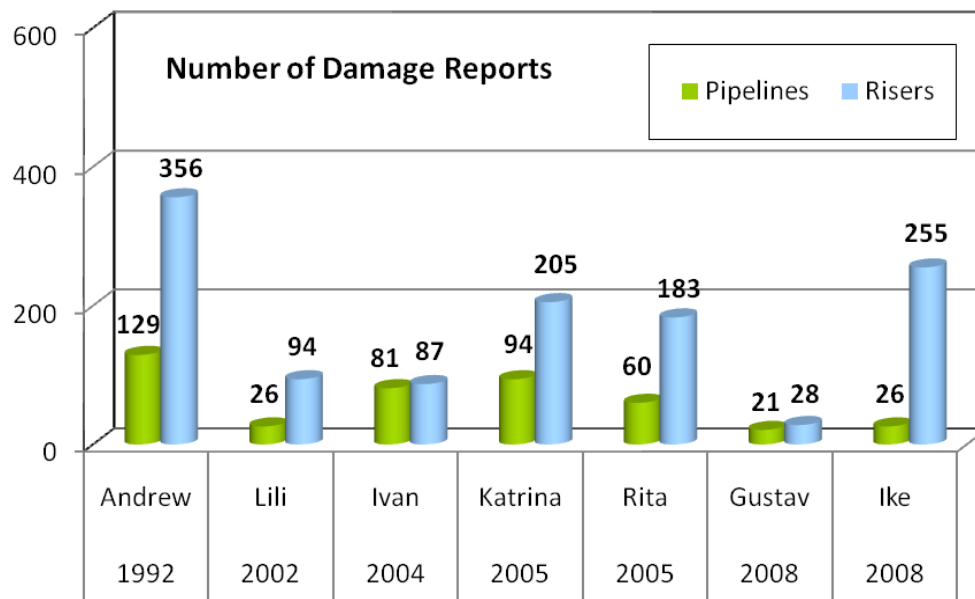
**Figure 7.2 Damage Reports for Pipelines versus Risers**

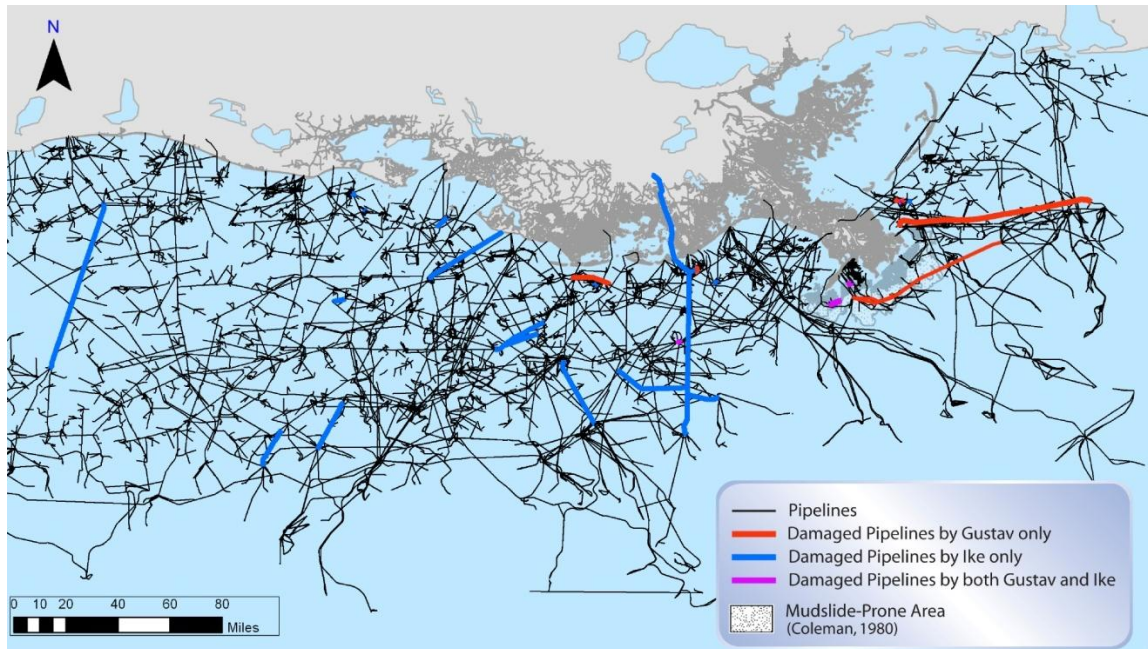
**Figure 7.3 Pipeline Damage Locations for Hurricanes Gustav and Ike**

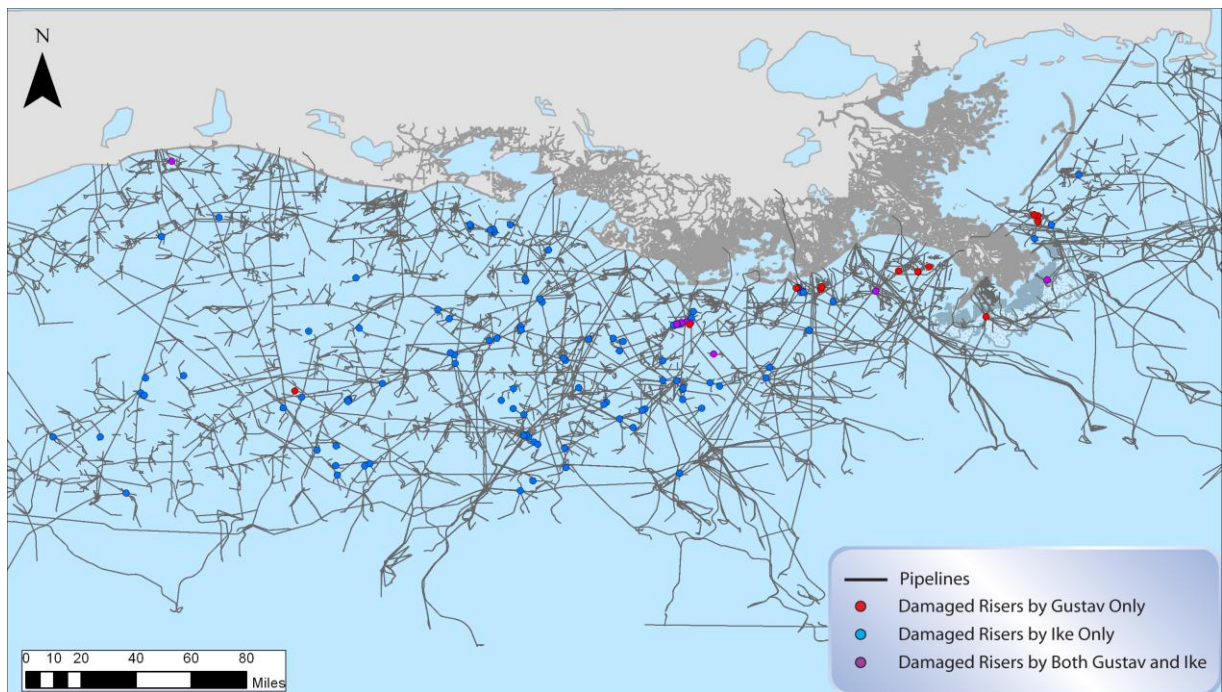
**Figure 7.4 Riser Damage Locations for Hurricanes Gustav and Ike**

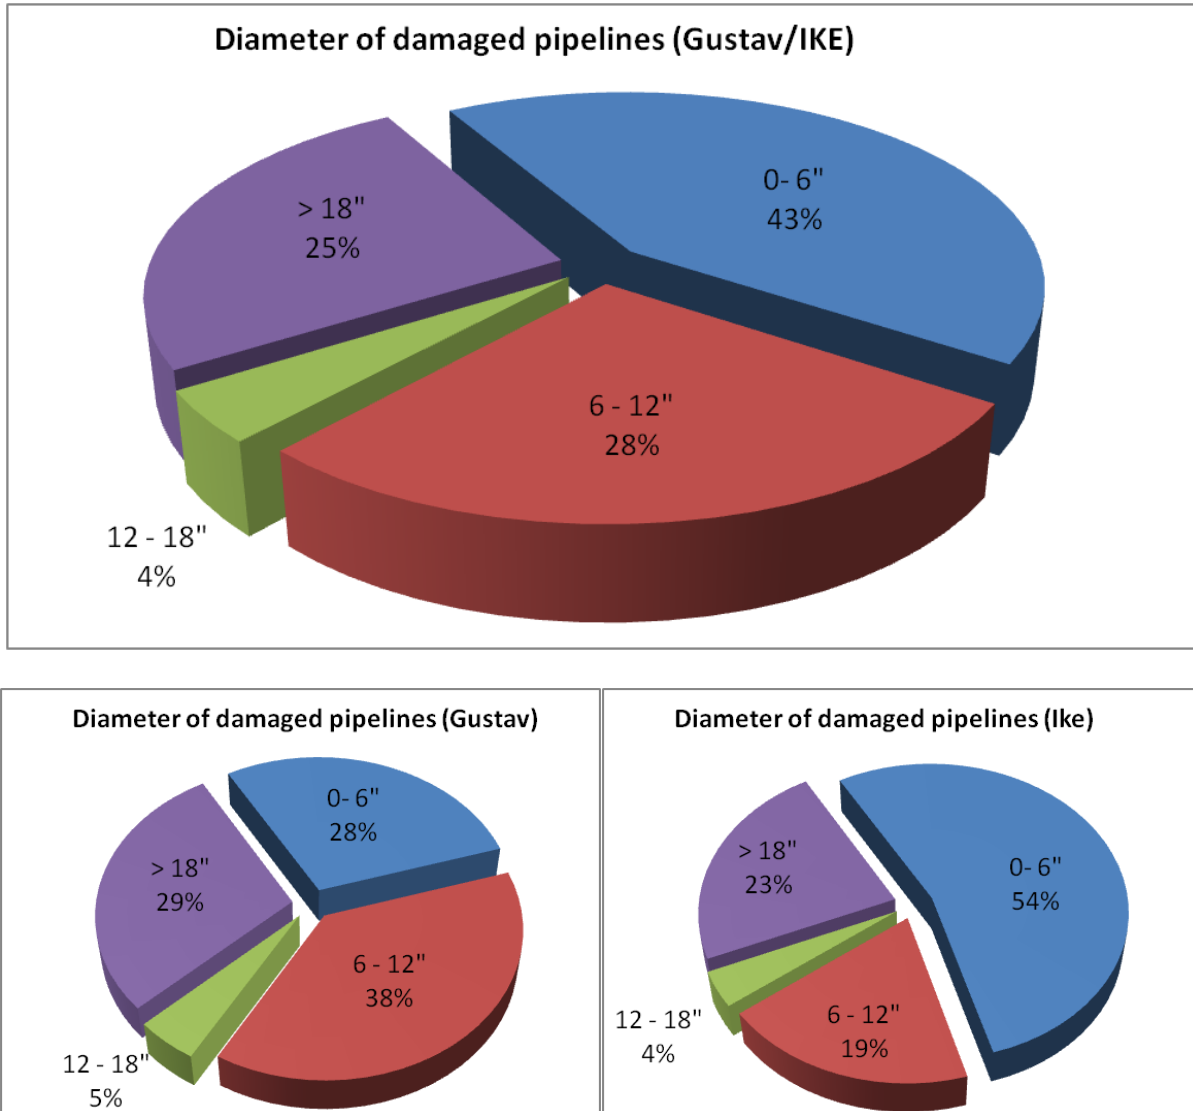
**Figure 7.5 Diameter of Damaged Pipelines**

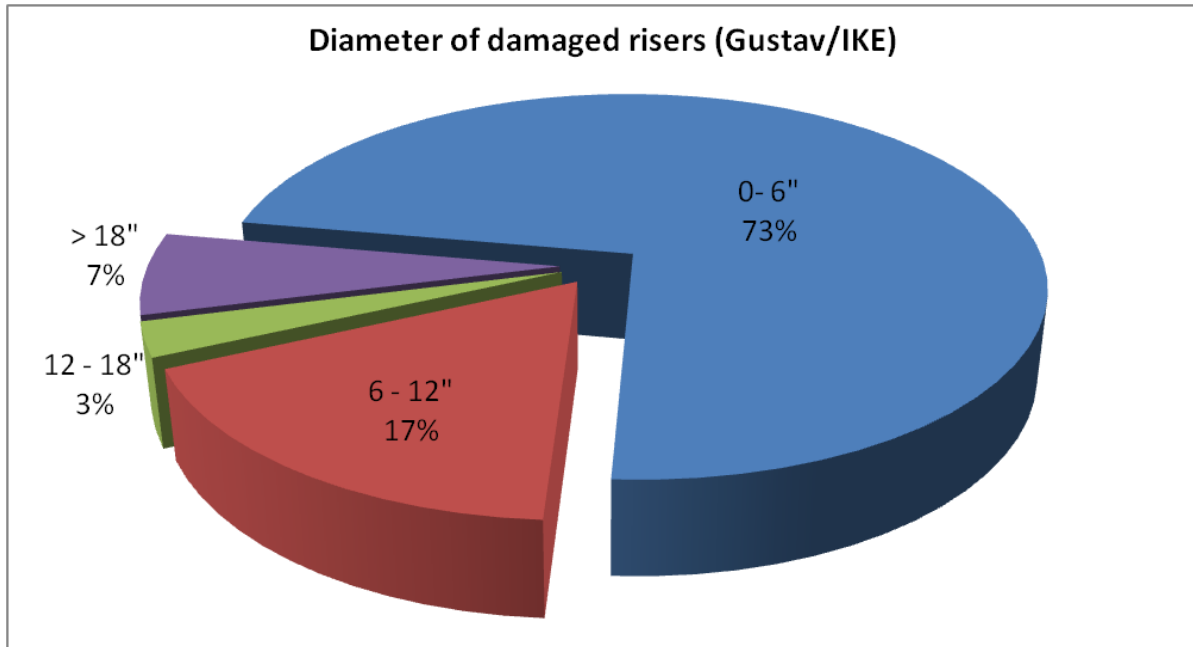
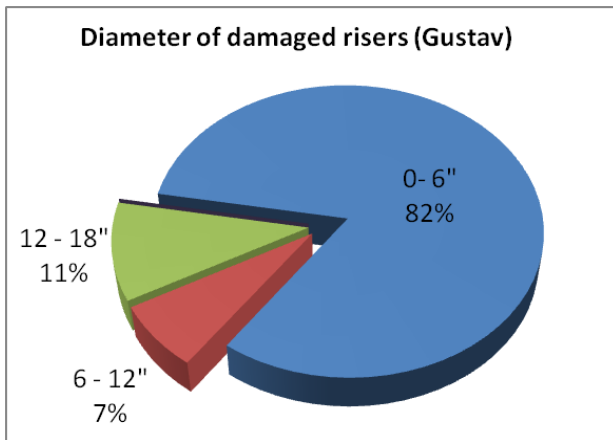
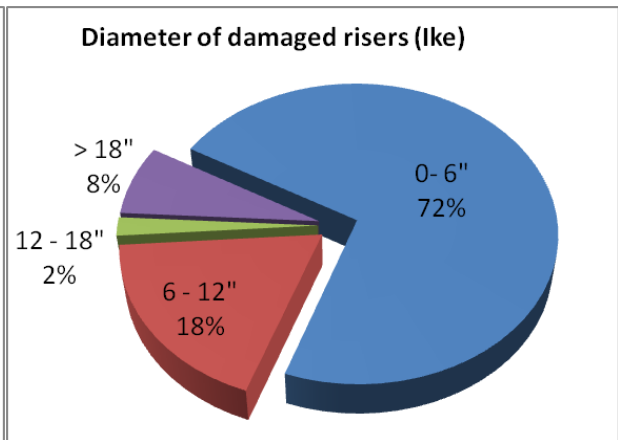
**Figure 7.6 Diameter of Damaged Risers**

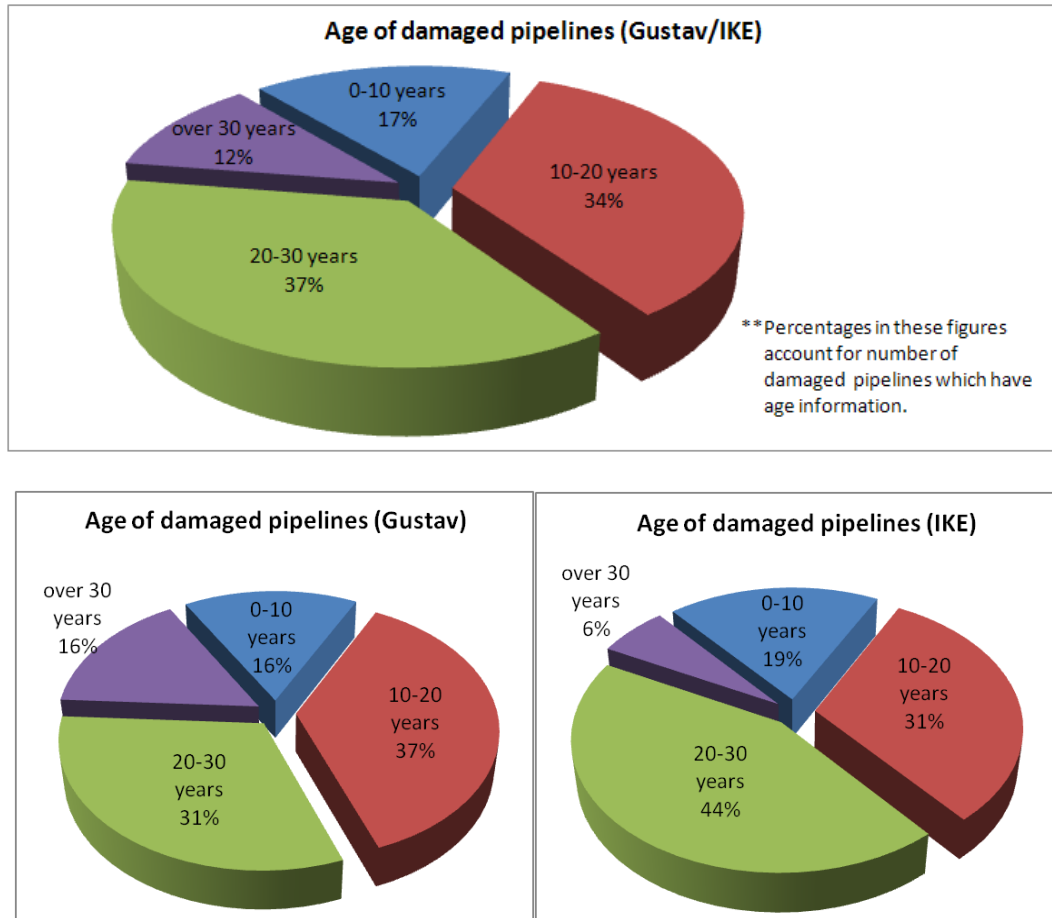
**Figure 7.7 Age of Damaged Pipelines**

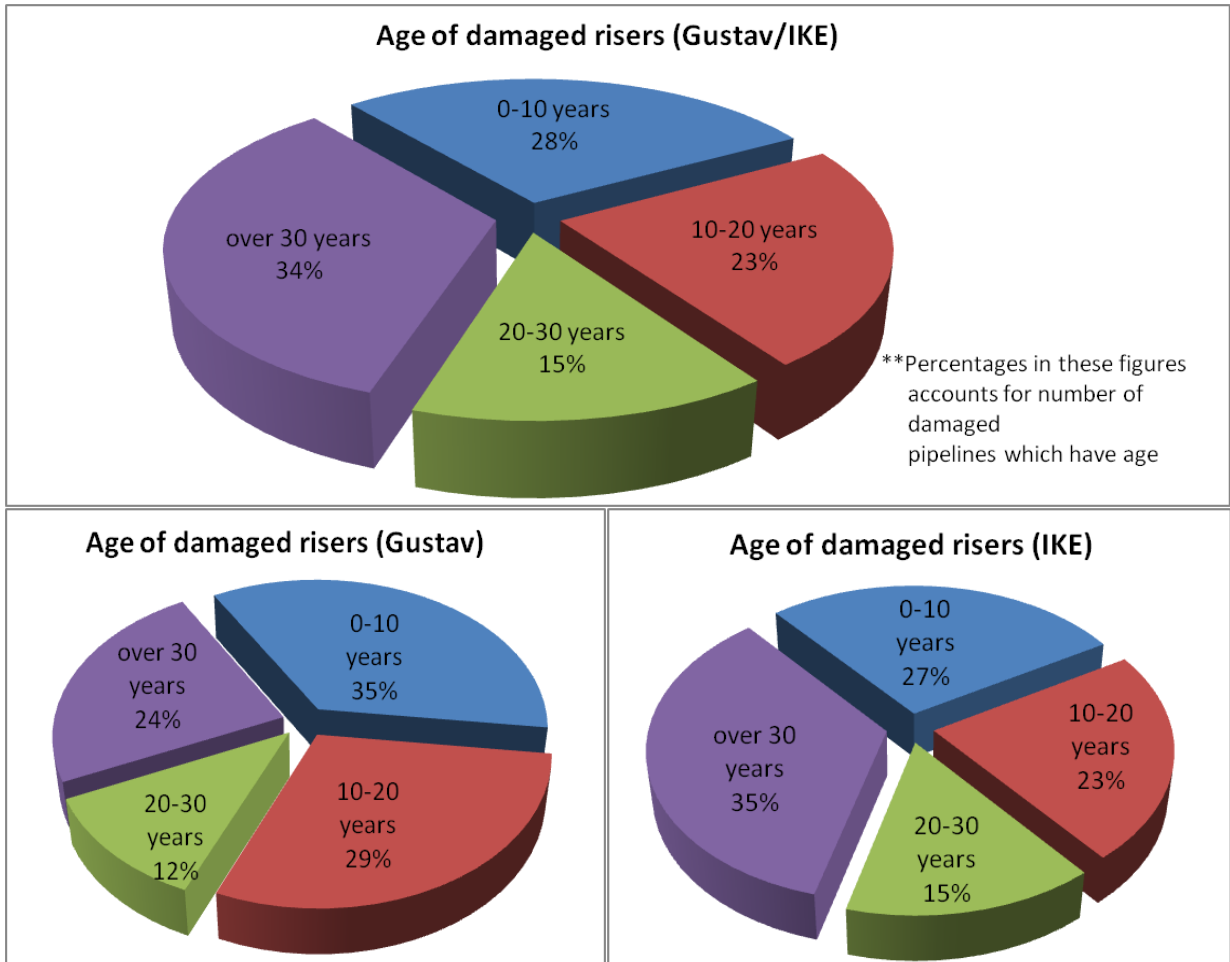
**Figure 7.8 Age of Damaged Risers**

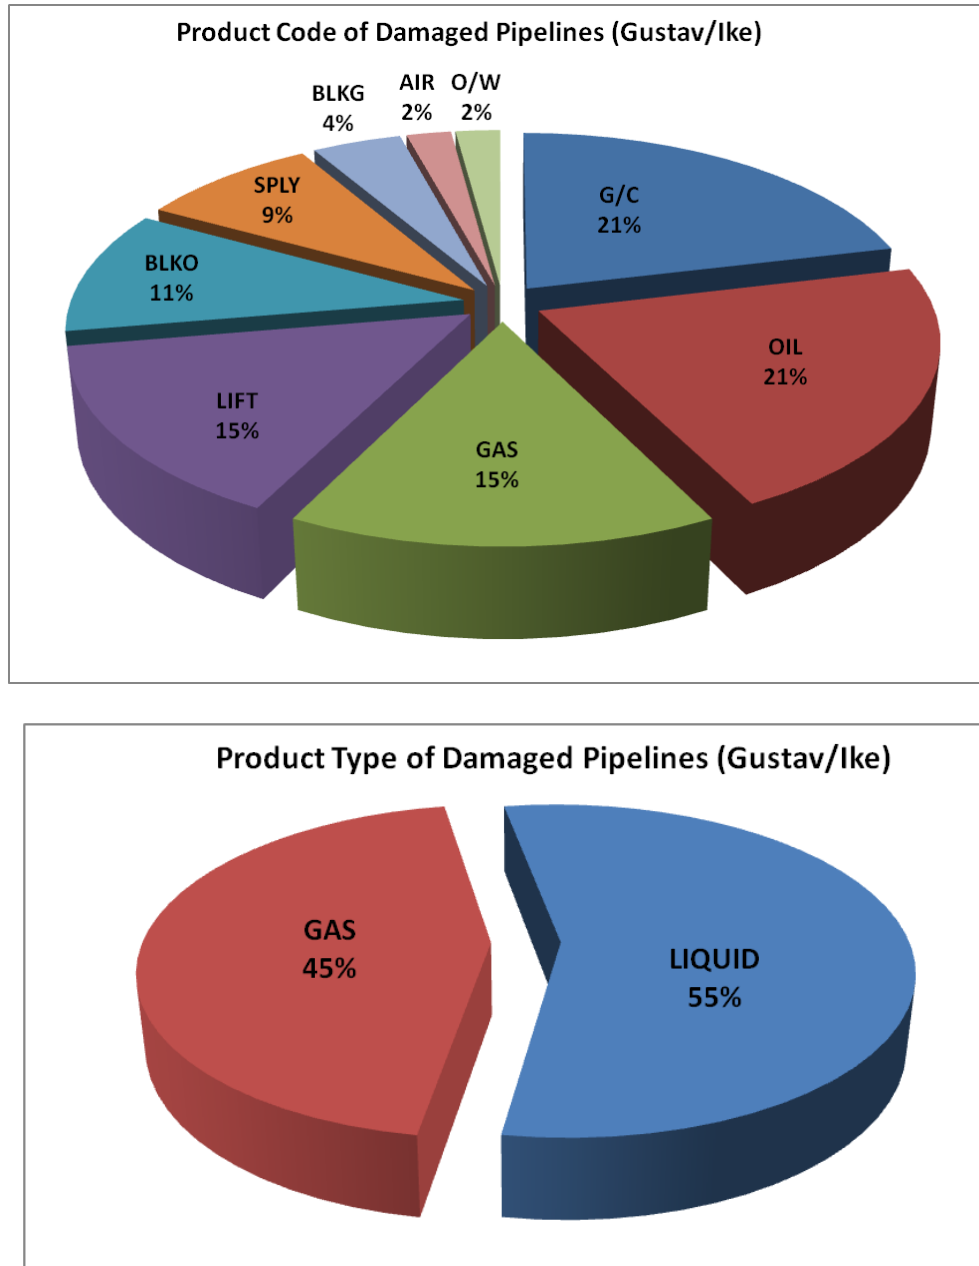
Figure 7.9 Product Carried by Damaged Pipelines

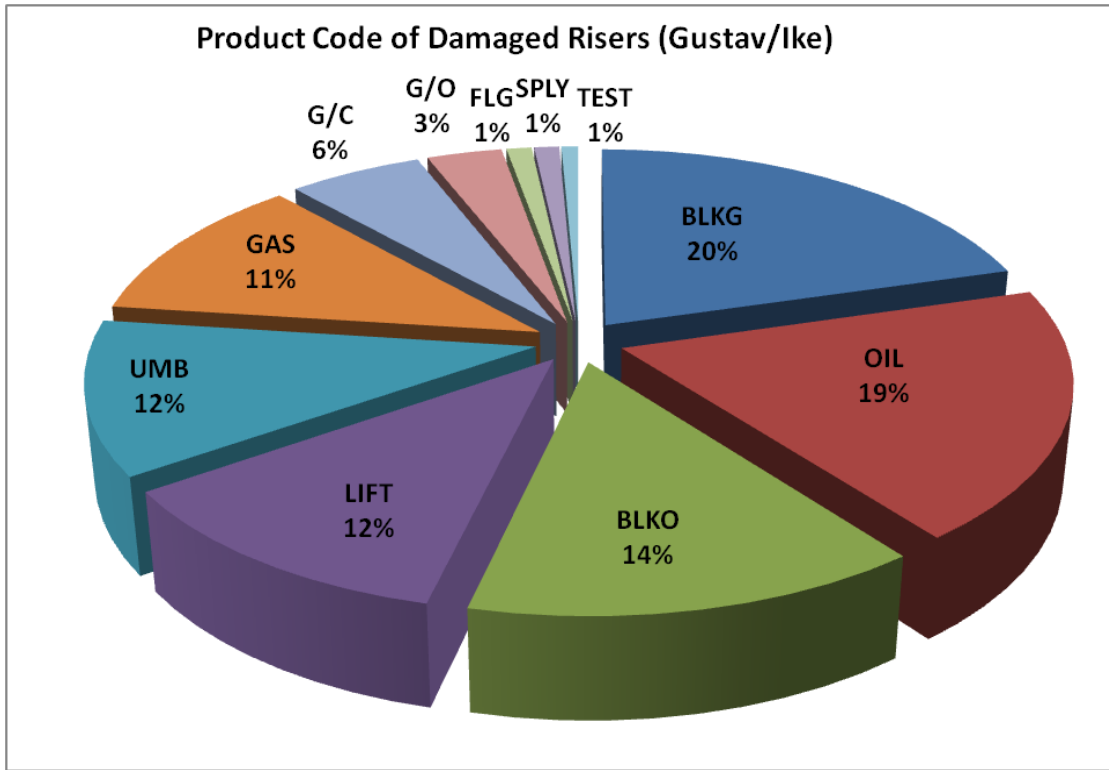
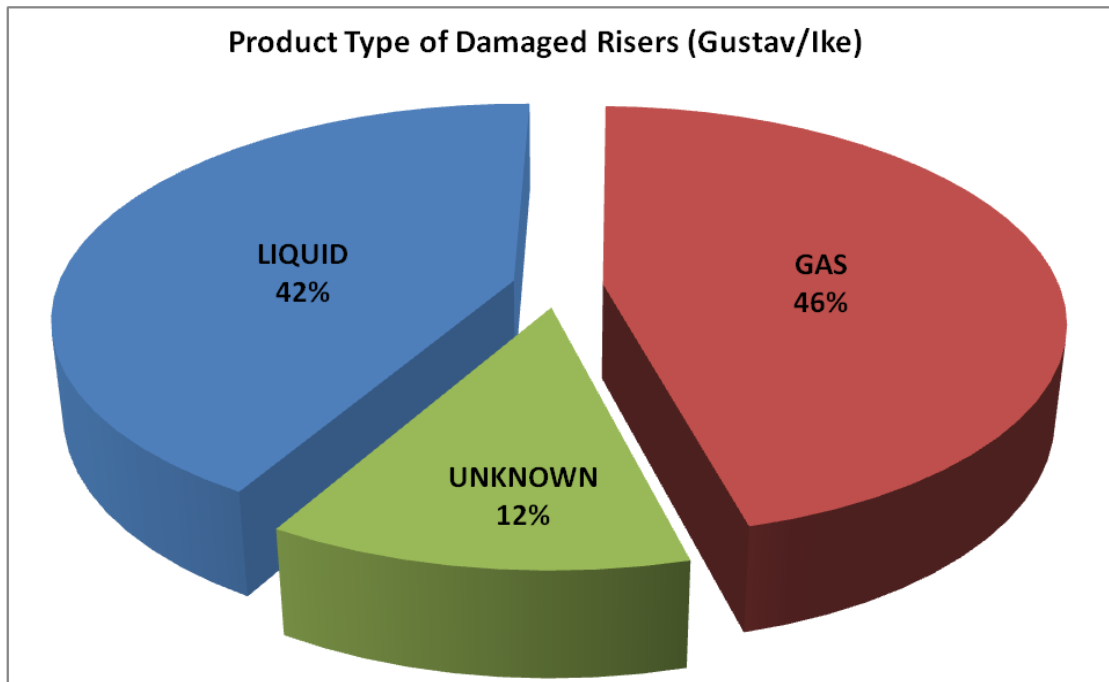
Figure 7.10 Product Carried by Damaged Risers

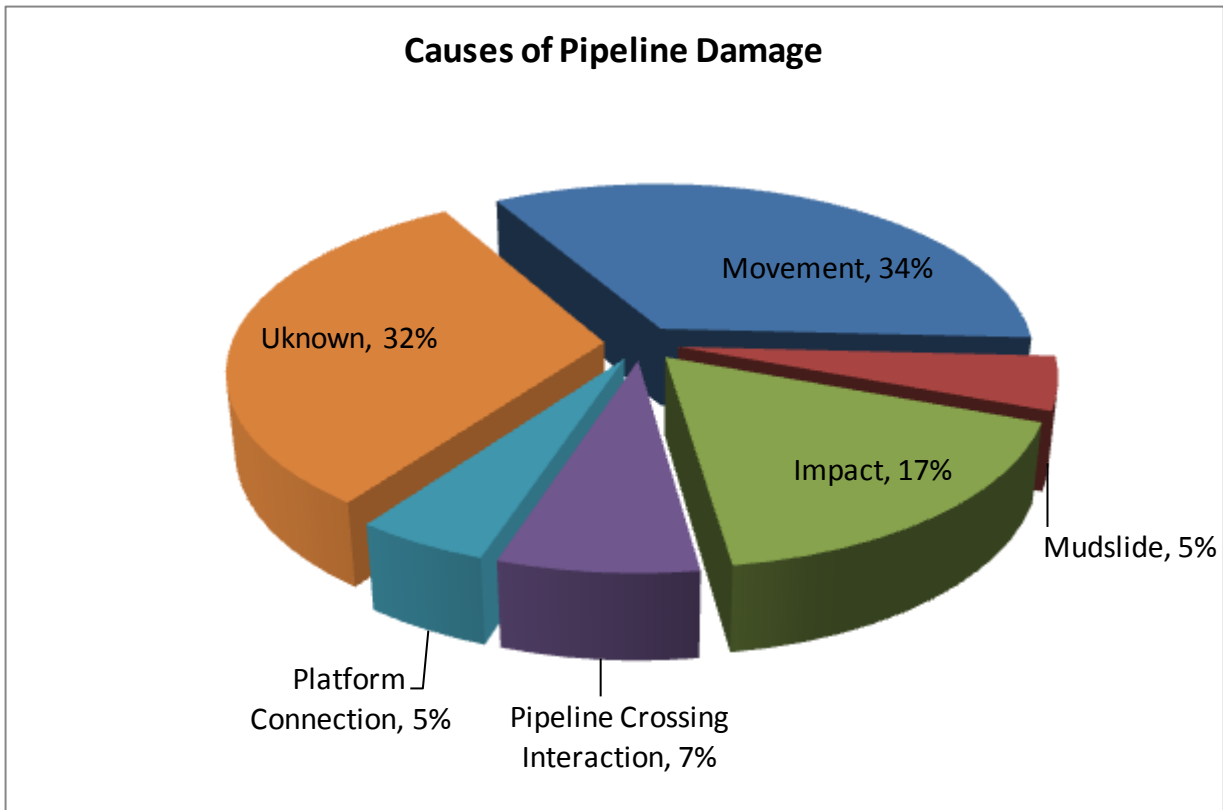
**Figure 7.11 Causes of Pipeline Damage for Hurricanes Gustav and Ike**

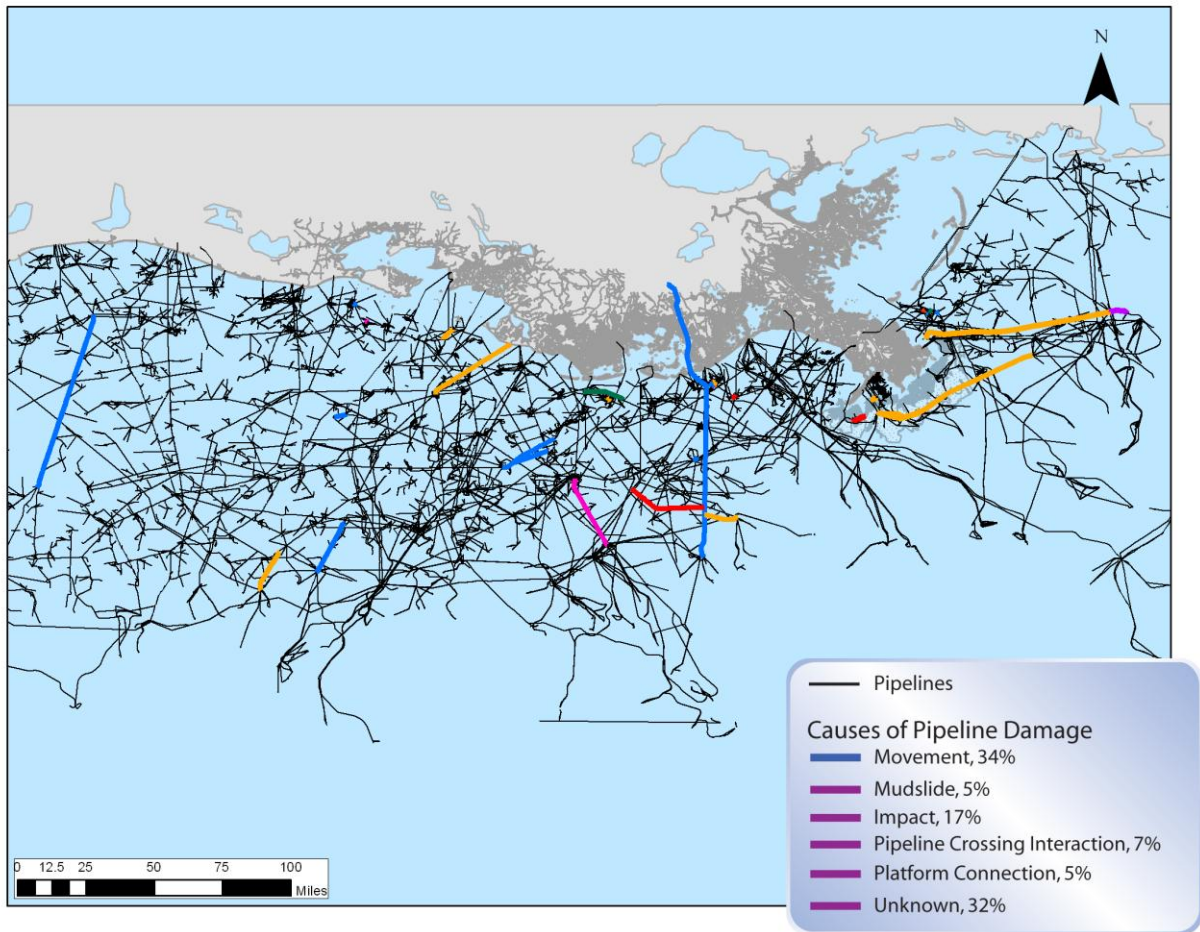
**Figure 7.12 Locations of Pipeline Damage by Cause for Hurricanes Gustav and Ike**

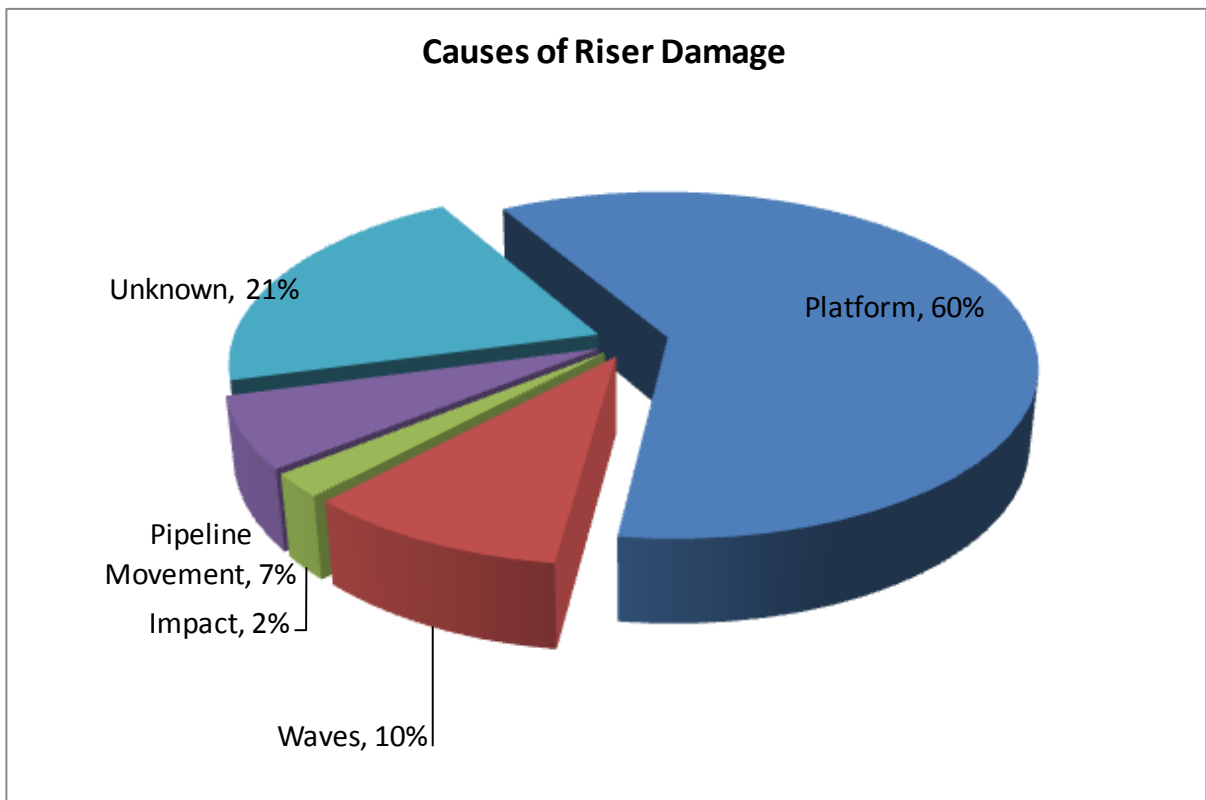
**Figure 7.13 Causes of Riser Damage for Hurricanes Gustav and Ike**

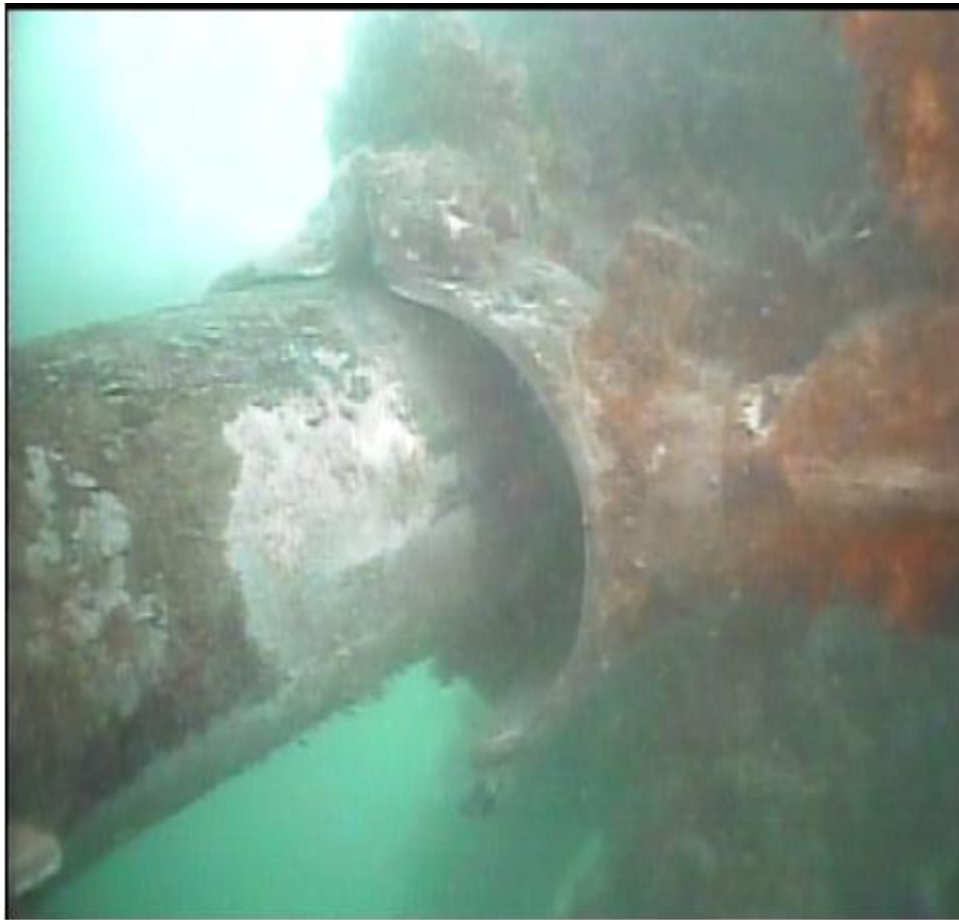
**Figure 7.14 Example of Riser Pulled from Leg Clamp**

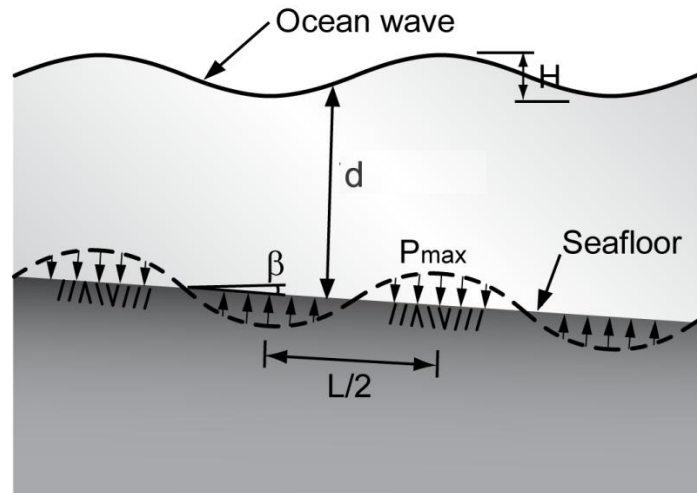
**Figure 7.15 Differential Bottom Pressure under Wave (from Nodine et al. 2009)**

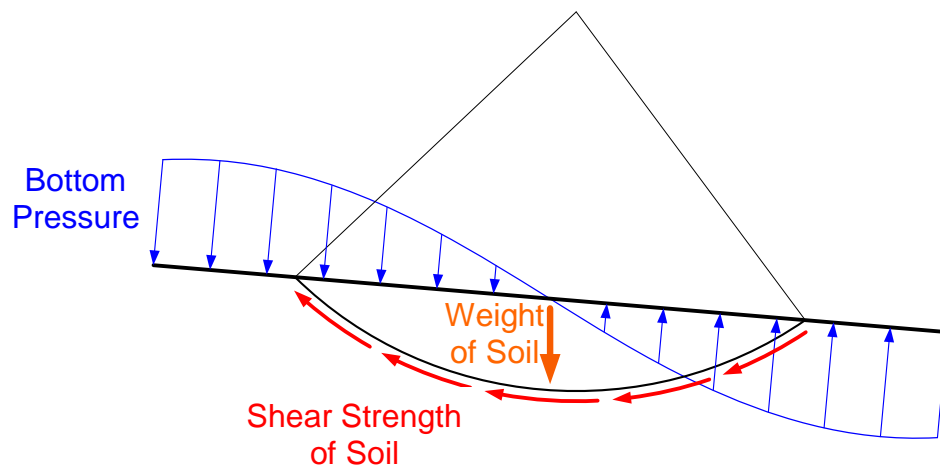
**Figure 7.16 Failure Mechanism for Wave-Induced Mudslide**

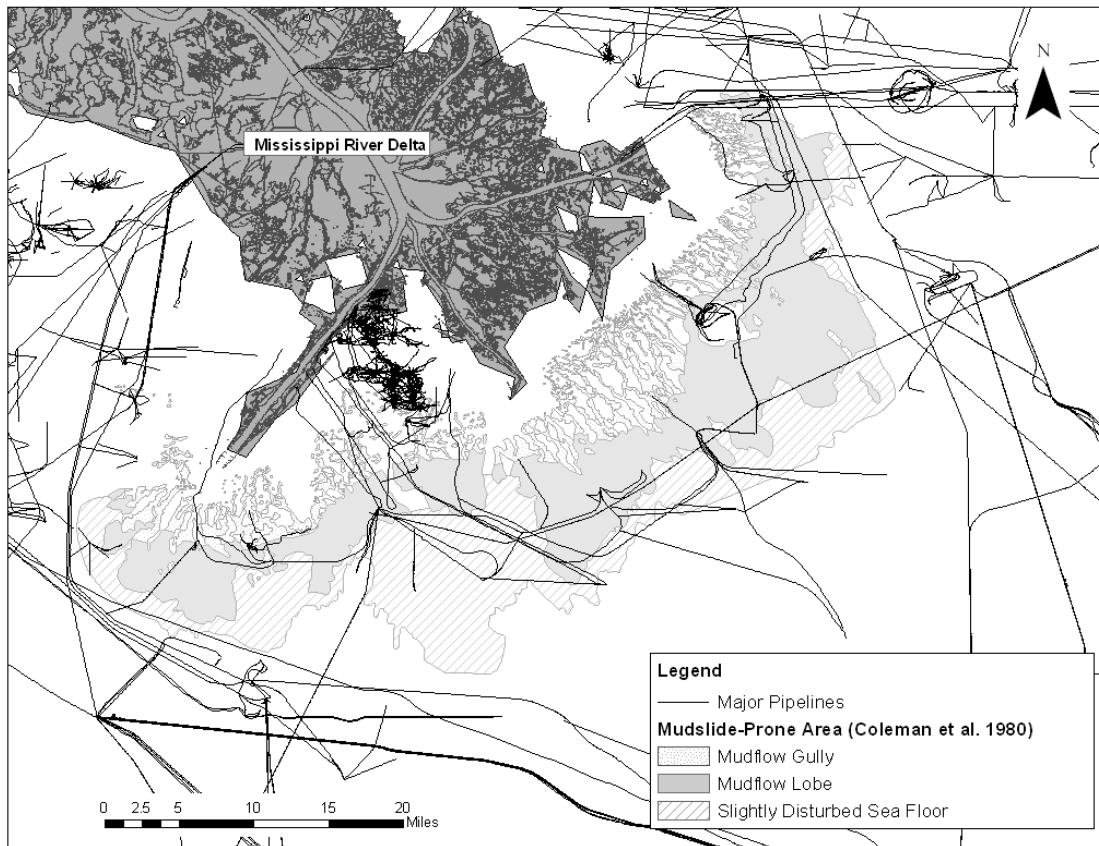
**Figure 7.17 Mudslide-Prone Area (from Nodine et al. 2008)**

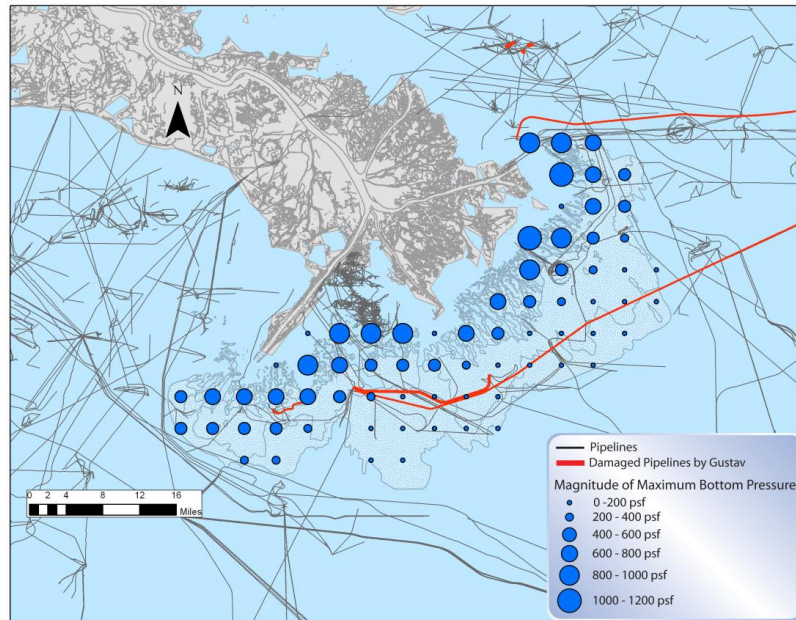
(a) Hurricane Gustav

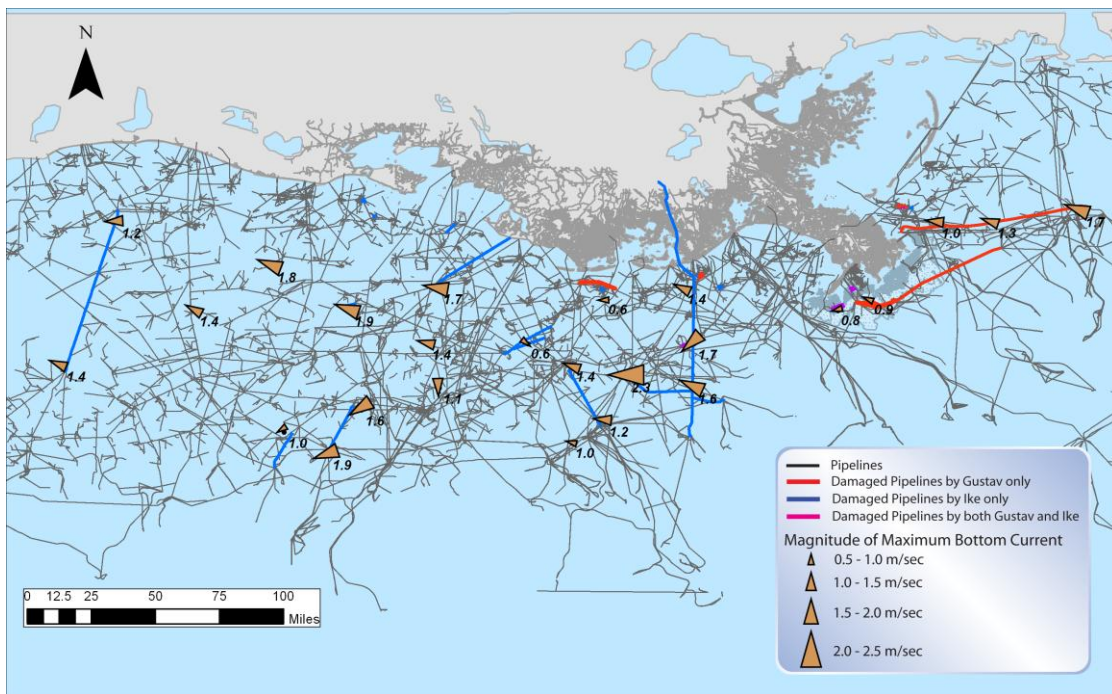
**Figure 7.21 Maximum Depth-Averaged Current Magnitude and Direction for Hurricane Ike with Damaged Pipeline Locations**
