***ASSESSMENT OF DAMAGE AND FAILURE  
MECHANISMS FOR OFFSHORE STRUCTURES AND  
PIPELINES IN HURRICANES GUSTAV AND IKE***

**FINAL REPORT  
February 2010**

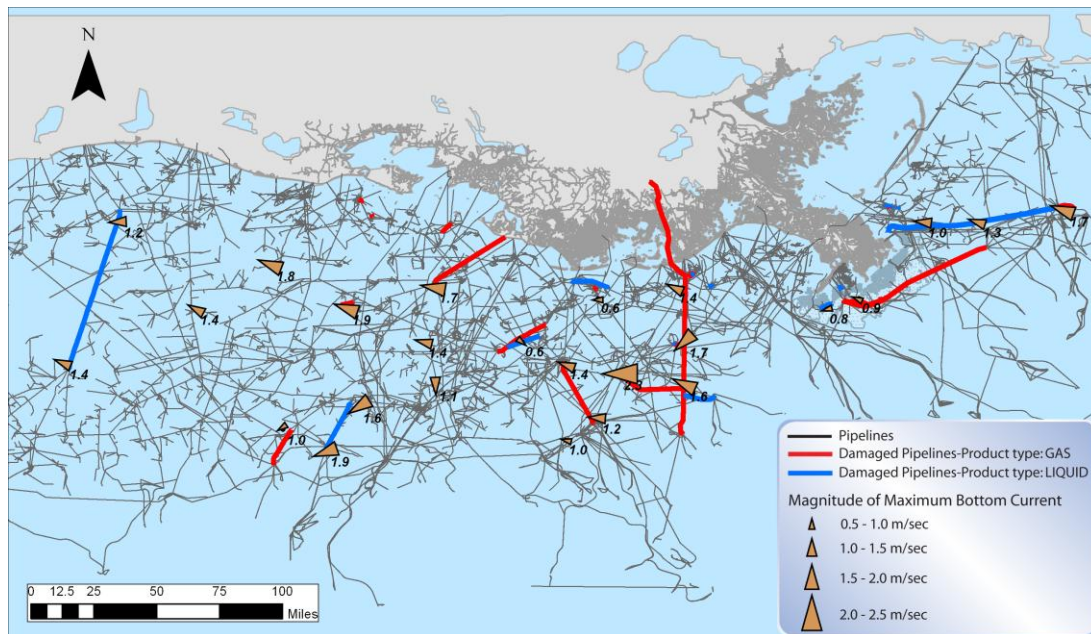
**Figure 7.22 Maximum Depth-Averaged Current Magnitude and Direction for Hurricane and Damaged Pipeline Types**
