BSEE PANEL REPORT 2023-004

Investigation of May 15, 2021, Fatality

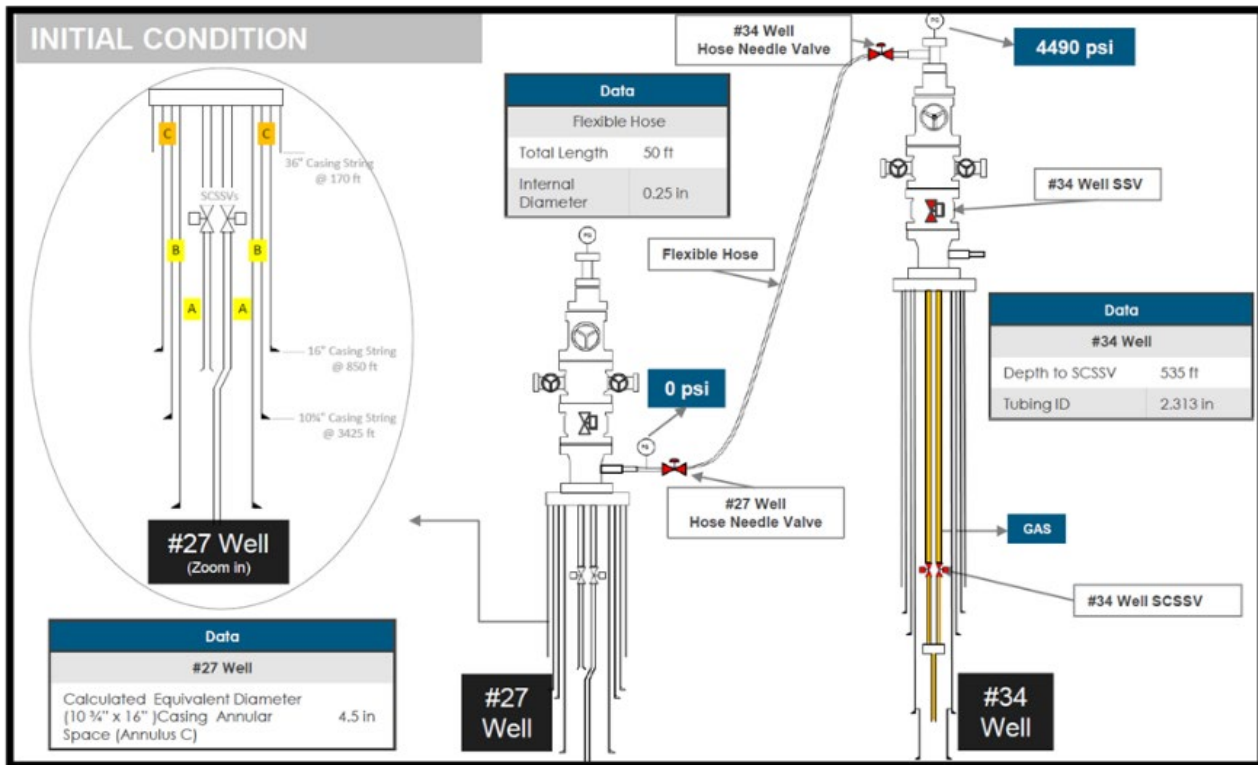
Figure 6 – Initial Condition of Well #27 and Well #34 before Explosion

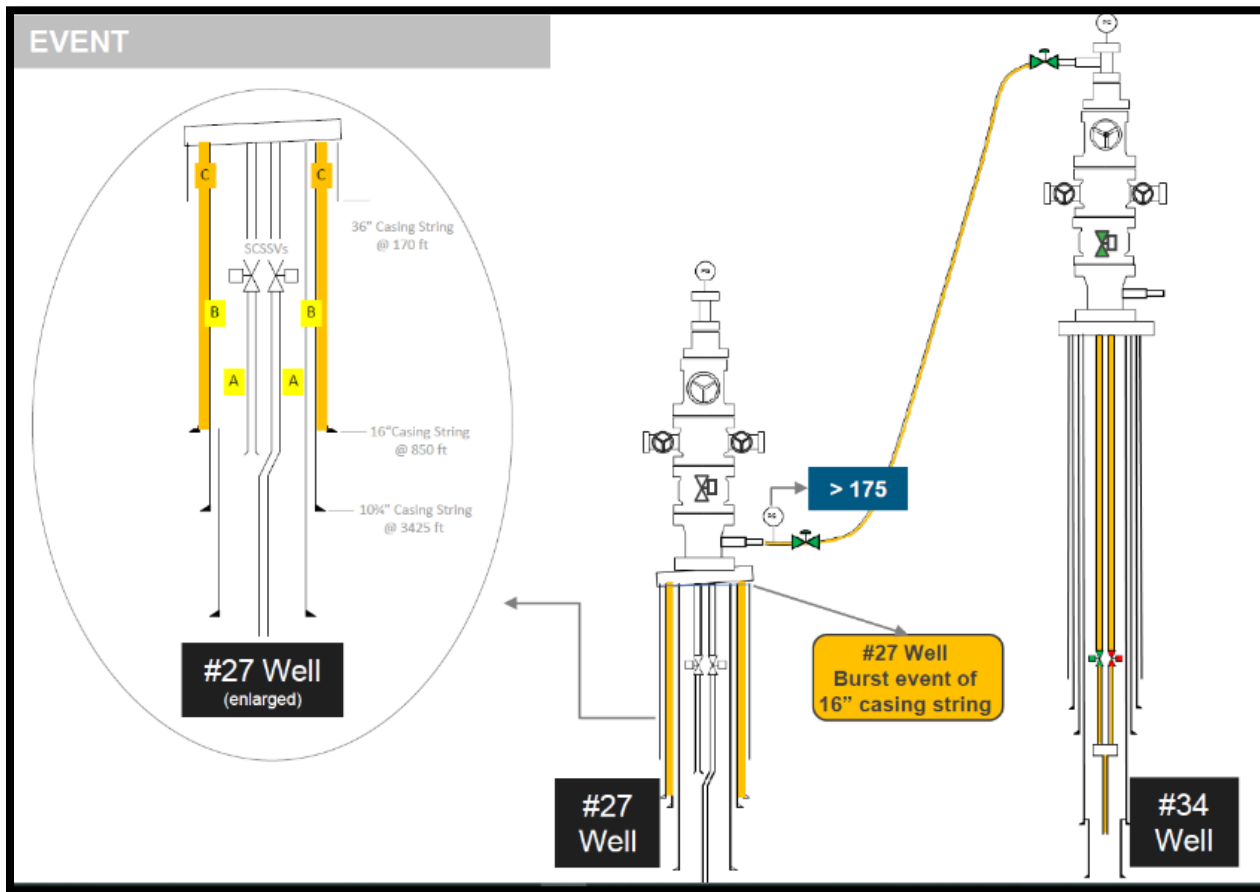
Figure 7 – Condition of Well #27 after Explosion

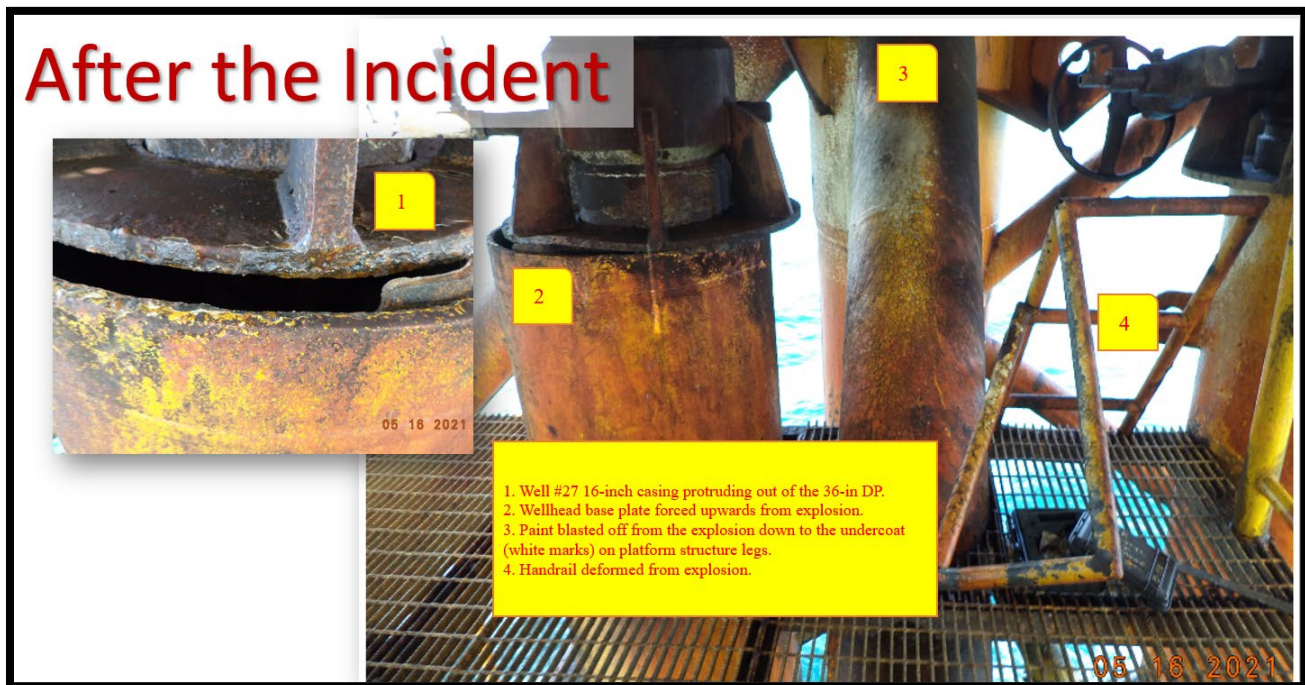
Figure 8 – Photograph of Incident Scene Showing Effect of Explosion

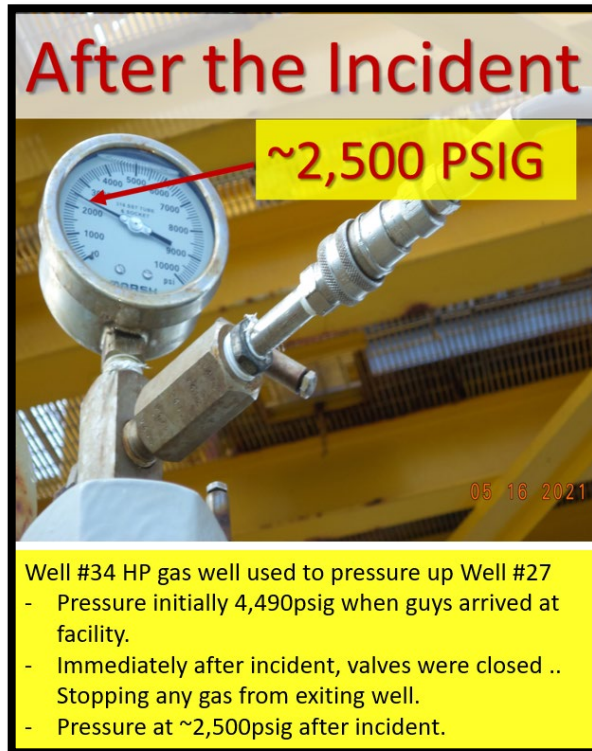
Figure 9 – Post-incident Photograph of Well #34 Shut-In Tubing Pressure

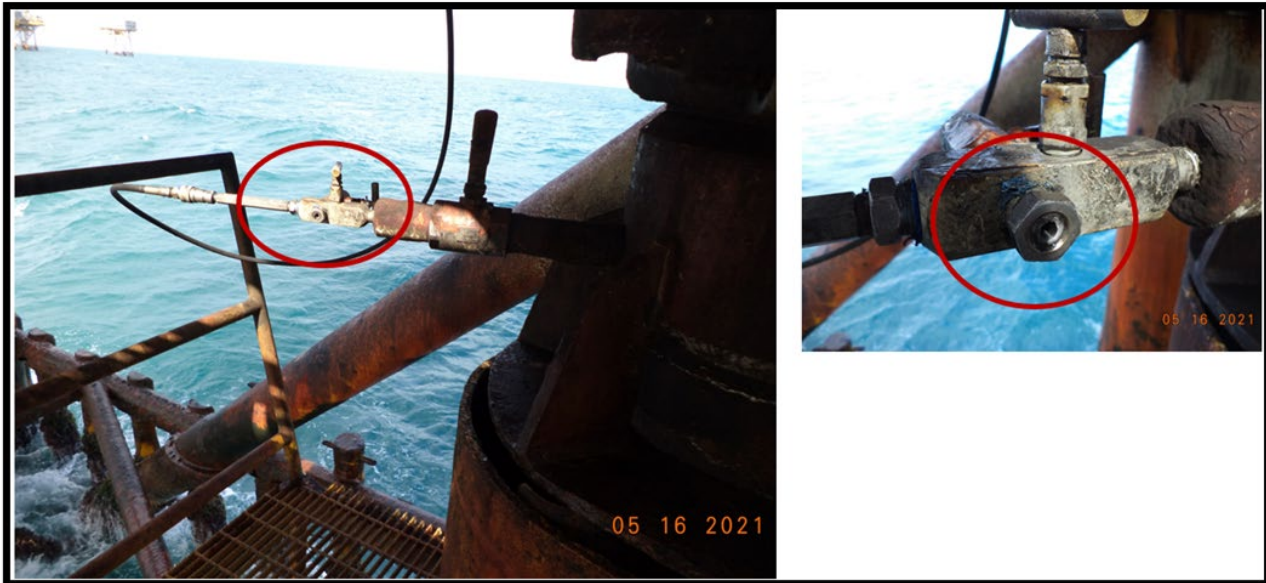
Figure 10 – Digital Gauge Connected to Well #27 16-inch Casing Sheared Off from Explosion

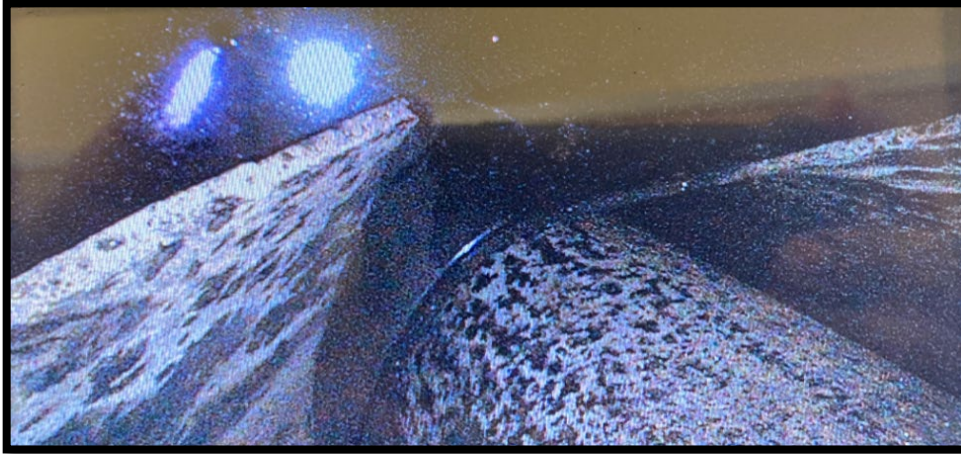
Figure 11 – Photograph of Well #27 Internal Damage of 16-inch Casing

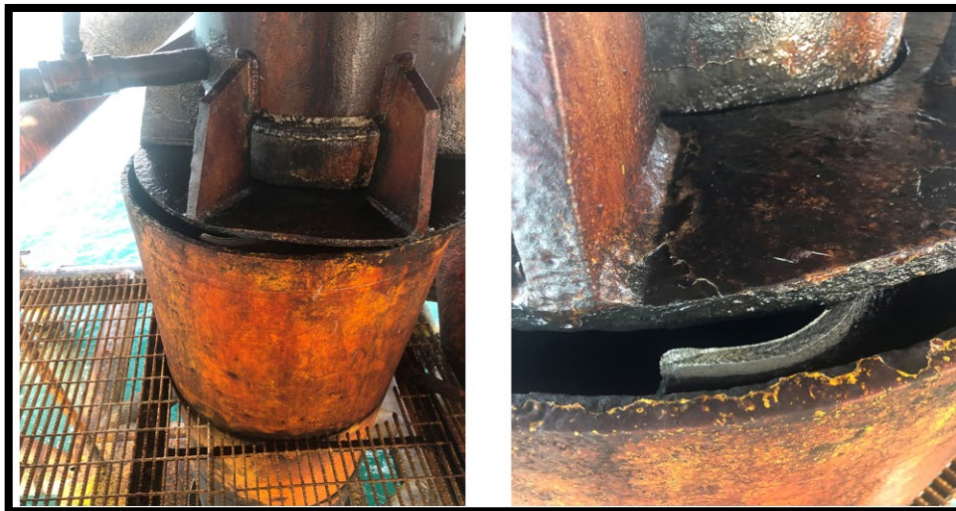
Figure 12 – Photographs of Well #27 Well Head Base Plate, 36-inch DP, and Piece of 16-inch Casing after Explosion
