Safety Alert No. 455

Person Injured When Safety Mechanisms Failed

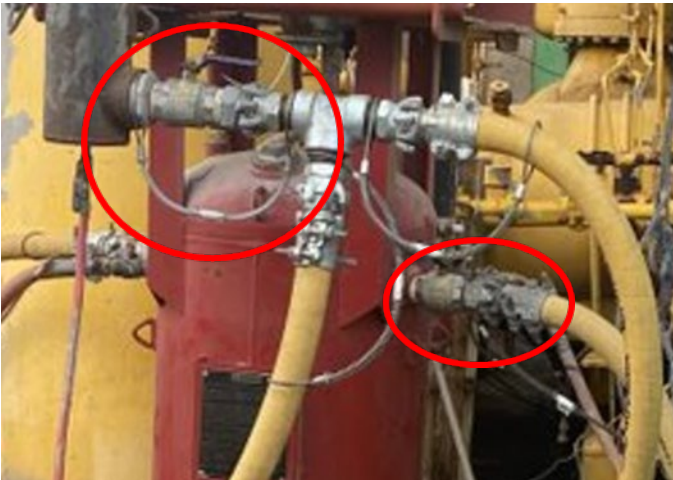
Figure 1 – Temporarily installed air dryer with bull hose connections. Original whip check position (*Left Circle*) and the location of the injured persons hand placement on the air supply valve (*Right Circle*).

- A worker was refilling the sand pot with an abrasive material to continue sandblasting operations.
- After confirming the air supply valve from the temporary air dryer to the sand pot was shut-in, the worker attempted to disconnect the air supply valve (Figure 1 – *Right Circle*) from the air dryer.
- As the worker tried to access this coupling, he loosened the T-connection. The T-connection blew off and broke the braided steel cable (i.e., whip check or safety cable) designed to suppress the hose recoil when a pressurized release occurs.
- The whip check ends were looped between the hose and the coupling connection. (Figure 1 – *Left Circle*).

- Conduct a pre-job hazard assessment with all affected personnel, including facility leadership, to confirm all aspects and associated mitigations of the task are understood.
- Install stainless steel tie wires in addition to whip checks on bull hoses to reduce the risk of disconnection.
- Install 90-degree fittings (Figure 4) to eliminate the horizontal orientation of the supply hose, reducing the stress at each connection.

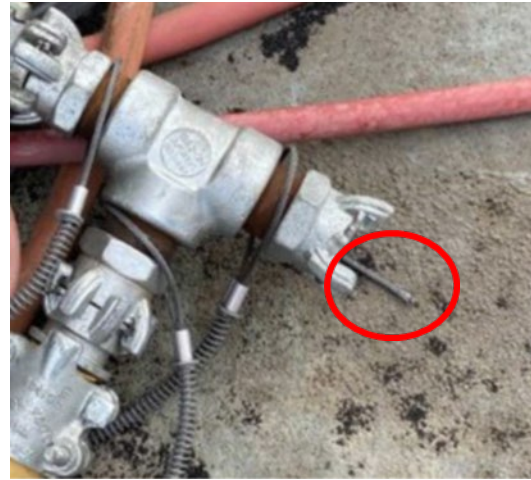
Figure 2 - Broken whip check from the incident.

- The T-connection and broken whip check (see Figure 2) caused multiple cuts and abrasions to the worker's head and shoulders.

- The baling wire involved in the incident (Figure 3) was slightly corroded, potentially diminishing its overall integrity. Baling wire is used as an additional safety measure to ensure couplings are securely connected. It is often used in place of a cotter pin on crowfoot couplings.
- The failed whip check cable was improperly crimped. Crimping the whip check cable before placing it into service allows it to function correctly at its full rated capacity.

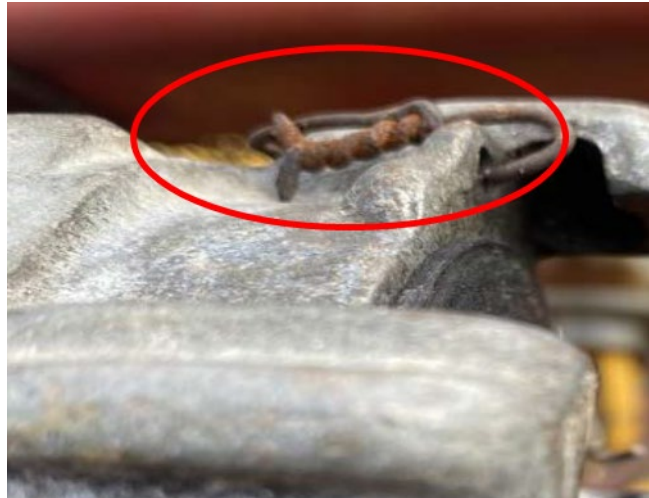
Figure 3 – Baling wire on coupling that released.

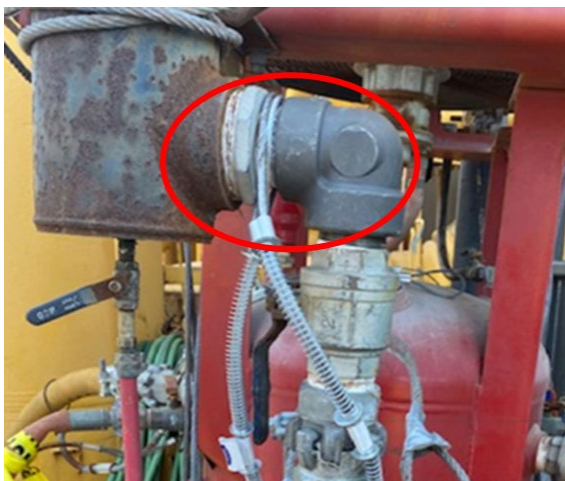
- The bull hose configuration on the air inlet valve from the platform air compressor was installed in a horizontal position. This added weight caused the T-connection to be off-center at the time of operation, adding stress on the associated couplings and baling wire. The added weight, combined with the worker's force when manipulating the air supply valve to the sand pot, resulted in air escaping the inlet valve from the platform compressor, likely causing the connection to come loose.

Figure 4 – 90-Degree fitting recommendation.
