Safety Alert No. 478

BSEE Investigates Three Incidents Caused by Inadequately Maintained Electrical Connections and Compromised Wiring Integrity

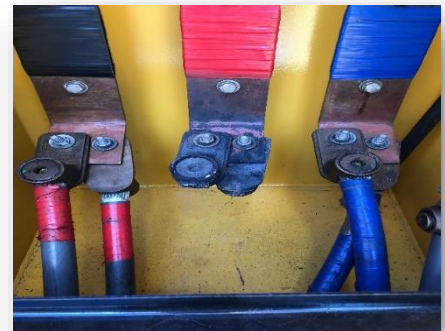
This incident involved a complete power loss of a temporary generator within the production facility. Upon investigation, the platform electrician identified that the 480-volt alternating current (VAC) #2 phase cable had melted off at the generator bus connection (refer to figure 1 & 2). This was attributed to a loose cable connection at the cable lug. In response to the situation, power was switched over to the platform's emergency generator. Fortunately, no injuries or damage beyond the wiring were reported. The root cause of the incident was traced back to the faulty cable connection at the cable lug, leading to excessive heat generation and subsequent cable melting.

Fig. 1 - Melted Cable Lug on Generator.

- Implementing a routine inspection and maintenance schedule for cable connections to ensure secure and correct function.
- Ensuring that personnel involved in cable connections and maintenance receive proper training and understand the importance of secure and reliable connections.

- Reviewing and reinforcing LO/TO procedures to ensure the safe and secure isolation of electrical components during maintenance and investigations.
- Conducting periodic thermographic inspections using a forward-looking infrared (FLIR) camera to identify any signs of overheating or loose connections.

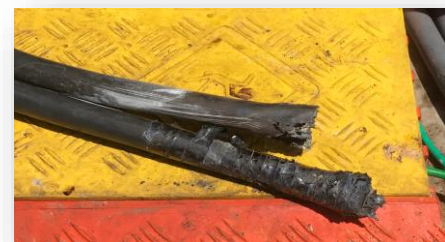
Fig.2 - #2 phase cable melted off lug connection.

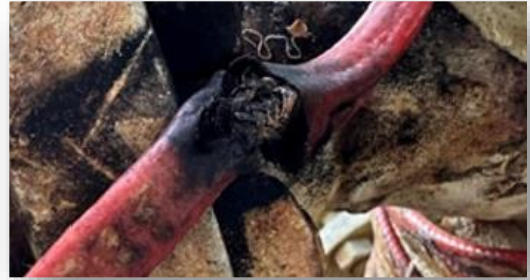
This incident unfolded during a routine nighttime equipment check at a production facility. Crew members detected smoke emerging from a gap in the insulation near the inlet flange on the second flanged section of a fuel gas line run (refer to figure 3). An electrician was alerted and was able to take immediate action by turning off the breaker in the junction box, which supplied power to the heat trace section,¹ ensuring a termination of all power. To prevent smoldering, the crew soaked the insulation with water.

Fig 3 - Damaged insulation on heat trace cable routed along the top of the inlet flange.

Upon subsequent investigations, a break in the heat trace cable insulation on the inlet flange of the gas volume bottle was found. The root cause of this incident was traced back to the failure of the breaker to terminate power to the heat trace, attributed to improper grounding. This failure resulted in excessive heat and smoldering of insulation.

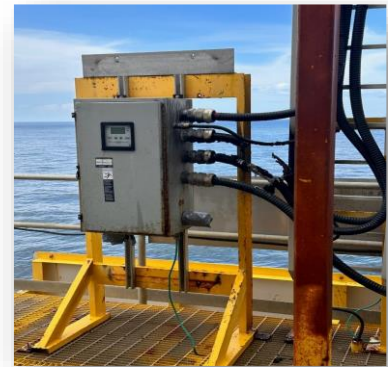
Personnel conducting daily checks during a rainstorm heard a sudden popping sound, which prompted immediate investigations and revealed wires arcing at the junction box (400 Automatic Transfer Switch (ATS)); refer to figure 4) for the gas generator. Personnel promptly initiated an emergency shutdown for the gas generator, activating the emergency diesel generator to supply power to the facility. Personnel strictly followed Lockout/Tagout (LO/TO) procedures as part of the emergency shutdown protocol. All valves to vessels on the facility were isolated and stop work authority² was invoked to ensure immediate safety.

Fig. 4 - Junction Box (400 Automatic Transfer Switch).

Personnel discovered that the top cable on the ATS from the platform diesel generator lacked a traditional drip loop. This absence allowed rainwater to flow onto the live power cable below, leading to its failure. Although designed to withstand weather, the improperly installed cable, exposed to constant sun and rain without adequate

protection, developed small fractures in its casing. Over an undetermined number of years, rainwater seeped into the cable, causing material fatigue, and ultimately resulting in the cable's failure during a thunderstorm.

- Utilizing locking type connections in areas where fouling of electrical lines due to water ingress is a risk.
