Safety Alert No. 481

Hazardous Helideck Conditions Result in Near Miss Incident

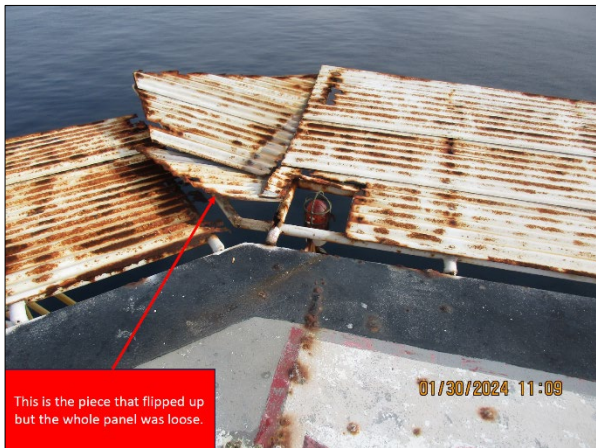
Figure 1. Damaged helideck skirting.

After receiving clearance for landing at an offshore helideck, the aircrew noticed upon landing that a section of the helideck's safety skirting was not properly secured to the support structure and was blowing upward and downward due to the helicopter's rotor downwash. This created an imminent hazard to safe helicopter operations with potentially catastrophic results (Figures 1 and 2).

- Ensuring personnel are aware of and understand related policies and procedures to prevent incidents during helideck operations. This includes verifying the condition of the helideck structure and the potential impacts of simultaneous operations prior to giving clearance to land or takeoff.

- Ensuring proper notifications are made for out-of-service helidecks to the appropriate BSEE District Office and Federal Aviation Administration (FAA) for Notice to Air Mission (NOTAM).

- Ensuring proper markings to identify out-of-service helidecks are clearly visible from the air.
- Ensuring safety-critical operations are well planned with the proper controls in place for flawless execution.

- Monitoring operations for signs of weakness or noncompliance, implementing specific actions to correct any identified issues.
- Developing and implementing facility-specific helicopter operations procedures to eliminate uncertainties and enhance safety protocols.

- Ensuring proper helideck management principles for pre-arrival briefings and toolbox meetings.

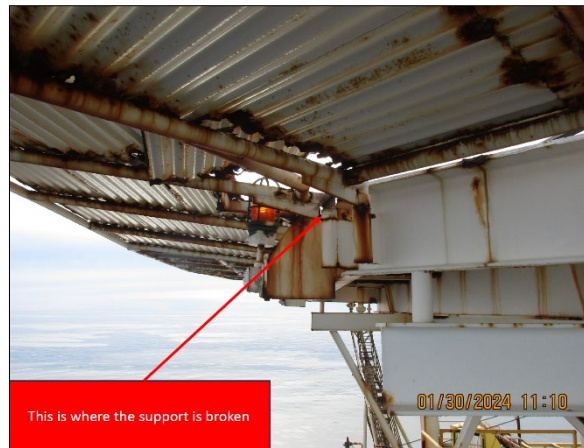
Figure 2. Damaged skirting substructure.
