Safety Alert No. 471

Pipe Bond Failure on Firefighting System Investigated and Repaired

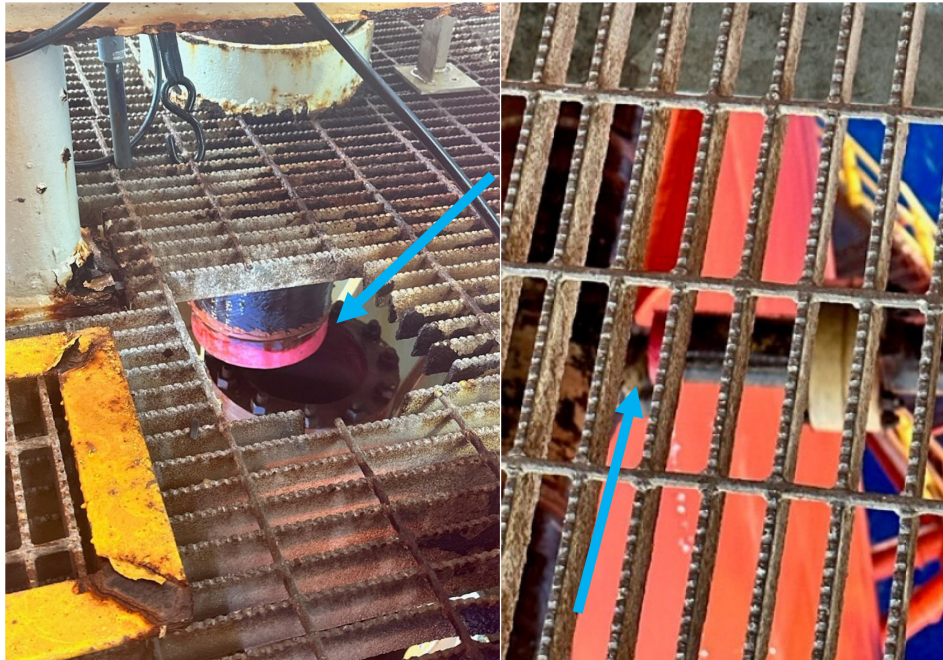
Figure 1: FRP pipes separated from flanges.

BSEE received notification of an incident involving the separation of a section of fiber reinforced plastic pipe (FRP) from its flange. As a safety precaution, production was immediately halted to investigate the situation. During the inspection, the team discovered that a segment of 10-inch FRP piping had disengaged from its attached flange, resulting in a 4-inch pipe also becoming detached due to the movement of the 10-inch pipe (see image above).

The operator identified a bond failure as a potential cause of the separation, which was subsequently addressed to prevent any reoccurrence.

To address the issue, the affected fire loop main was promptly isolated from the rest of the system, allowing the remainder of the system to resume normal operation. Repairs were swiftly carried out on the fire main, and once the necessary repairs were completed, production at the facility resumed.

- Reviewing preventative maintenance records and ensuring adequate inspection and routine checks of firefighting equipment.
- Providing instructions, training, competency assessments, and proper supervision to operators and maintenance personnel.
- Testing, if possible, the connection between the FRP pipe and flange to ensure an adequate seal.
- Visually checking for leaks while the mains are pressurized during routine firewater system tests. According to regulations for fire water systems (as per API RP 14G 4th Edition, Section 5.2), it is essential to maintain sufficient pressure (a minimum of 75 psig) when hose streams are flowing, unless the nozzle manufacturer specifies higher pressure requirements. Even a fire water system with small leaks may initially meet the pressure requirement, but addressing smaller leaks promptly can prevent more significant failures from occurring.
