Safety Alert No. 494

BSEE Investigates Nitrogen Cylinder Rupture Causing Worker Injuries and Equipment Damage; Issues Recommendations to Enhance Safety and Prevent Future Incidents

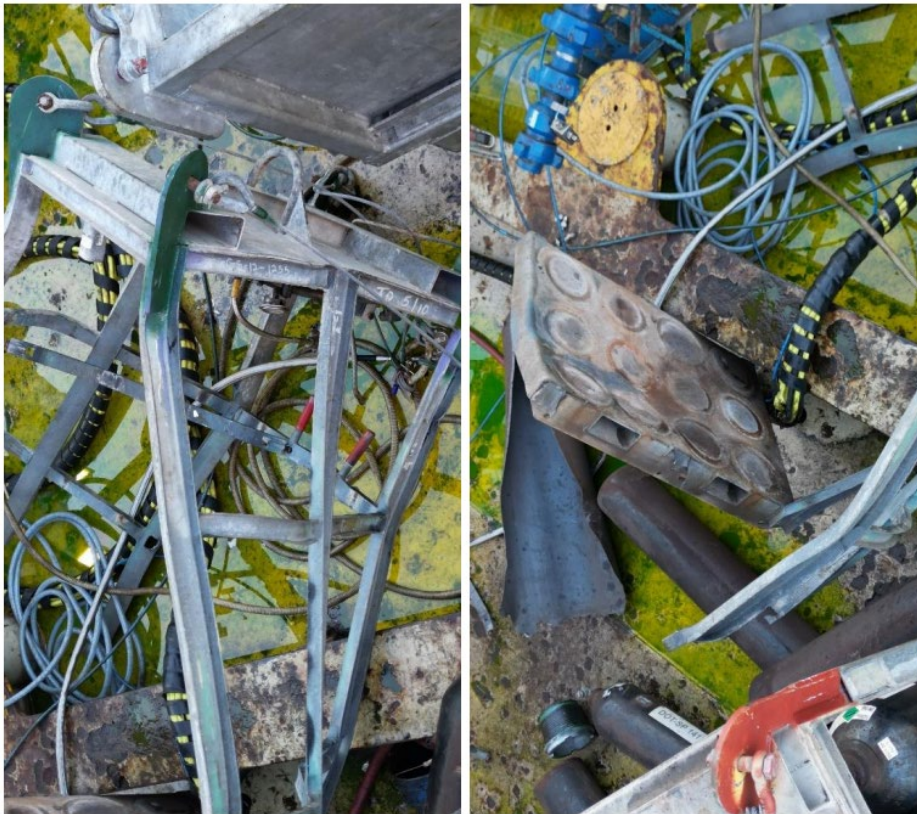
Post-Incident Images of Nitrogen Cylinder Rack and Debris.

The Bureau of Safety and Environmental Enforcement (BSEE) recently investigated the rupture of an improperly inspected nitrogen cylinder that led to multiple injuries and equipment damage. At the time of the incident, rig personnel had positioned a rack with 12 nitrogen cylinders to begin pre-charging the accumulator system cylinders with nitrogen. One of the nitrogen cylinders within the rack subsequently ruptured at its base, resulting in the dispersion of both the nitrogen cylinders and debris that was within the rack, as well as of the remaining cylinders situated in the immediate and port aft areas of the rig. Three rig personnel sustained minor injuries from shrapnel.

The failure of the nitrogen cylinder, which is attributed to corrosive wall loss exacerbated by environmental factors and structural conditions, highlights critical vulnerabilities in the storage and maintenance of nitrogen cylinders, particularly in marine environments. The presence of crevices at the base of the cylinders, combined with moisture accumulation, significantly accelerated the corrosion process, leading to the hazardous failure. Heavy deterioration of the galvanic coating on the storage rack further compounded the failure, indicating systemic neglect of maintenance protocols that could prevent such incidents.

BSEE recommends that operators and their contractors, where appropriate, do the following:

- Ensure that all cylinders are properly labeled and marked with the appropriate United States Department of Transportation (DOT) identification number.

- Verify that all cylinders are within their recertification period and have been properly recertified.
- Ensure that all cylinders are filled to the appropriate pressure and the filling process is properly documented.

- Train all personnel handling and transporting high-pressure cylinders on the proper procedures and safety precautions.
- Train all personnel on the importance of monitoring environmental conditions and identifying the early signs of corrosion.

- Foster a culture of safety and diligence regarding the handling and maintenance of gas cylinders.
- Regularly review and update high-pressure cylinder safety procedures to ensure compliance with current DOT regulations.

- Implement a robust inspection program and monitoring system to track the condition of high-pressure cylinders and storage racks regularly. Establish a reporting mechanism for any observed deterioration or safety concerns.

- Establish a routine maintenance schedule that includes cleaning, inspection, and protective coating application to prevent corrosion. This should also involve checking for and addressing any crevices or pooling of water around the bases of the cylinders.
