Special Report 84-2

**US Army Corps
of Engineers**

Ice observation program on the semisubmersible drilling vessel SEDCO 708

L. David Minsk

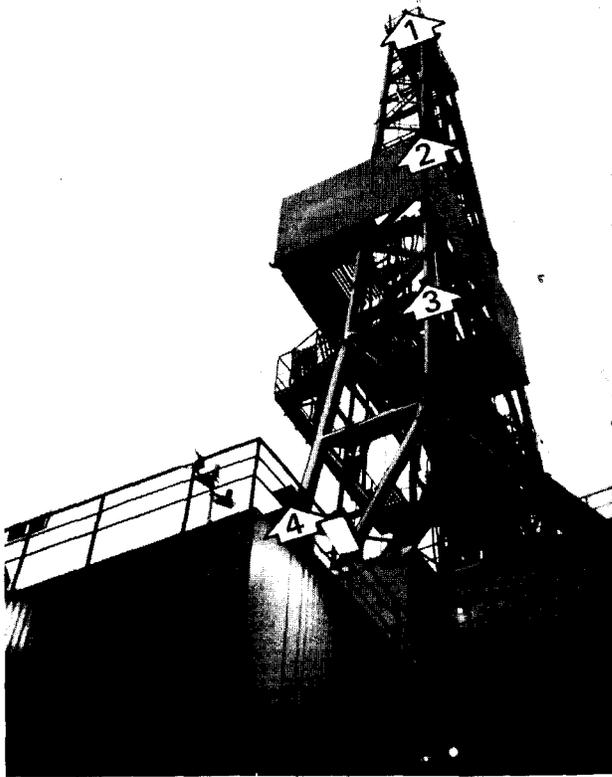
Figure 3. Locations of Rosemount ice detectors on derrick. Heights (above deck) are 1 - 180 ft; 2 - 120 ft; and 3 80 ft. Number 4 is on the railing above the diving bell area, about 20 ft above deck.

Three of the ice detectors were located on the derrick at heights above the deck of 80, 120 and 180 ft (Fig. 3). The fourth detector was mounted on the railing on the roof of the diving bell storage area, about 20 ft above the deck.

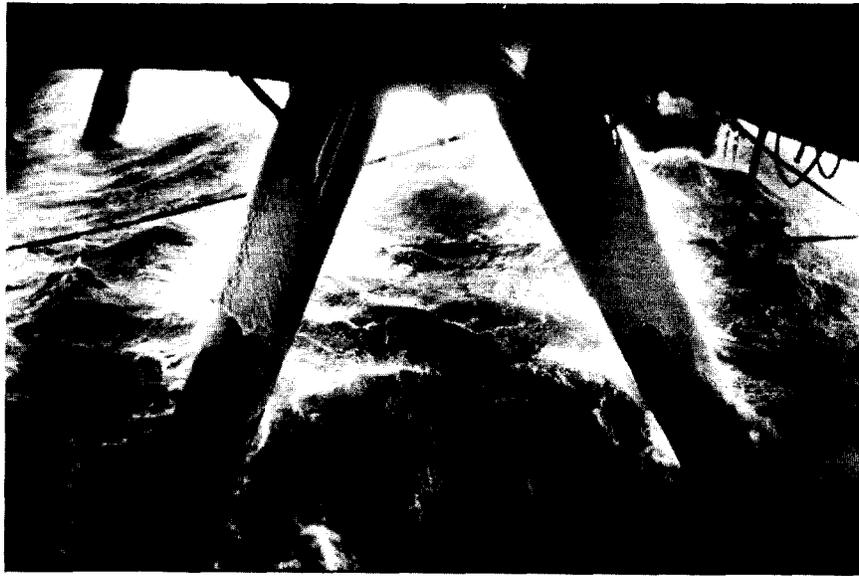
Figure 9. Ice accumulation on diagonal cylindrical trusses under rig (immediately aft of below-deck porthole), which reached a thickness of about 5 in. at bottom, tapering to near zero at underside of main deck. View southwest from below-deck porthole of aft port area (6 January 1983).

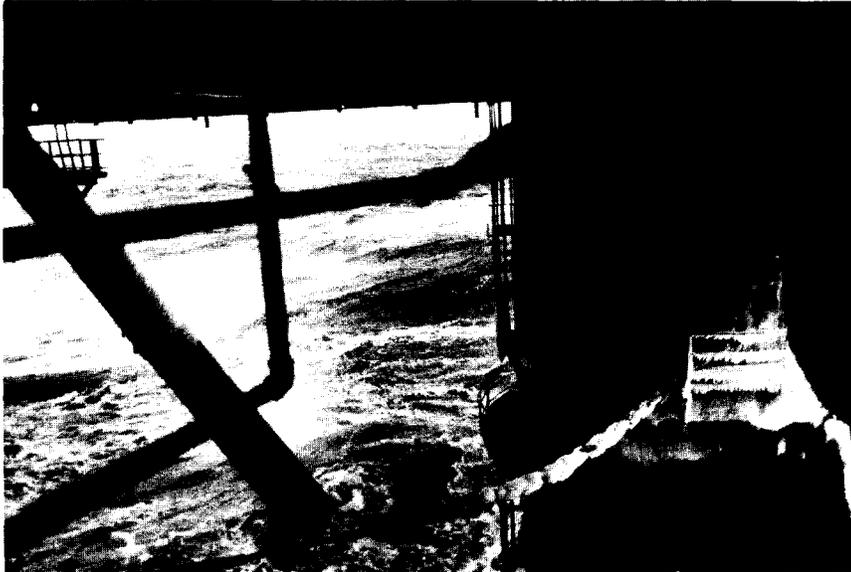
Figure 11. View southwest from below-deck porthole of forward port column; note that underside of deck has no ice accumulation (6 January 1983).
