**THE BUREAU OF OCEAN ENERGY MANAGEMENT,
REGULATION AND ENFORCEMENT**

**REPORT REGARDING THE CAUSES OF THE APRIL 20, 2010
MACONDO WELL BLOWOUT**

September 14, 2011

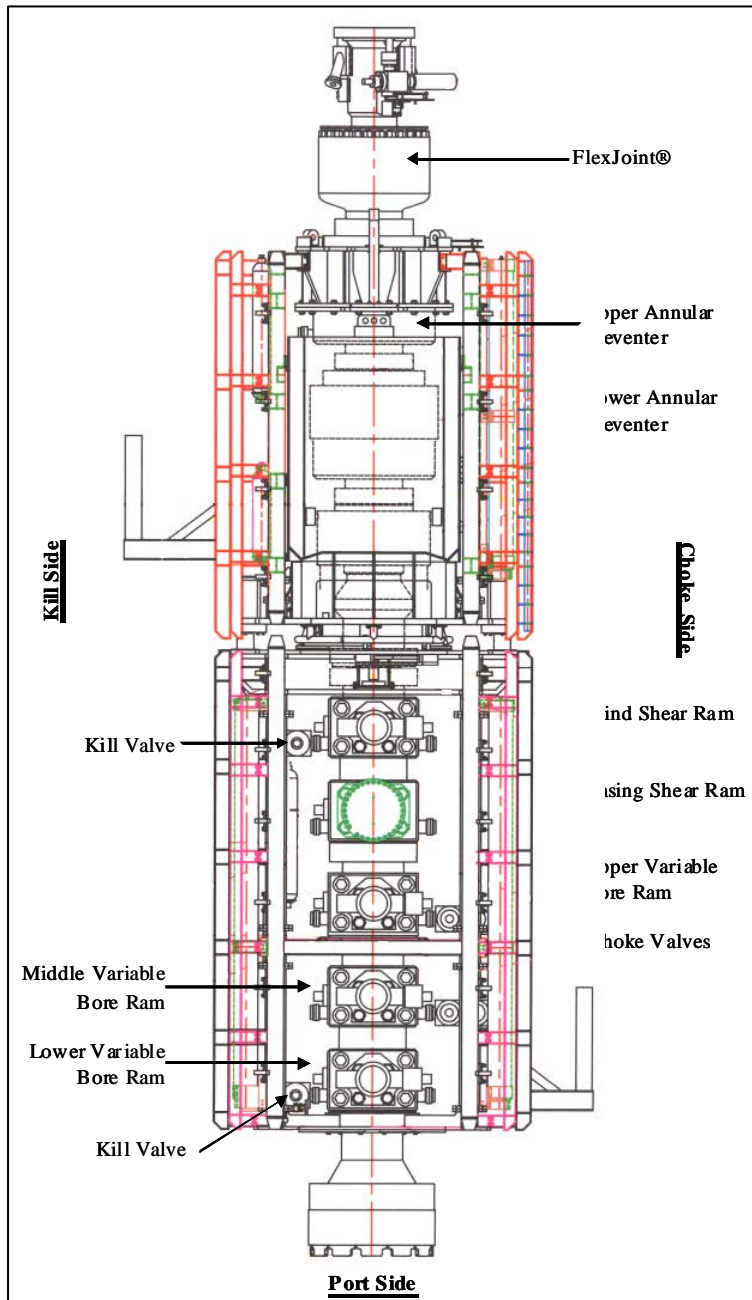
Figure 10 – Schematic of the *Deepwater Horizon* BOP Stack

The *Deepwater Horizon* BOP assembly consisted of two major sections: the stack and the lower marine riser package (*see* Figure 10). At the time of the blowout, the major components of the *Deepwater Horizon* main stack consisted of the following:
