BSEE PANEL REPORT 2024-01

**Investigation of March 25, 2022, Hydraulic Workover Unit Failure Fatality**

**Lease OCS-G04909**

**Main Pass Block 64 Platform #19**

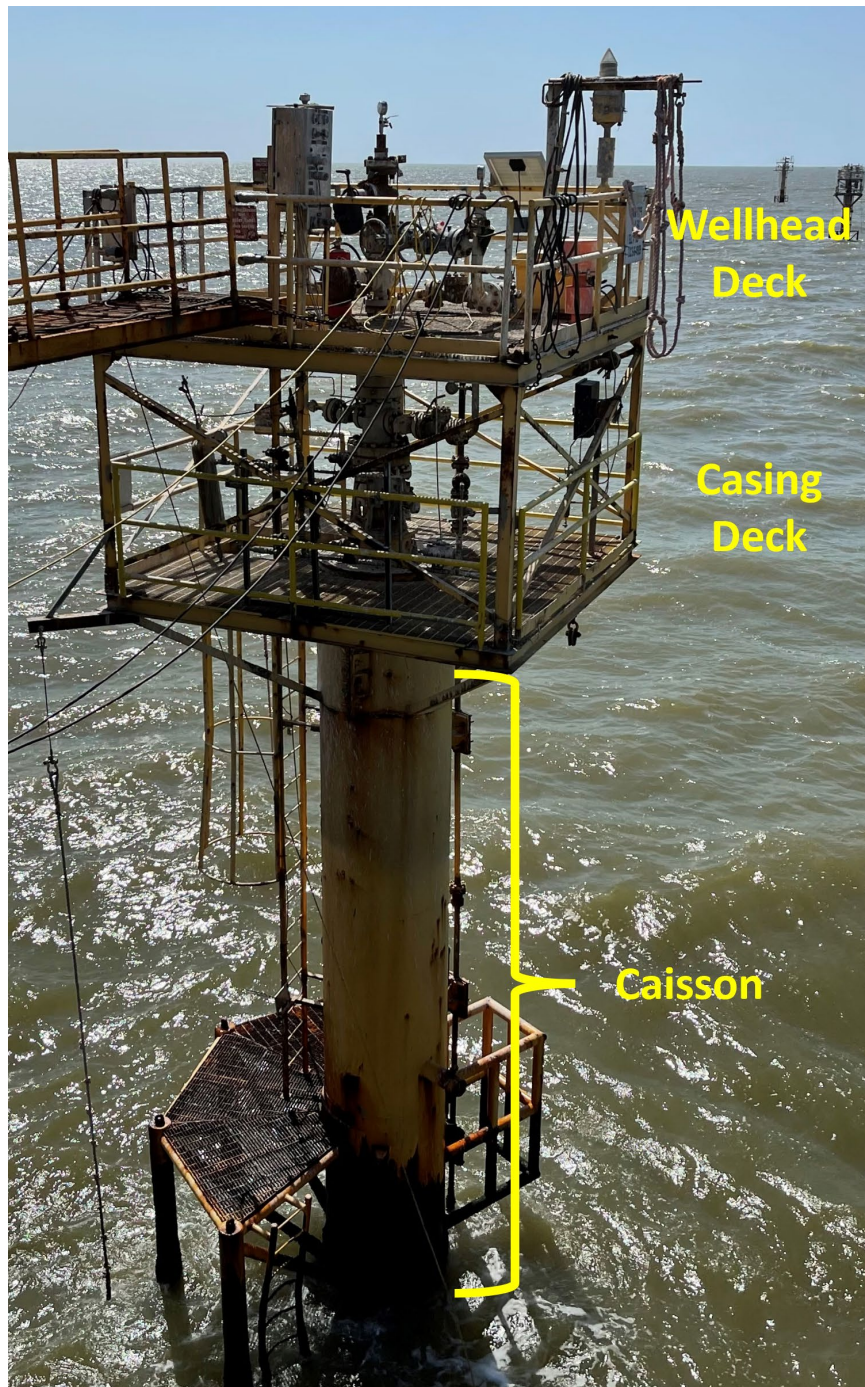
Figure 2: View of Main Pass 64 #19 Platform from L/B Swordfish Pre-Incident

MP 64 #19, shown in Figure 2, is a single well caisson structure with a water depth of 36 feet. Howell Petroleum Corporation installed the platform in 1991. The platform consisted of a wellhead deck and casing deck (Figure 2).

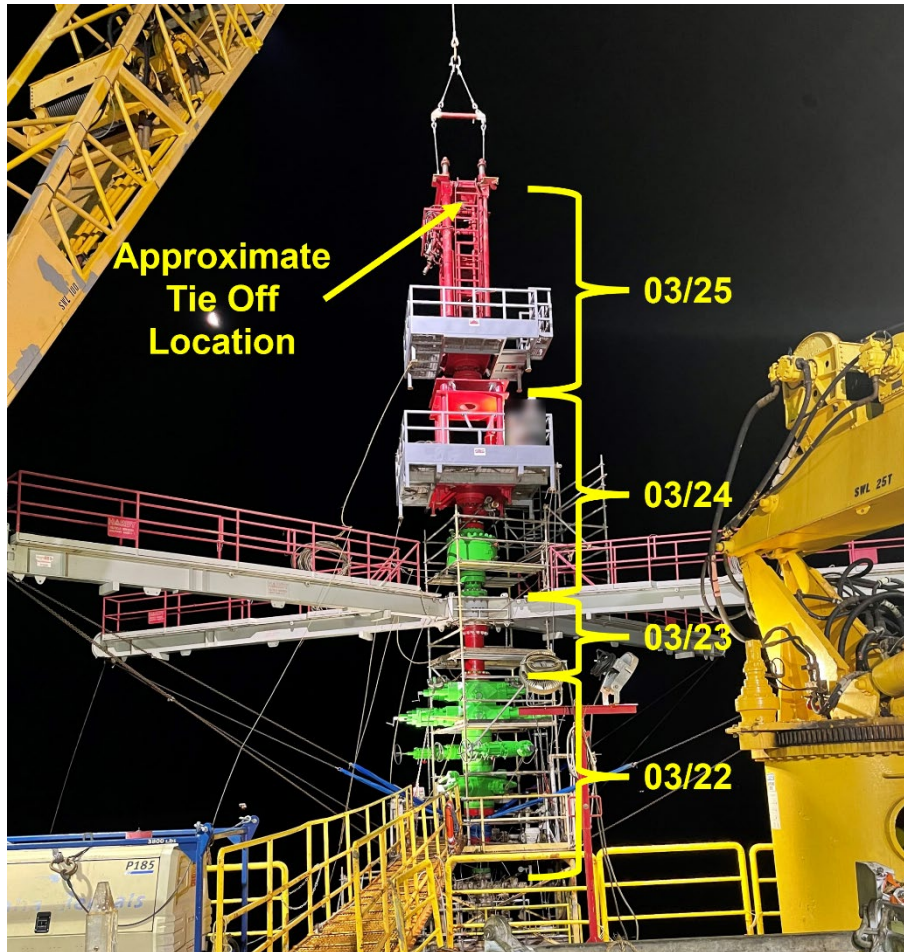
Figure 3: HWU Makeup Process by Day

March 22, 2022: at approximately 1000 hours, Fastorq personnel started the production tree removal operations. At approximately 1500 hours, the day crew made up an adaptor riser spool along with a single pipe ram, flow cross, and double pipe ram to the wellhead (Figure 3). That morning, SBS personnel noticed that the locations on the platform I-beams where the pad eyes were welded needed to be reinforced due to metal loss from corrosion. The welders were called back out to add material to the corners of the platform's I-beams to strengthen the sites where pad eyes were welded. At approximately 1800 hours, a construction crew began installing

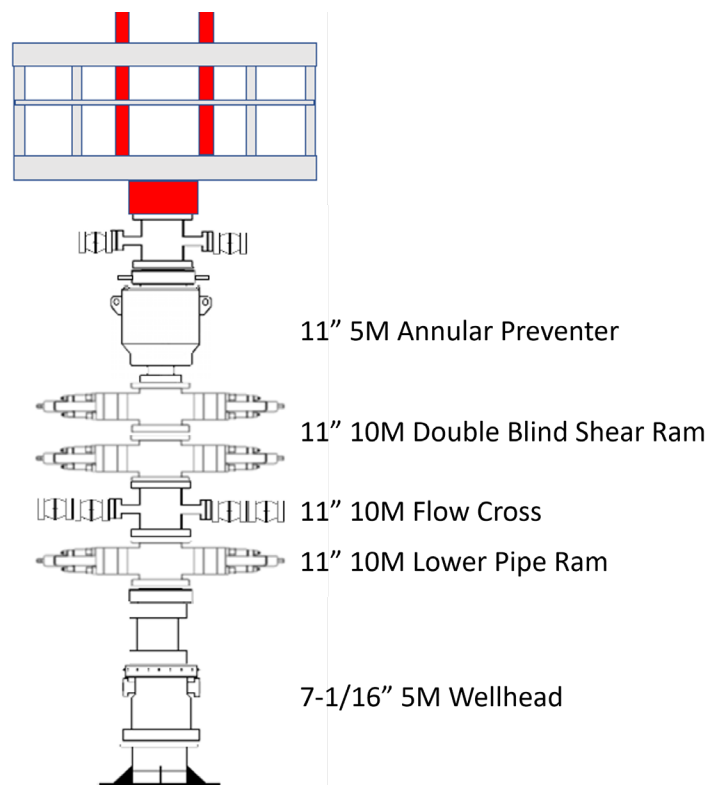
Figure 5: Annotated BOP Stack Diagram

SBS was installing its hydraulic workover and snubbing signature 340k unit. The 340k denotes that the maximum pull capacity of the pipe jack is 340,000 pounds. The pressure ratings of BOP system components are identified as 5M, 10M, or 15M, and these ratings correspond to 5,000 psi, 10,000 psi, and 15,000 psi, respectively. The BOP system in use at the time of the incident consisted of an 11-inch 10M lower pipe ram, a flow cross, a double blind/shear ram, an 11-inch 5M annular preventer, and assorted adaptor/spacer spools (Figure 5). An adaptor spool was used to make up the 11-inch 10M lower pipe ram to the 7-1/16-inch 5M wellhead. The rig up of the HWU in this incident used a piece of equipment from HOS called the Anchor Spool. The Anchor Spool was located between the double blind/shear ram and the annular preventer. The total weight of the equipment on the wellhead, axial load, at the time of the incident was approximately 120,000 pounds.
