Safety Alert No. 490
October 10, 2024

Delay in Publication of Derated Helideck Weight Capacity Leads to Near Miss Incident

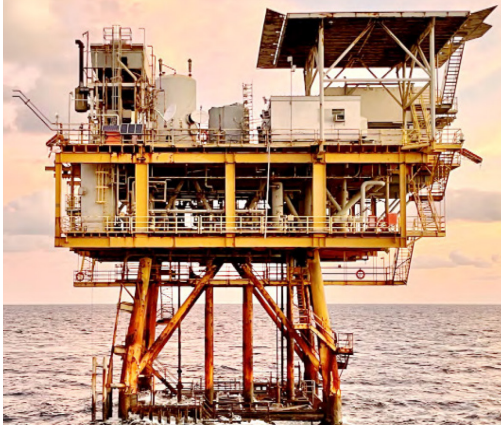
Figure 1. Offshore Facility

The Bureau of Safety and Environmental Enforcement (BSEE) has observed a concerning trend of safety incidents linked to unsafe helideck conditions and improper adherence to established protocols. A recent near-miss incident that occurred during a helicopter flight to an offshore facility that had recently downgraded its helideck weight capacity serves as a precautionary example and underscores the critical need for effective communication and protocol compliance regarding helideck operations and conditions.

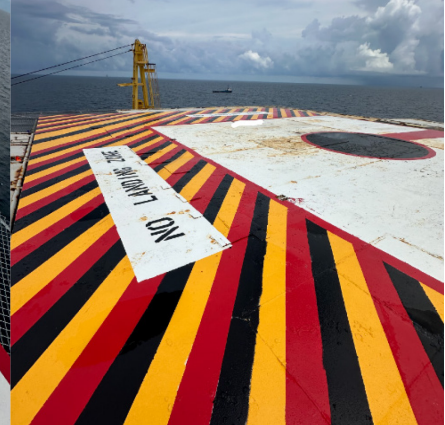
Figure 3. Helideck Safety Labeling

Upon arrival and prior to landing at the facility, the pilot observed a freshly painted red-hatched area and a new visible weight rating of 6,000 lbs. (Figure 2) After verbally confirming with the platform operator over the radio that a helideck downgrade had occurred, the pilot deemed it unsafe to land. The pilot informed the flight operations center to revise the flight plan for a safe landing at a nearby facility.

This incident highlights the risks associated with delaying the publication of accurate helideck conditions. While the pilot's alertness prevented a potential incident, the event underscores significant gaps in communication and documentation procedures.

- Ensuring all helideck conditions are accurate, validated, and published, including recent updates and/or deratings, through direct communication with facility operators and the FAA.

- Verbally confirming helideck weight ratings and conditions before takeoff and just prior to landing, especially for decommissioned or modified structures.

- Implementing mandatory checks to confirm helideck capacities and conditions regularly.
- Reinforcing clear communication of helideck status changes to all personnel, ensuring updated information is accessible.

- Implementing continuous monitoring of helideck conditions and markings and updating operational protocols as needed.
