BSEE Panel Report 2023-001

Investigation of July 25, 2020, Flowline Jumper Failure

Lease OCS-G34536

Green Canyon Area Block 40

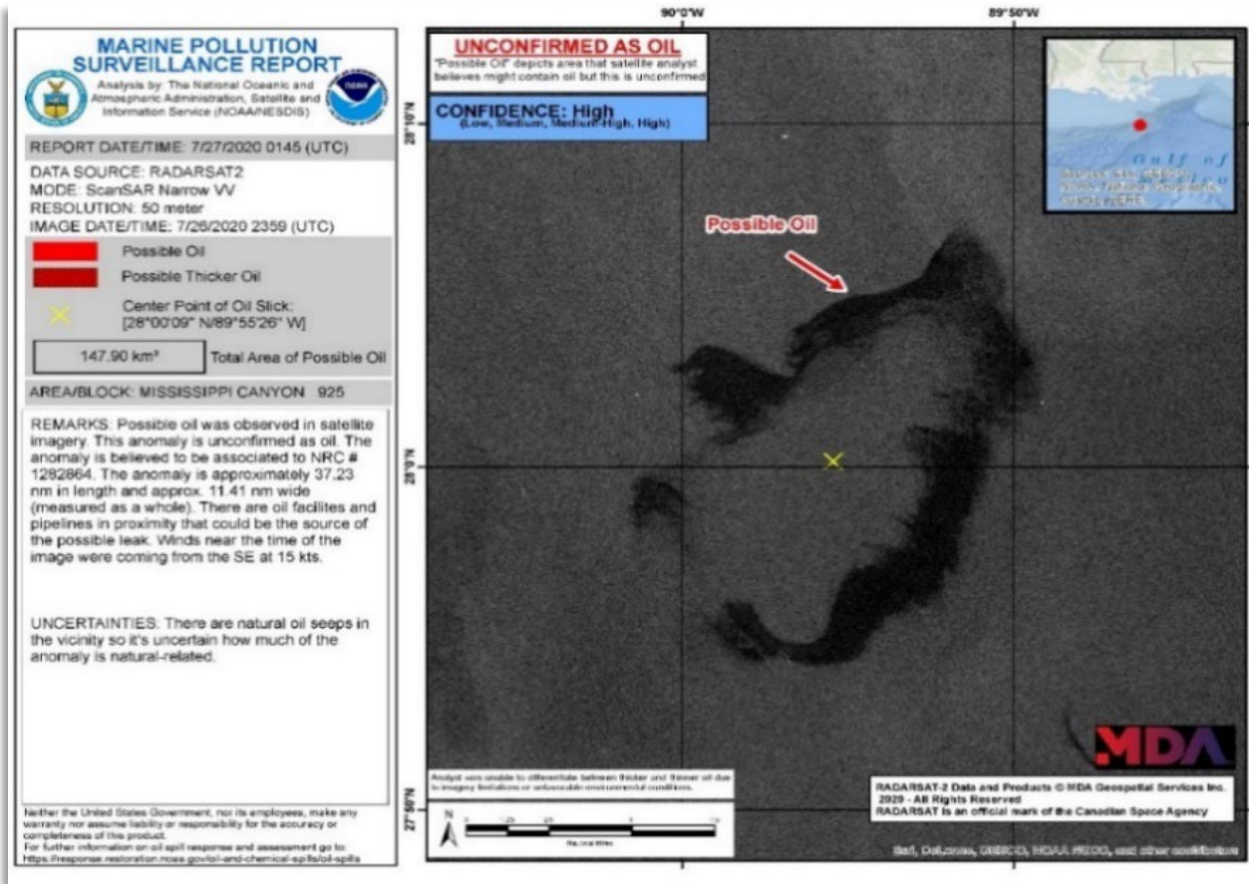
Figure 5: NOAA MPSR dated July 27, 2020, 0145 (UTC)

On July 26, 2020, at 8:45 p.m. a Marine Pollution Surveillance Report (MPSR) was issued by the NOAA Satellite Analysis Branch (SAB) showing an anomaly of possible oil a few miles from the K1 Well in GC Block 40 (Figure 5). The report displayed a satellite image from July 26, 2020, at 6:59 p.m., which the BSEE Panel concluded is related to the NRC report describing the discovery of a large slick coming from a flowline associated with an offshore oil well in GC Block 40. The anomaly was measured at 37.23 nautical miles in length and 11.41 nm wide (measured as a whole), with a 147.9km² total area of possible oil.
