Society of Naval Architects & Marine Engineers
Northern California Section
Student Paper Presentation
April 9, 1992

The Grounding of *Exxon Valdez*: An Examination of the Human and Organizational Factors

by
William H. Moore, Student Member
Department of Naval Architecture & Offshore Engineering
University of California at Berkeley

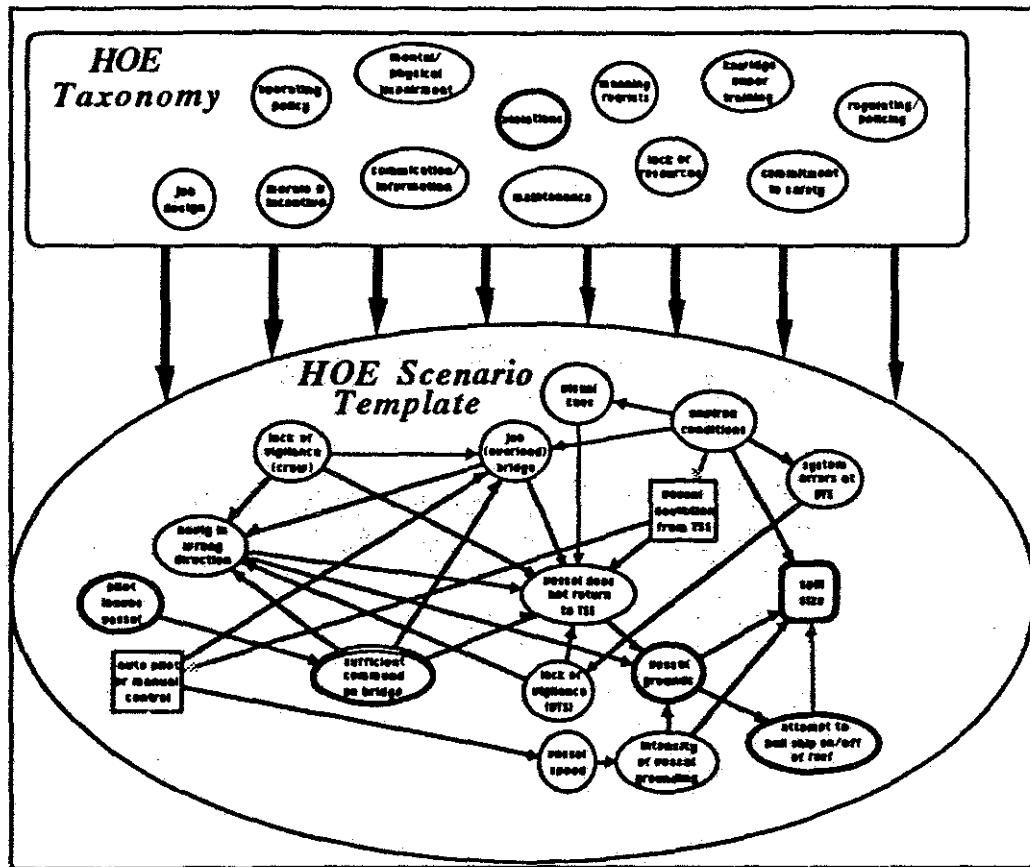
Figure 6: Influence diagram template for vessel groundings

There are three primary purposes of conducting post-mortem HOE analysis studies such as the one being conducted on *Exxon Valdez*. First, well documented case histories can give valuable insight into the interaction of causal factors over an extended time. This assists in determining the sources of human errors in various states and stages of accident scenarios. Second, they provide a basis in which to examine the effects of HOE management alternatives of various classes of accidents. Figure 4 provides a basis for a "template" to examine the impacts of OPA 90 and similar existing regulation, policy or operating procedures. Third, general templates are to be formed to examine the impact of a class of accidents similar to *Exxon Valdez*. For example, Figure 6 is a generalized template of the class of grounding accidents. Establishing dependencies between events, decisions, and HOE causes would be at the discretion of the user. Additional nodes and arcs unique to the operating system, environment, procedures or policies are added by the users. The models are then evaluated to determine the overall failure probabilities.
