Safety Alert No. 479

January 16, 2024

## Lack of Adherence to Helideck Safety Procedures Results in Series of Near Miss Incidents

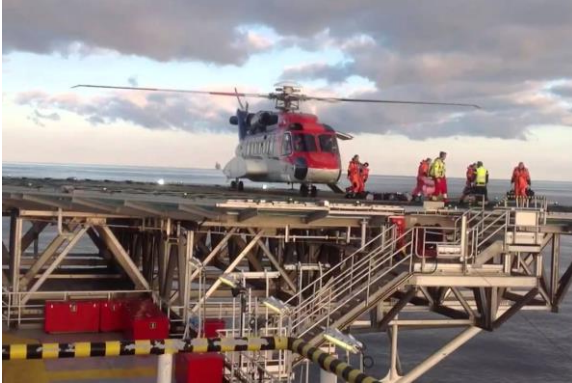
Figure 1: Offshore Helideck in Operation.

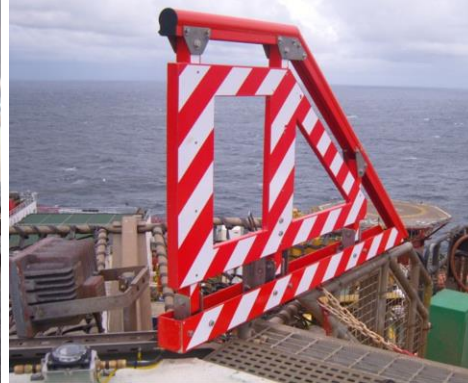
Figure 2: Stowable Handrail on Helideck.

A helicopter was erroneously given a green deck clearance for landing despite the hazard posed by a stowable helideck handrail that had been left in the up position. The air crew recognized the hazard and promptly communicated with the ground crew to avoid the hazard. Because of effective communications and prompt actions, a potential serious aviation incident was averted.

**In light of the above incidents, BSEE recommends that operators and their contractors, where appropriate, consider the following:**

- Ensuring personnel are instructed and familiar with related policies and procedures to prevent incidents during helideck operations.
- Ensuring safety-critical operations are well planned, with the proper controls in place for flawless execution.
- Reviewing policy guidelines in the organizational Health, Safety and Environmental (HSE) manual, including area-specific regulatory requirements and recommended practices.
- Evaluating operations for signs of weakness or noncompliance, implementing specific actions to correct any identified issues.

- Developing and implementing facility-specific helicopter operations procedures to eliminate uncertainties and enhance safety protocols.
- Considering proper Helideck Management Principles for Pre-arrival Briefings and Toolbox Meetings.
