Safety Alert No. 488

BSEE Alerts Offshore Workers to the Potential Risk of Flash Fires During Welding Operations

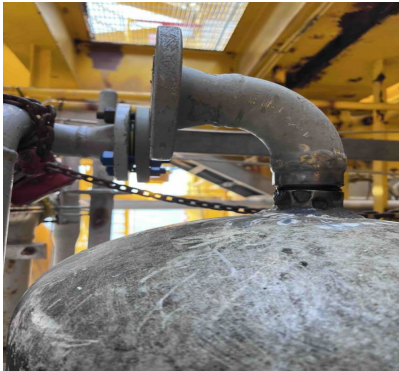
Figure 1. Installation of new nozzle.

The incident occurred during a welding operation with a fit-up nozzle (Figure 1). As the welder was completing the first tack weld and commencing the second, vapors inside the tank ignited, triggering a flash fire and a subsequent blast that propelled the welder against a rail. The welder was properly tied off, so did not sustain injuries.

- Conduct thorough checks for potential hazards prior to any welding or hot work activity, including vapor presence and explosive limits. Verify the integrity of equipment such as fuel gas scrubbers and vessels to ensure they are properly sealed and filled with inert substances like water.

- Establish clear protocols for performing hot work, including welding, cutting, and grinding. This should include obtaining appropriate permissions and conducting necessary safety assessments, such as checking for flammable vapors and ensuring adequate ventilation.

- Implement engineering controls to minimize the risk of flash fires, such as installing flame arrestors or inert gas purging systems in areas where hot work is conducted on potentially flammable equipment.

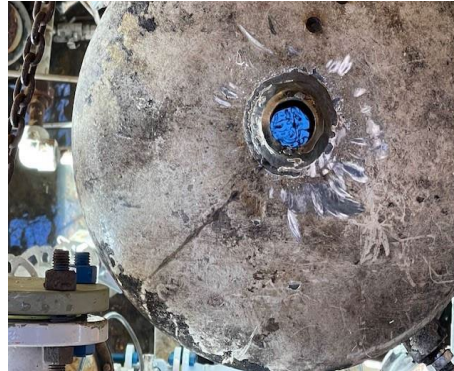
Figure 2. Nozzle removed from top of vessel.

Preparations preceding the incident involved cutting a nozzle off the top of a pressure vessel¹ (Figure 2), with supervisor approval to proceed. After cutting and grinding the bevel, operations were paused until the necessary spool piece arrived. Once the spool
